Public Health Assessment for

**FLORIDA STEEL CORPORATION
INDIANTOWN, MARTIN COUNTY, FLORIDA
CERCLIS NO. FLD050432251
SEPTEMBER 10, 1992**

PUBLIC HEALTH ASSESSMENT
FLORIDA STEEL CORPORATION
INDIANTOWN, MARTIN COUNTY, FLORIDA
CERCLIS NO. FLD050432251

Florida Department of Health and Rehabilitative Services
Under a cooperative agreement with:
Agency for Toxic Substances and Disease Registry

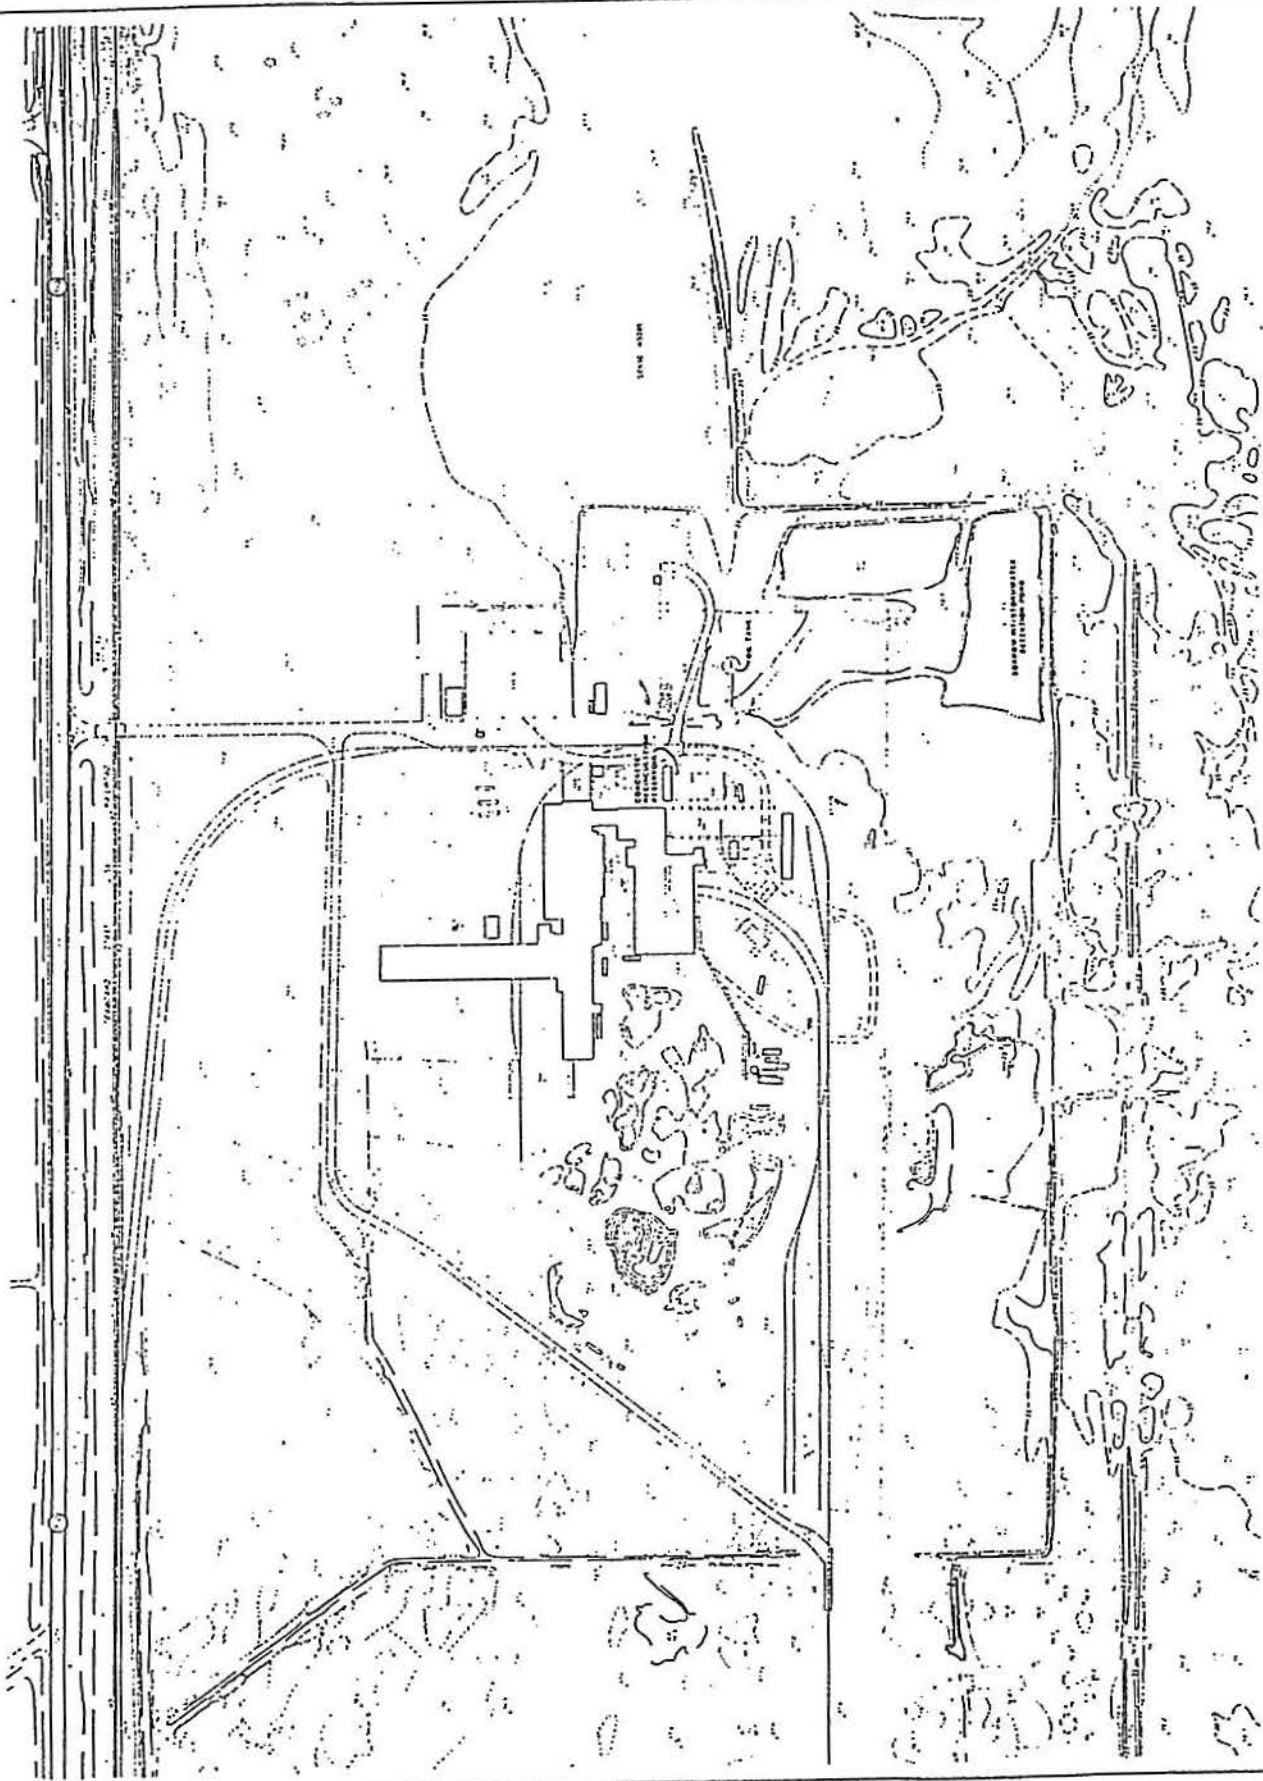
Figure 2

Connie Garrett of the Florida Department of Health and Rehabilitative Services (HRS) visited the site on December 6, 1990. The site was surrounded by an 8-foot chain-link fence posted with trespassing and hazard warning signs. The large mill building and one smaller building were within the fence. Incinerator ash was stored in the mill building. Part of the mill building was leased by O & H Materials for the maintenance and storage of a mobile PCB incineration unit. Steel mill machinery and other equipment have been moved to other steel mills. West of the mill building was a vault constructed of slag and site soil. This vault held the PCB-contaminated soils and emission control dust prior to incineration. There was also an electric power sub-station on this site. An easement allows Florida Power and Light staff access to this power sub-station. There are two borrow-pits in the southeastern corner of the site. There are also three storage tanks on the site. An office building and an area leased for storage of metal cable spools was outside the fence, northeast of the site (Figure 2, Appendix).

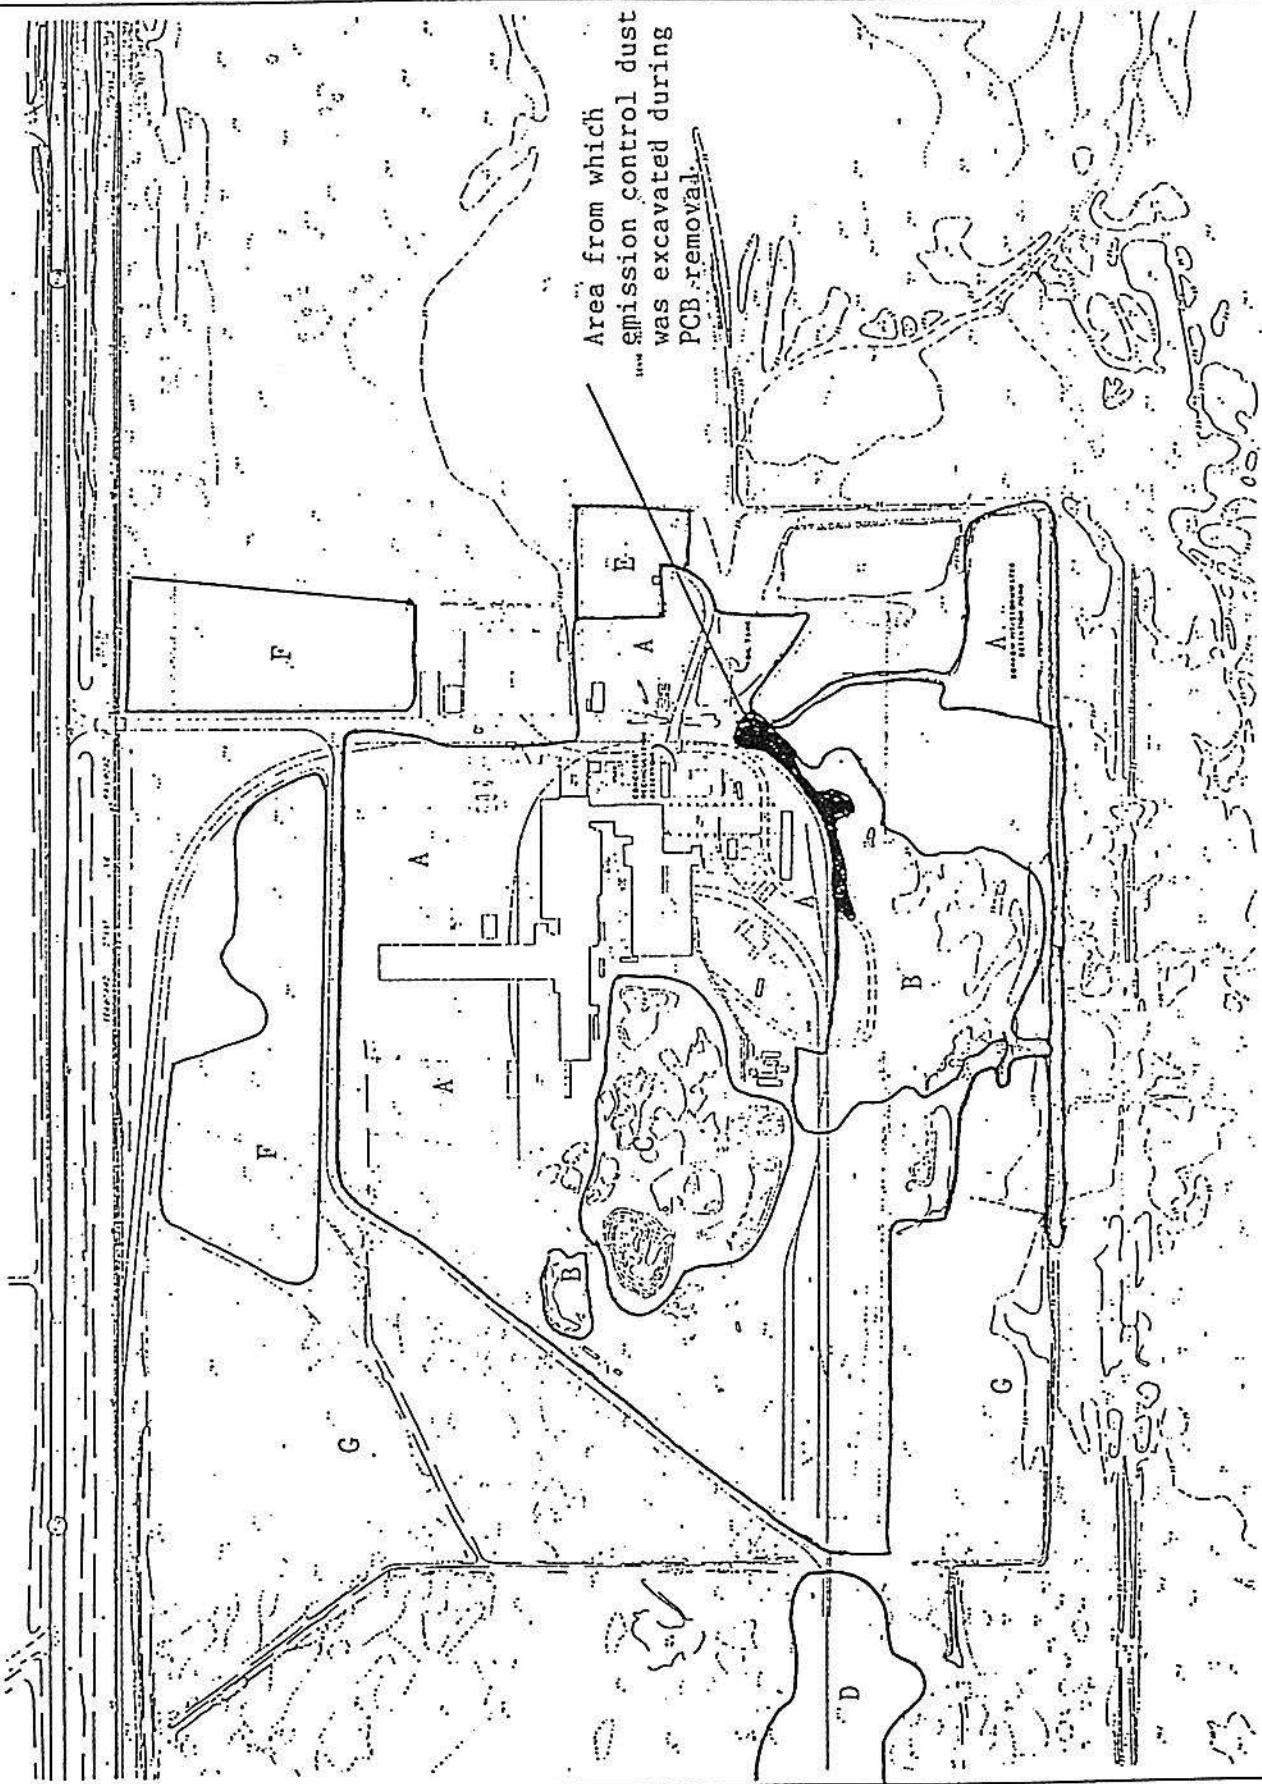
Figure 4: Delineation of Investigated Areas

The highest concentrations of heavy metals in soils were found in the emission control dust disposal areas west and south of the mill building, and around the bag houses south of the mill building (Figure 4, Appendix). Elevated levels of metals were also found along the north-south road east of the mill building and between the railroad tracks west of the large emission control dust disposal area. The highest concentration of lead in the sediments was detected in the on-site drainage ditch along the southern property line. Lead concentrations were also elevated in drainage ditch sediments south and east of the site. The sediment samples from the drainage ditch adjacent to West Farm Road contained 5 parts per million lead. This level is four times greater than the lead levels detected in background samples and exceeds the five year Environmental Media Evaluation Guide level for children of 1 part per million (ATSDR, 1990). Sediment lead concentrations, however, decreased rapidly downstream of the
