***Construction Summary: Assessment of the Nitrogen Removal and Viability of a Reactive Layer with Liner under a Conventional Septic System Drainfield***

***Division of Environmental Assessment and Restoration***

***Florida Department of Environmental Protection***

***August 2016***

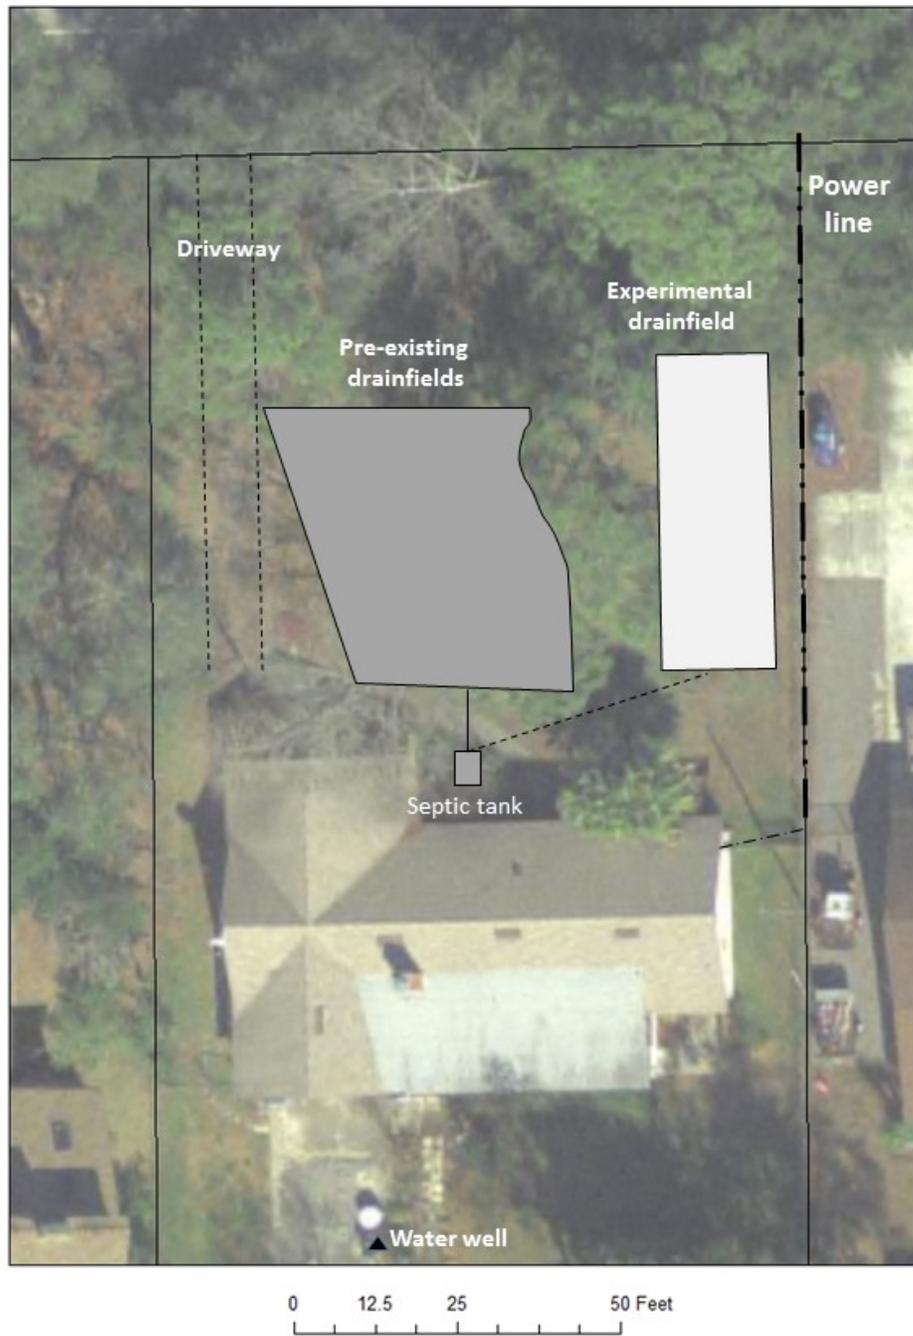
*Figure 1. Study site with existing septic tank, old drainfield area, and experimental drainfield locations.*

This experimental drainfield was constructed as designed for the most part. Construction activities, actual dimensions and deviations are described below. **Figure 1** shows the site layout. **Figures 2, 3 and 4** show the actual dimensions and depths of components as installed. **Figures 5 and 6** show the actual locations and depths of the monitoring components. **Table 1** provides summary information on the construction depths and relative elevations of system components and monitoring devices. Photographs in **Appendix A** document the stages of construction and methods used for installation.

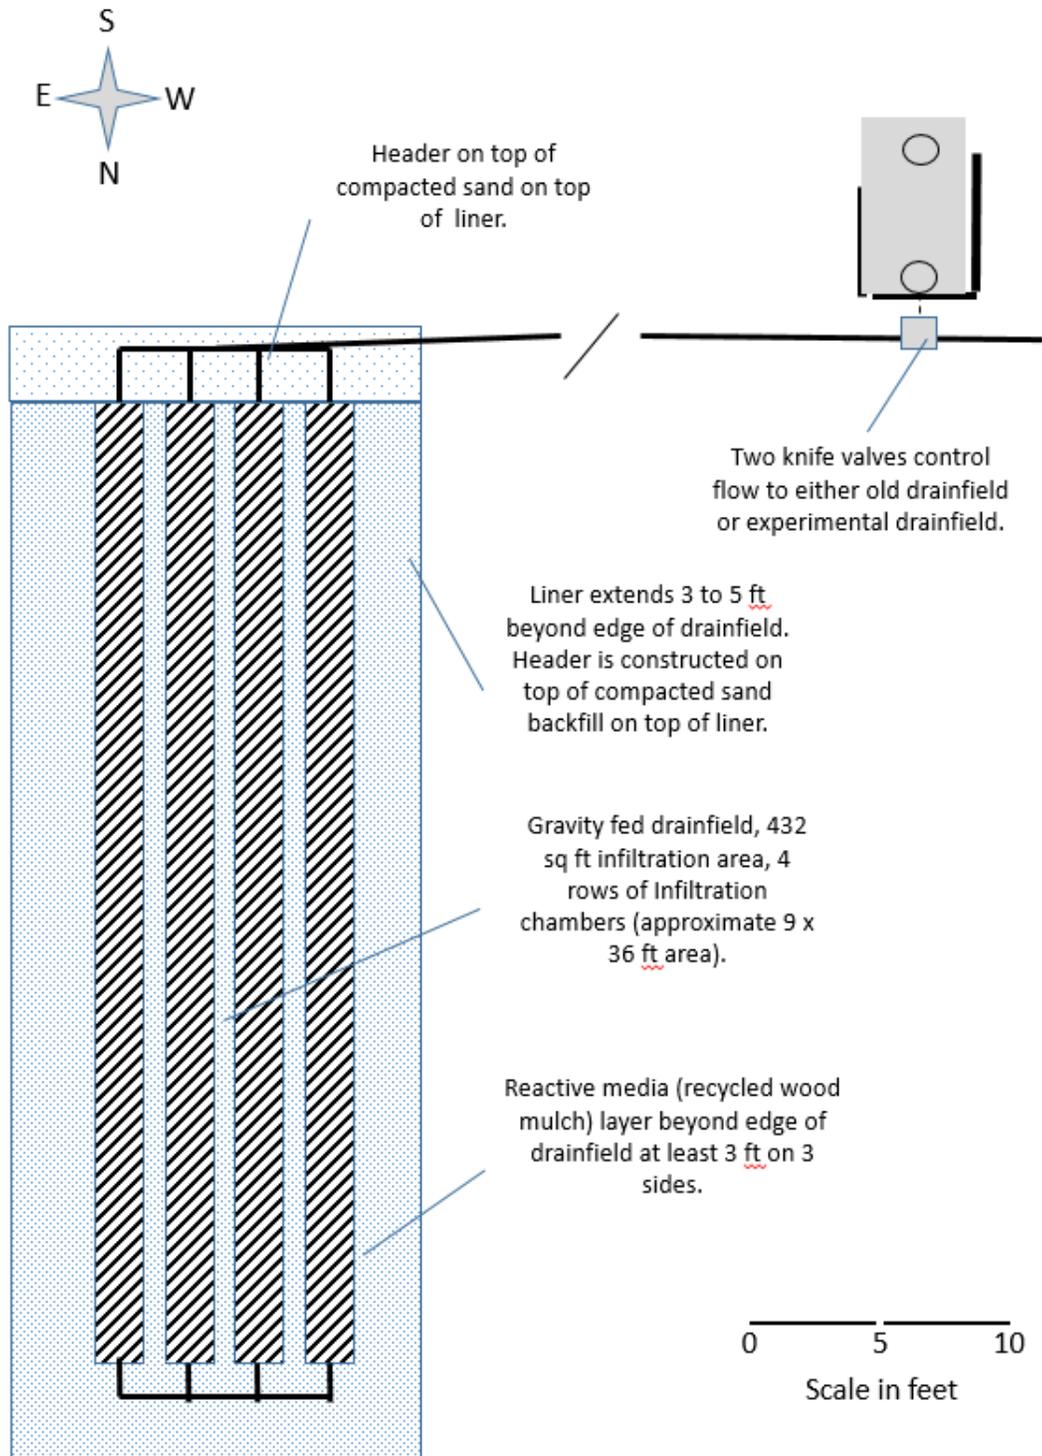
*Figure 2. Plan view of experimental drainfield.*

Wood mulch and liner extend  
3-5' beyond edge of drainfield

- This design was constructed using a conventional gravity flow drainfield system consisting of a bed of infiltration chambers. The actual drainfield footprint was 9 feet by 36 feet instead of 10 by 36 feet, which resulted in a wider than anticipated margin between the drainfield edge and the edge of the liner.
- The drainfield was underlain by 19 to 20 inch thickness of native sand.
- A 13 to 14-inch thickness of recycled wood mulch was installed. After compaction, the thickness of the wood mulch layer may be closer to 10 inches in thickness. The recycled wood mulch consisted of 4 inch or finer shredded hardwood obtained from Raynor Shine Wood Mulch Products in Apopka.
- A 30 mil reinforced polyethylene liner was installed on a level surface before the mulch was emplaced. Leveling of the bottom was done by hand with use of a laser level and

**6-Drainfield Installation:** The drainfield was constructed of 4 rows of infiltration chambers that were spaced approximately 6 inches apart. This drainfield is 9 feet wide by approximately 36 feet long and has 432 square feet of infiltrative surface. The drainfield was constructed of Infiltrator Quick 4 EQ36™ infiltration chambers that were covered by fabric prior to burial. The drainfield was oriented on top of the lined area so that a minimum of 3 feet of lined margin extended on all sides. Actual margin ranged from 3 feet 4 inches to 5 feet because the drainfield was 1 foot narrower than the design and had to be articulated slightly to accommodate piezometers that were installed earlier. The edge of the liner was marked by wooden stakes and PVC pipes that were placed to help locate the position of deep lysimeters to be installed after construction.

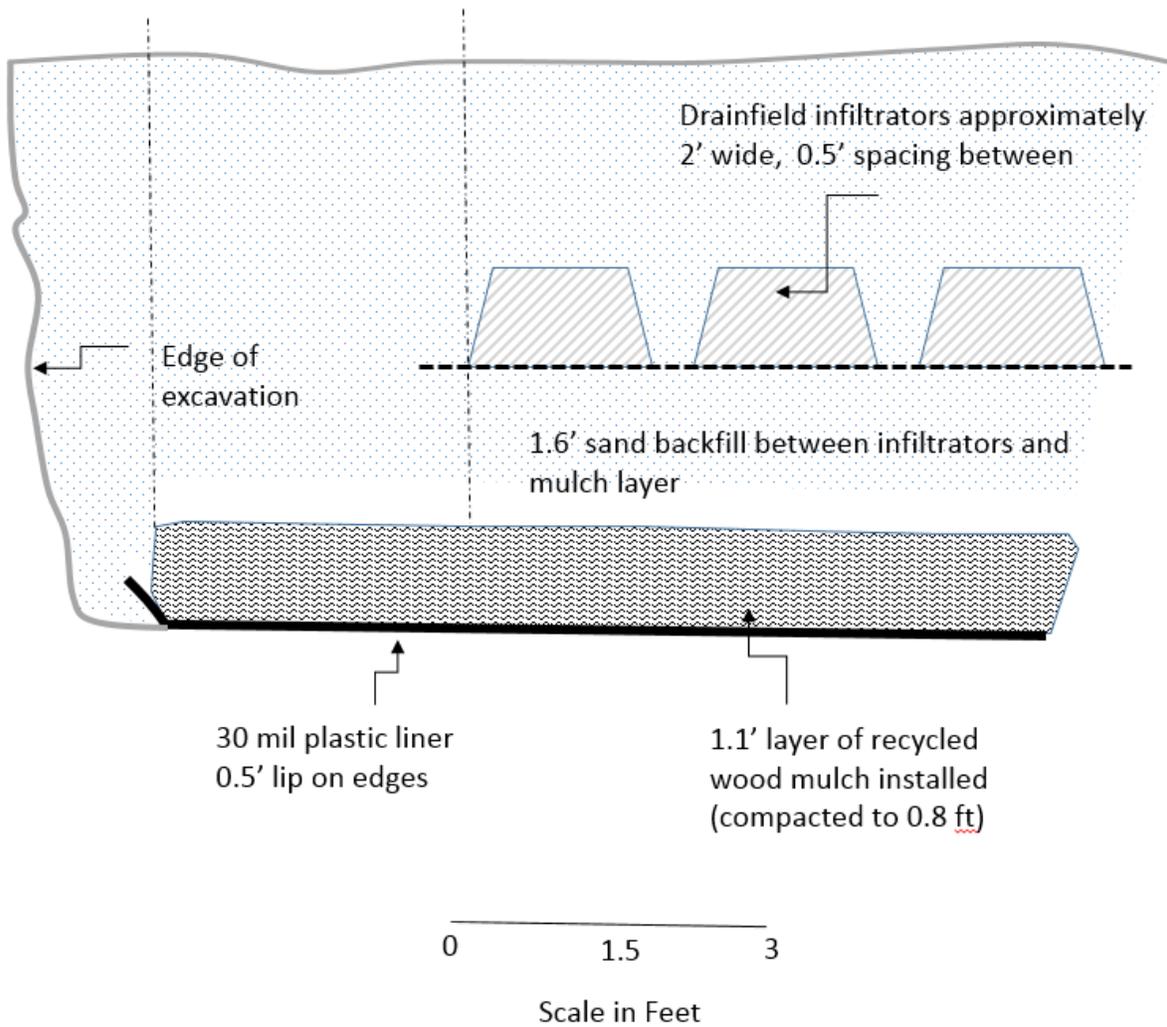
*Figure 3. Cross sectional view of experimental drainfield.*

**3-Liner Installation:** The liner was installed in three stages and met the construction specifications for width and length and uniform depth below the reference elevation. At completion, the bottom of the lined area was 16 by 42 feet. To allow it to be installed in stages, the liner was first unfolded and spread out on an obstruction-free area, properly oriented to be installed, then rolled up so that it could be put in the pit and unrolled as construction proceeded. Installation proceeded from the header end, with liner installed beneath the area to be covered by the header. It was emplaced on the smoothed and leveled bottom of the pit so that at least 3 feet of liner extended beyond the anticipated edge of the drainfield in all four directions. The edges of the liner were turned up on a sloped berm of sand to create a uniform 6 inch depth of the reservoir. The liner bottom is approximately 75 inches (6.8 feet) below land surface, which is 39 inches (3.3 feet) below the septic tank outlet.

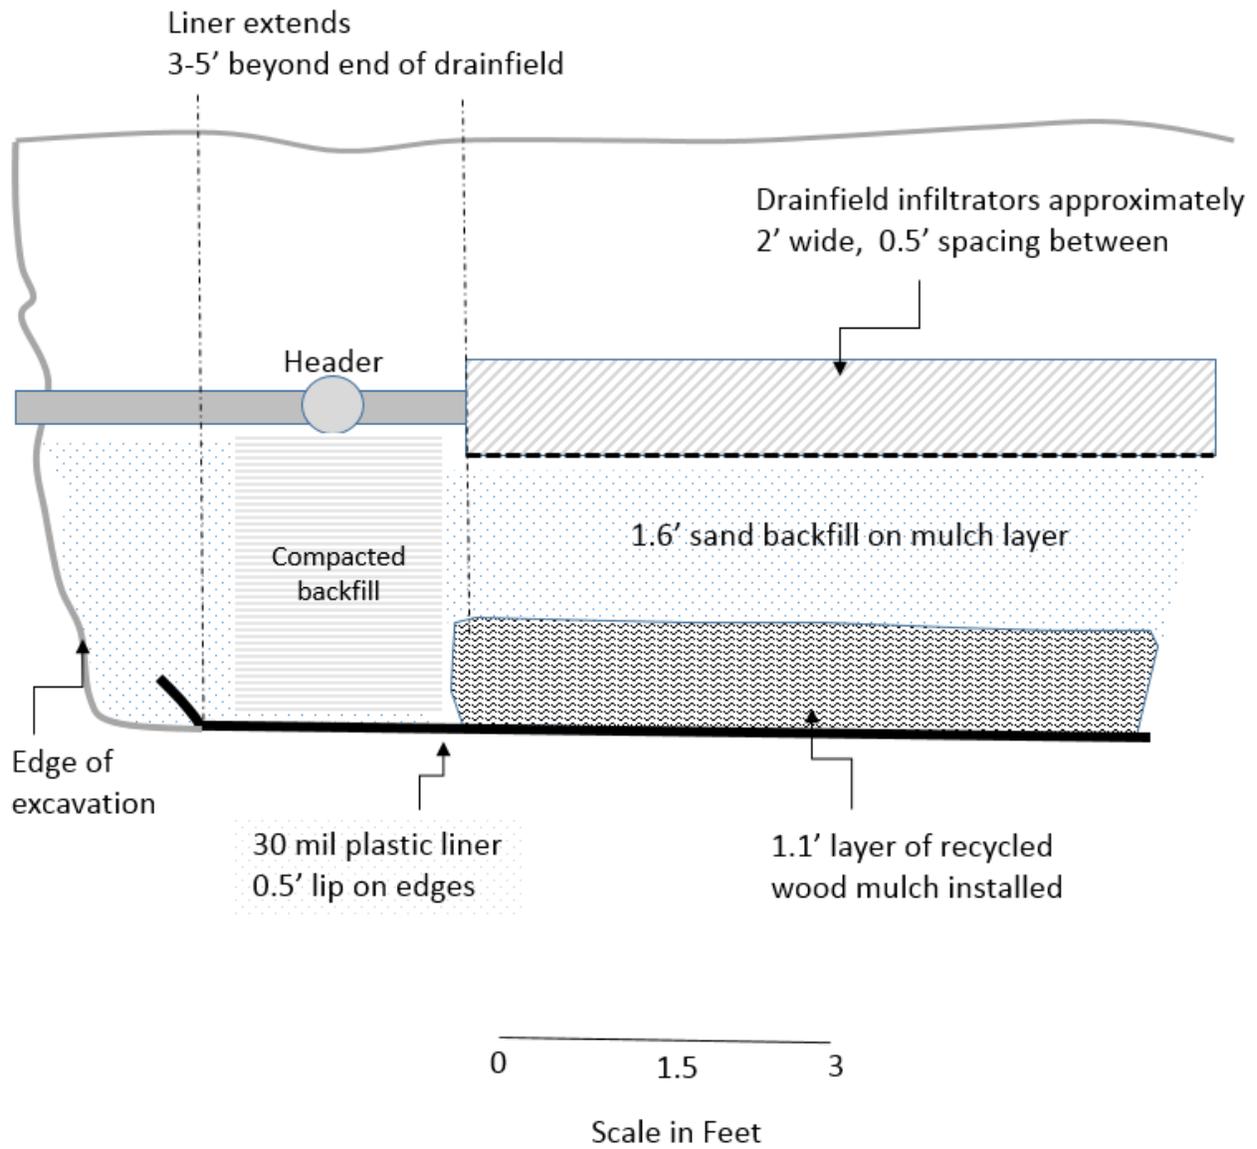
**Figure 4. Cross sectional view of header area, experimental drainfield.**

**5-Backfilled Sand Layer Installation:** Clean sand from the stockpile was installed on top of the mulch layer after it was installed. Sand was installed to an average thickness of 19 inches (1.6 feet). Sand installed directly on the liner at the header end of the drainfield was packed down and built up to support the header. After setting the header, the sand layer was then smoothed and sloped to achieve the necessary fall from the header as the rows of infiltrators were installed.

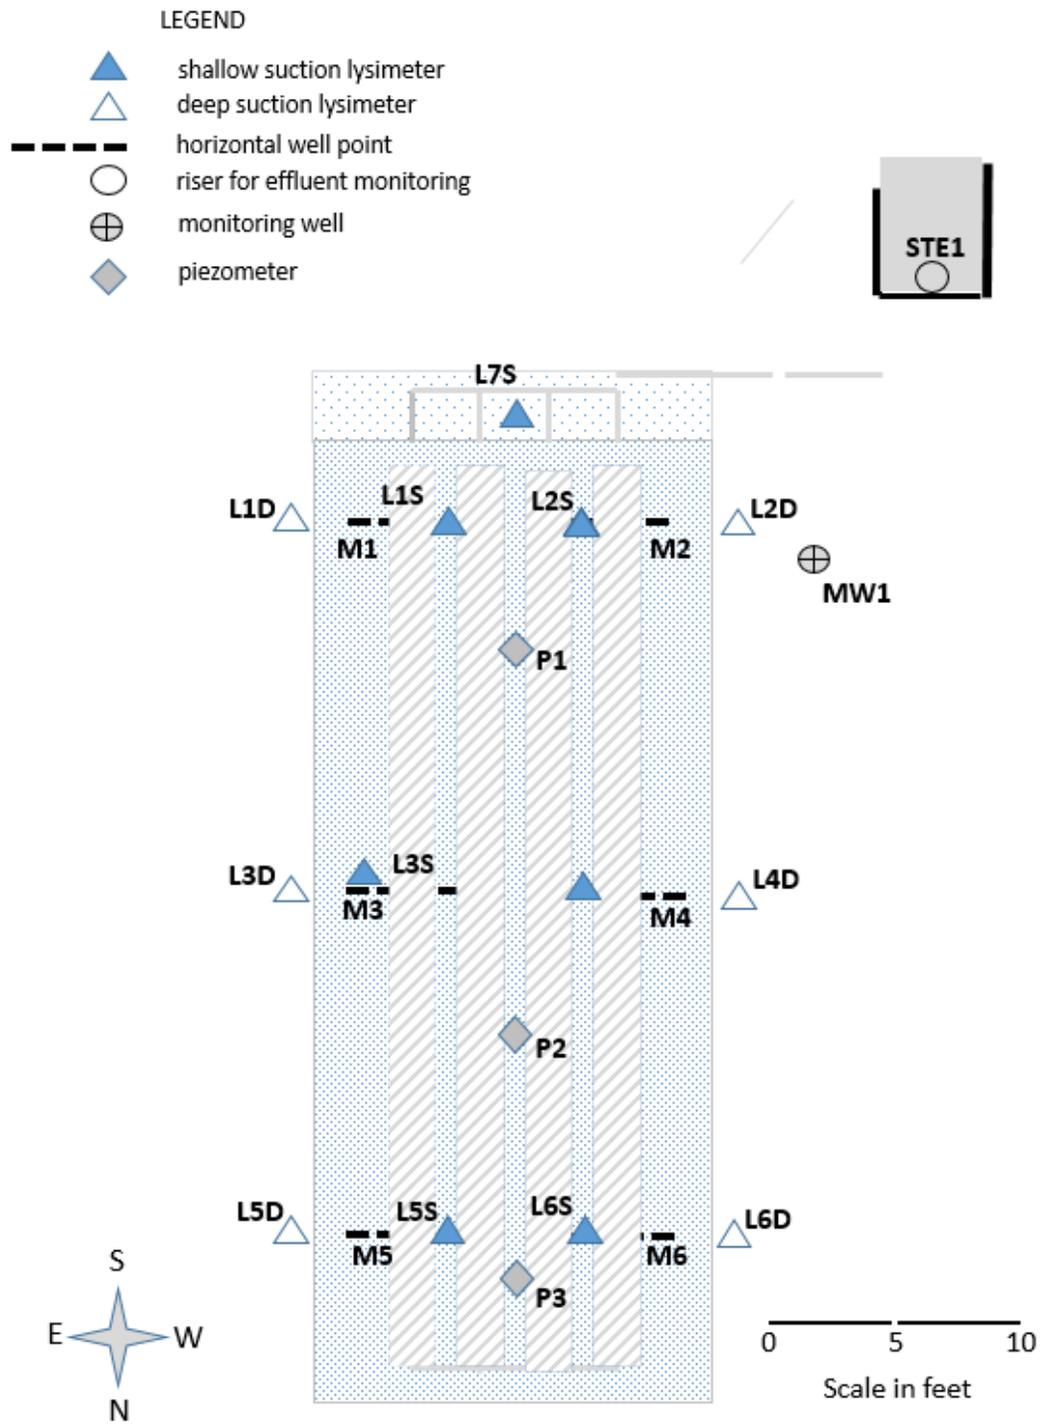
Figure 5. Plan view of monitoring locations at experimental drainfield.

**7-Monitoring Device Installation:** The monitoring devices installed during the construction phase included 6 horizontal well points installed on top of the liner perpendicular to the long axis and 3 piezometers that were installed on top of the liner along the midline of the drainfield. After the construction, 6 deep lysimeters were installed along the edge of the liner, 6 shallow lysimeters were installed between the infiltration chambers to monitor infiltrating water above the mulch layer and 1 shallow lysimeter was installed beneath the header. In addition, a flow meter was installed on the water supply line from the well to measure flow of water to the house and drainfield (excluding the irrigation system). A monitoring well installed adjacent to the drainfield site prior to the construction activities will also be included in the monitoring plan. Depths of the monitoring devices were established using the bottom of the septic tank outlet as an elevation point of reference. **Table 1**

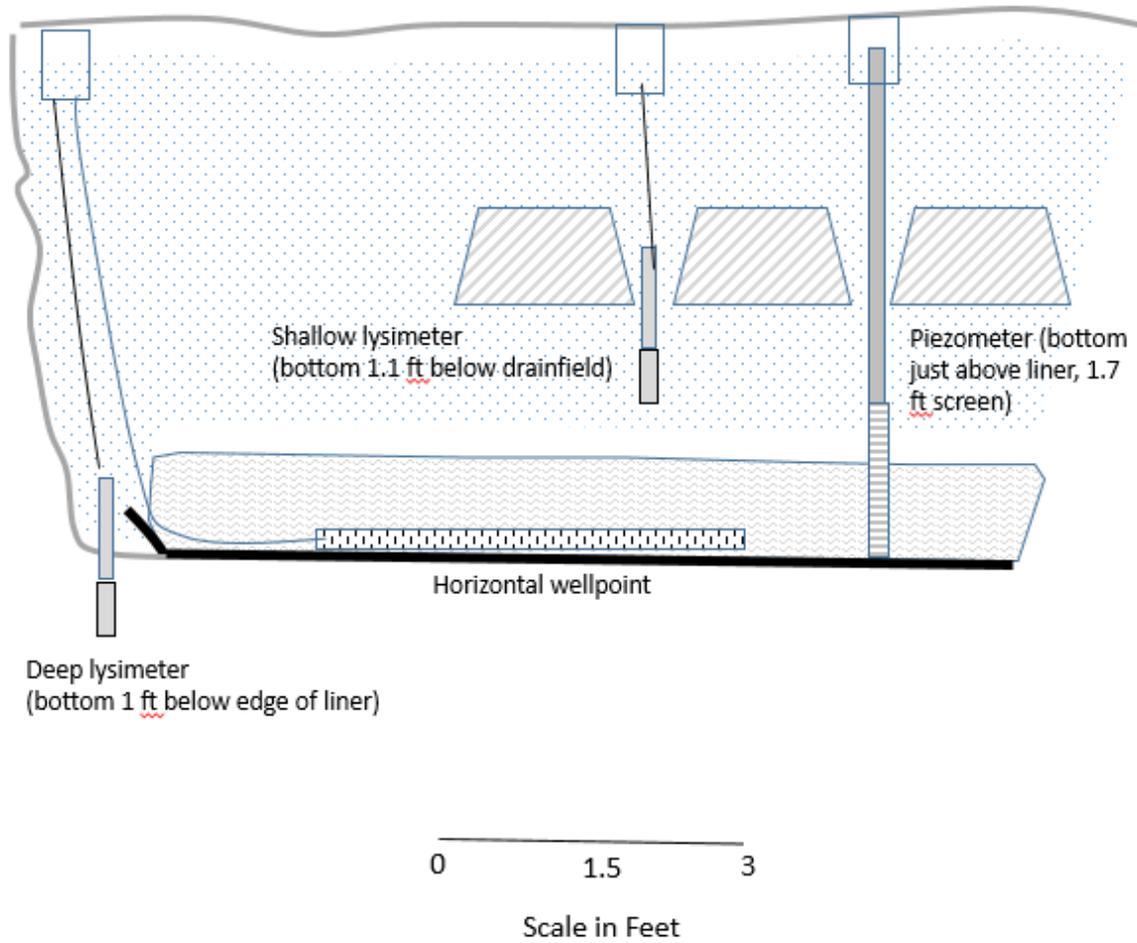
*Figure 6. Cross section showing zones being monitored at experimental drainfield.*

- Monitoring devices were installed to measure water quality in the effluent, infiltrating effluent above the mulch layer, water residing within the saturated zone on top of the liner, infiltrating treated water along the liner edges, and shallow ground water immediately adjacent to the experimental drainfield. Water levels will be measured to monitor mounding within the mulch layer and flow to the system will be measured with a flow meter installed on the water supply line to the residence.

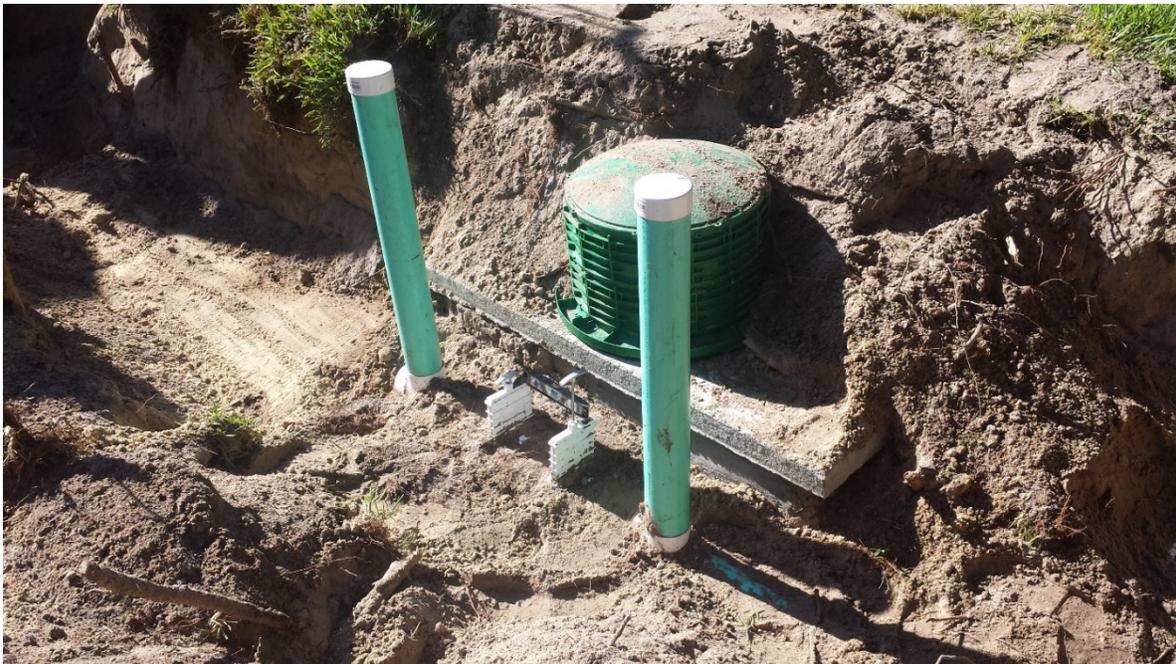
*Knife valves and effluent sampling/inspection riser on septic tank. Green pipes are inspection ports to confirm flow direction.*

**1-Preparing the Septic Tank Outlet and Installation of Flow Diversion:** Shelley's Septic Tanks was the contractor who installed the system. The contractor exposed the top and outlet end of the septic tank to install new piping to connect the septic tank to both the in-use drainfield and the experimental drainfield. Two knife valves were installed side by side at the septic tank outlet end to divert flow. These were both enclosed in a 2-foot-diameter riser with domed lid. In addition, the contractor replaced a section of the septic tank lid which showed signs of deterioration and installed a riser on top of the new lid at the tank outlet end. The tank outlet was used as an elevation reference for all of the experimental drainfield

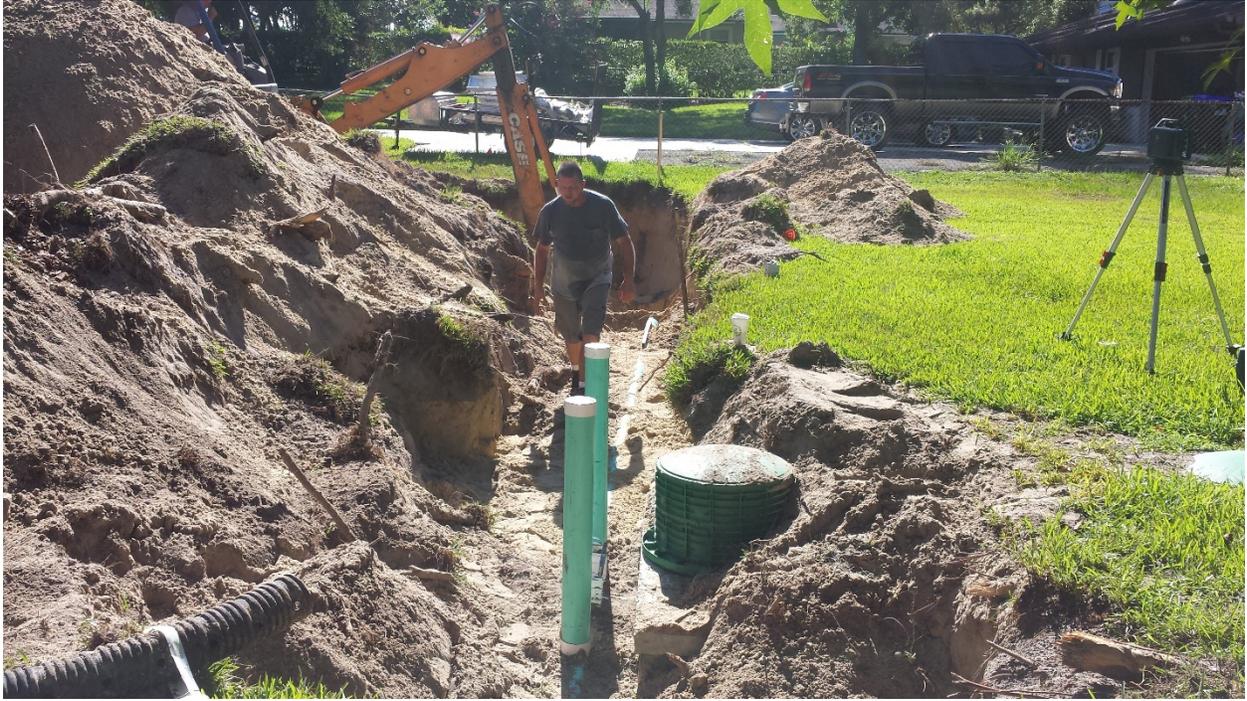
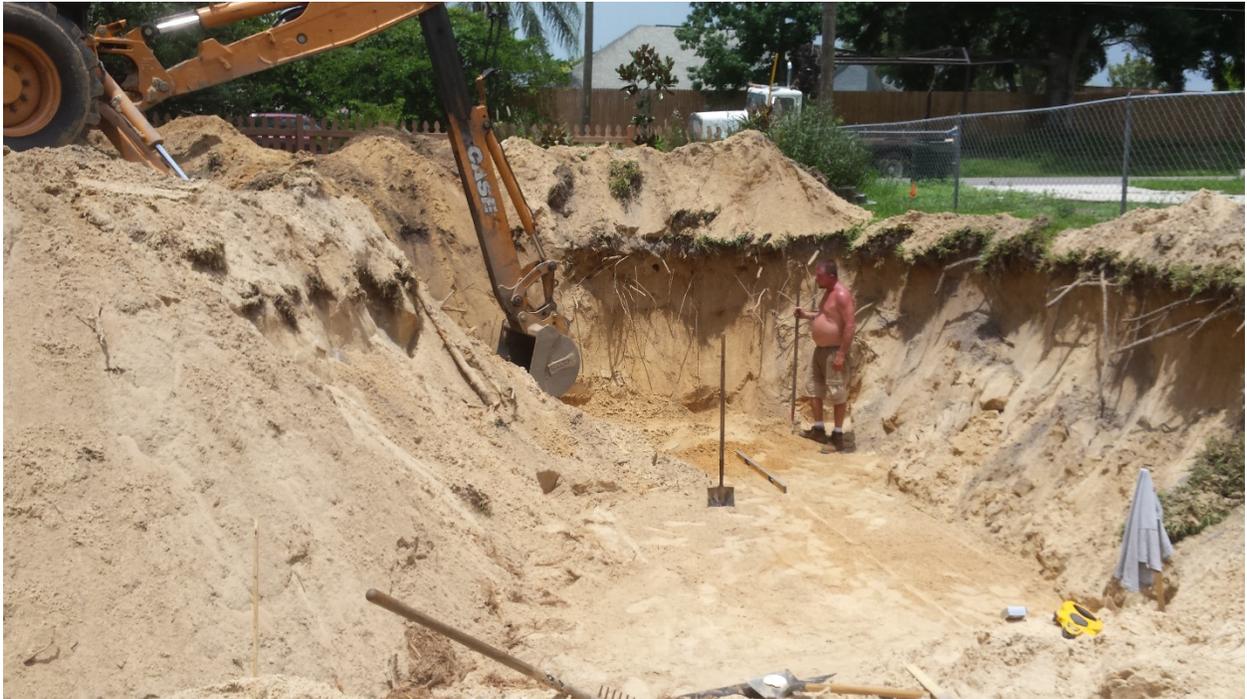
*Excavation of pit and leveling for liner installation*

**2-Excavation of Pit and Leveling:** The contractor used a Case 580 Series backhoe loader to excavate the pit for installation of the liner, mulch, sand backfill, and drainfield and a mini trachoe to complete backfilling and leveling. Due to caving sands, the actual excavation dimensions exceeded the footprint of the 16 by 42 foot lined area by 3 to 4 feet on each side. Due to the depth of the septic tank outlet, which was approximately 3 feet below land surface, it was necessary to excavate the pit to a depth of approximately 7 feet. This required removal and management of approximately 300 cubic yards of material from the pit area. To manage the amount of stockpiled material and allow access of the equipment for mulch installation and backfilling, the excavation of the pit, installation of the liner and installation of the mulch occurred in stages.

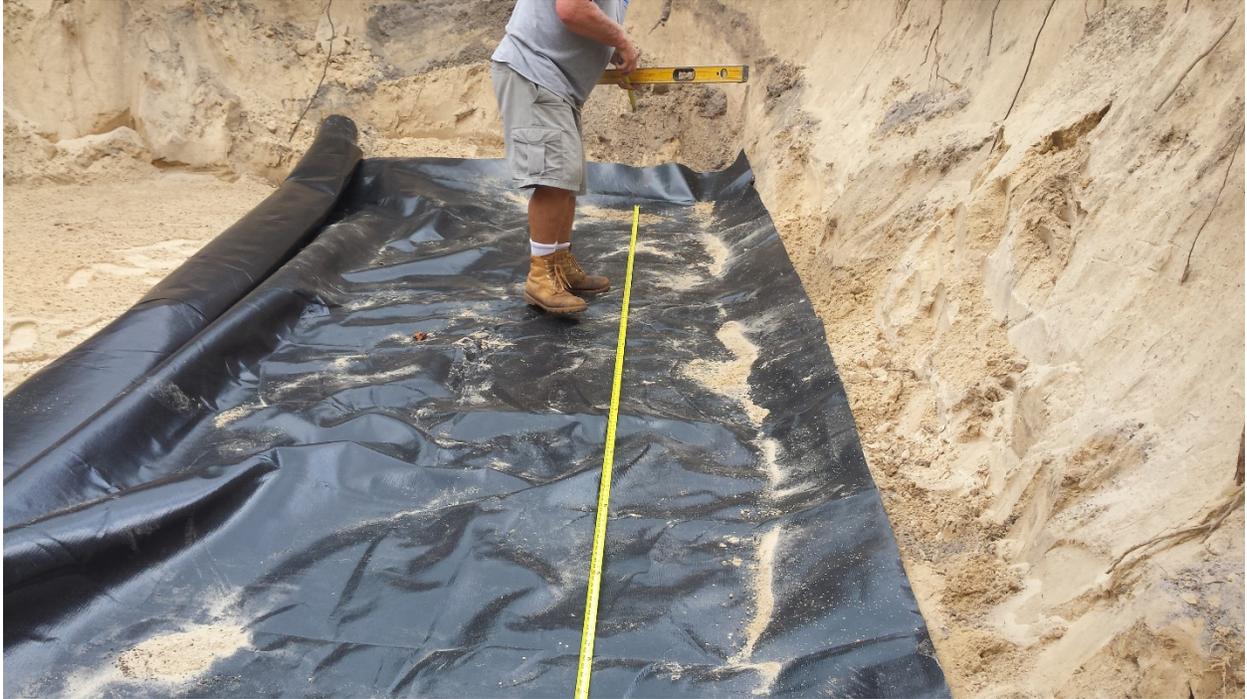
*Liner installation, first stage*

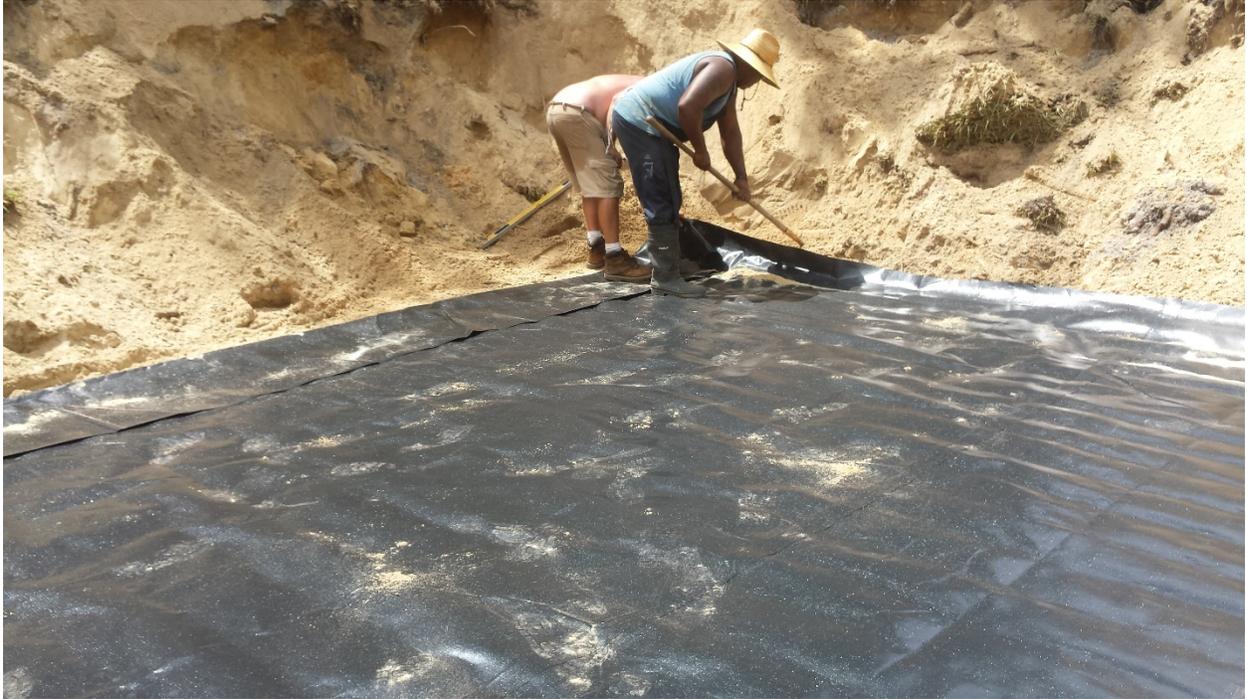
*Building up berm around edge of liner*

carpenter's level. The liner was manufactured by GEI Works for ponds and lagoons. Sand was installed by hand along the outside edge of the liner to create a sloped berm around the margins of the liner. A level and tape were used to make certain that the edge of the liner on the berm was consistently 6 inches about the bottom. Water percolating through the sand and wood mulch will collect on the liner to create a saturated zone of 6 inches within the mulch, flow over the edge of the plastic sheeting, and continue to seep downward.

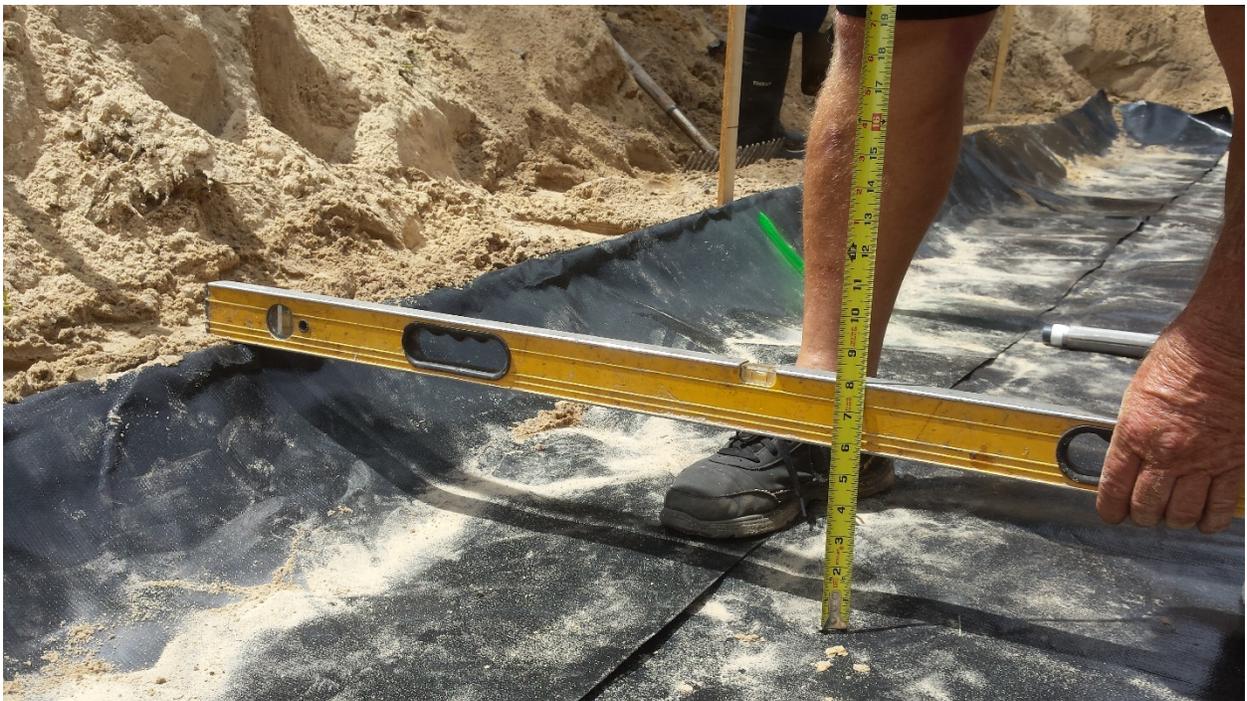
*Leveling to assure 6 inch depth*

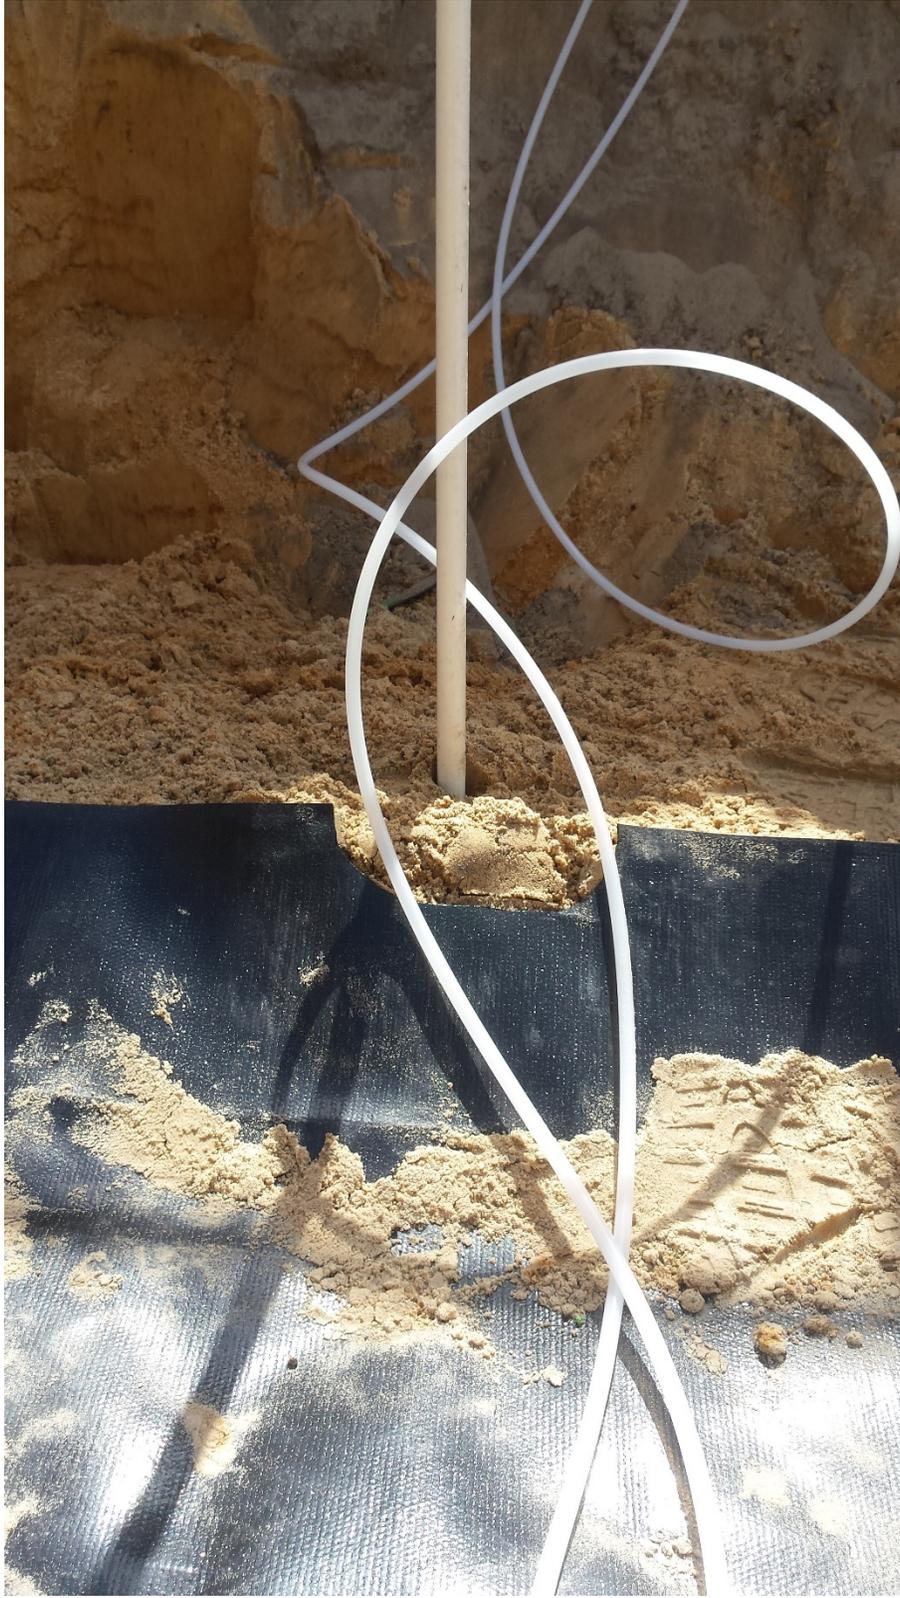
*PVC pipe marking location for deep lysimeter, notch in liner to direct flow to lysimeter*

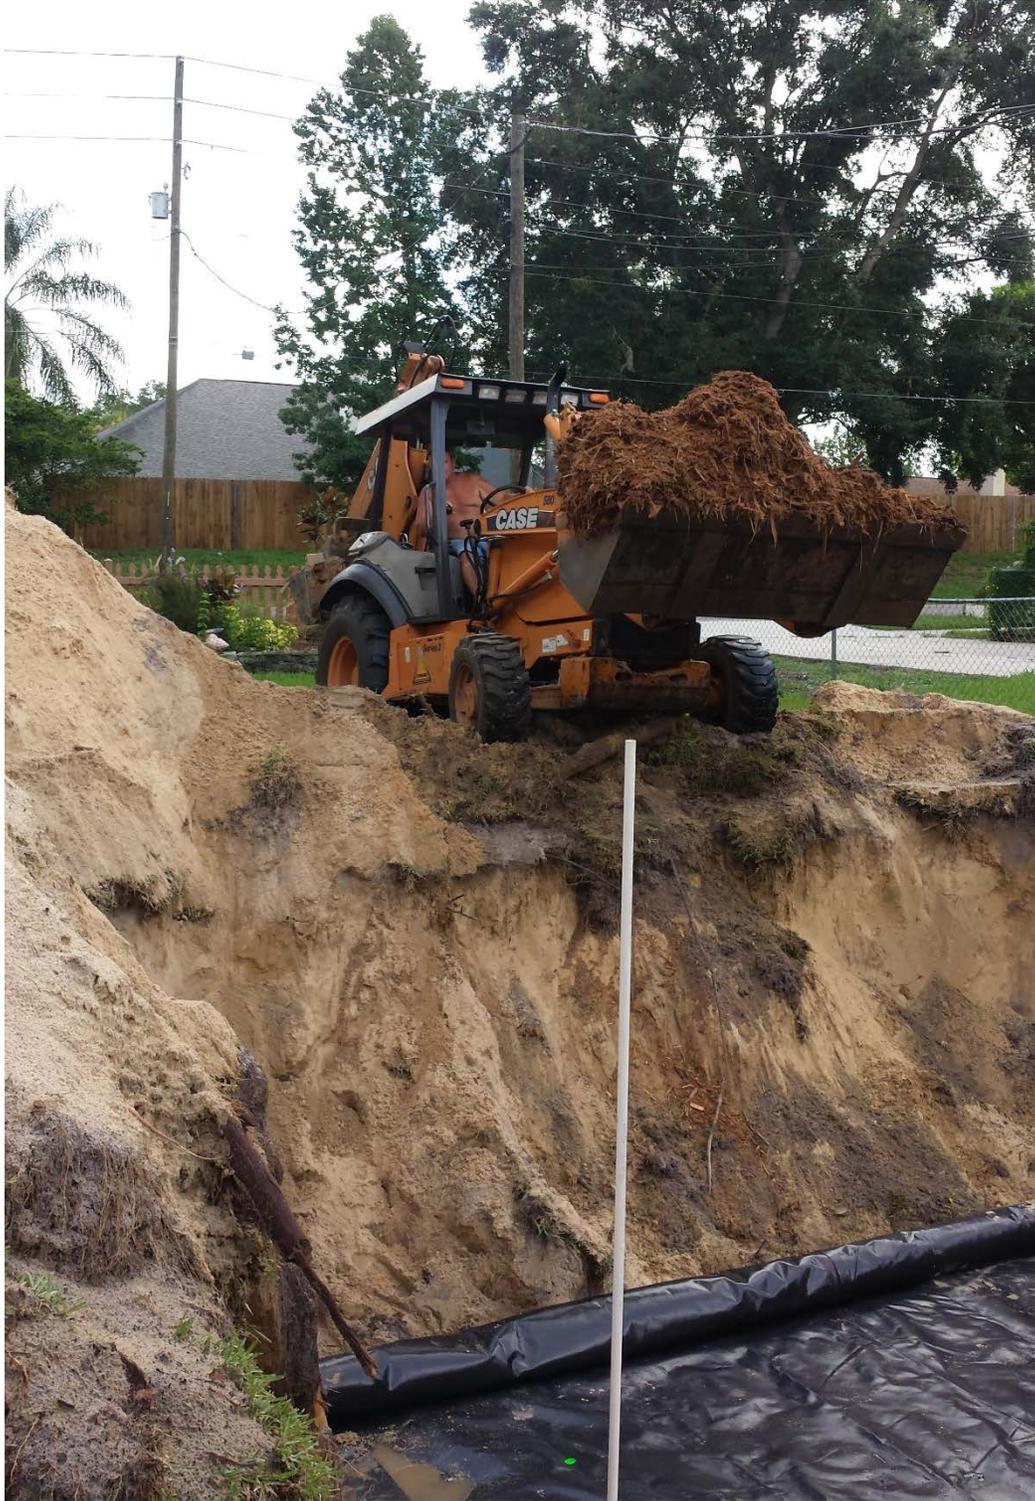
*Mulch installation, second stage*

**4-Mulch Layer Installation:** The contractor obtained approximately 27 cubic yards of wood mulch from Raynor Shine and stockpiled it for installation after the liner was prepared. The installation of the mulch was preceded by the installation of clean backfill on top of the liner at the header end. At the header end, the sand layer extended to the edge of the drainfield. The installation of the mulch then proceeded. Marked stakes inserted in the mulch area on top of the liner were used to maintain a uniform thickness of mulch as it was

installed, compacted by walking on it, and leveled. The edge of the mulch layer was kept within the level portion of the lined area. The thickness of the mulch at installation ranged from 13 to 14 inches (1.1 feet), as the surface of the mulch was irregular.

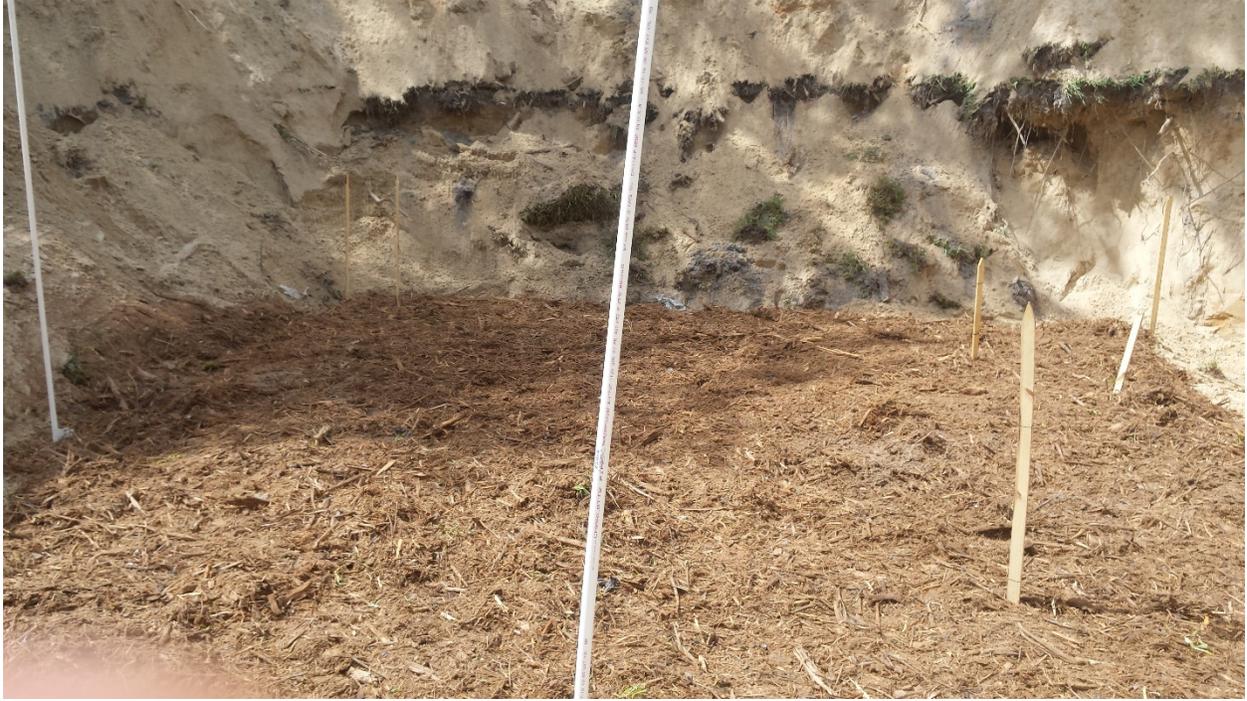
*Completed mulch installation. Pipe is piezometer. Stakes used to assure uniform depth of mulch*

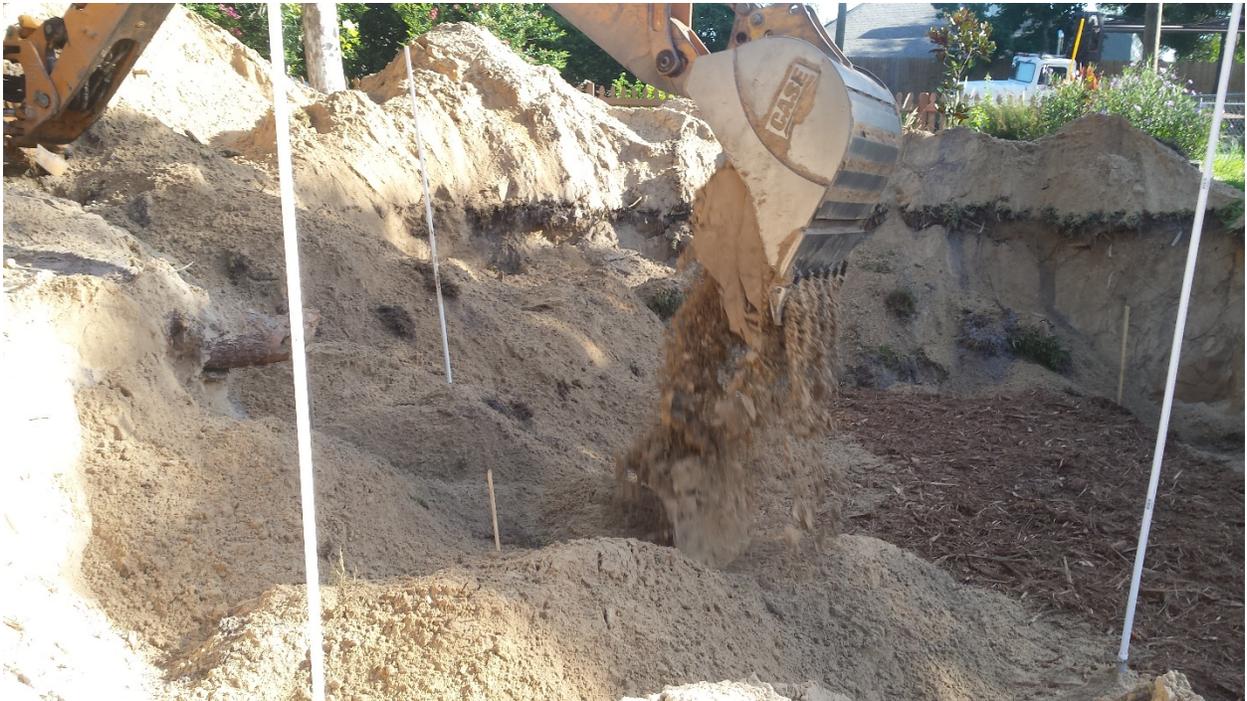
*Installing backfill on top of mulch, 19 to 20 inches thick*

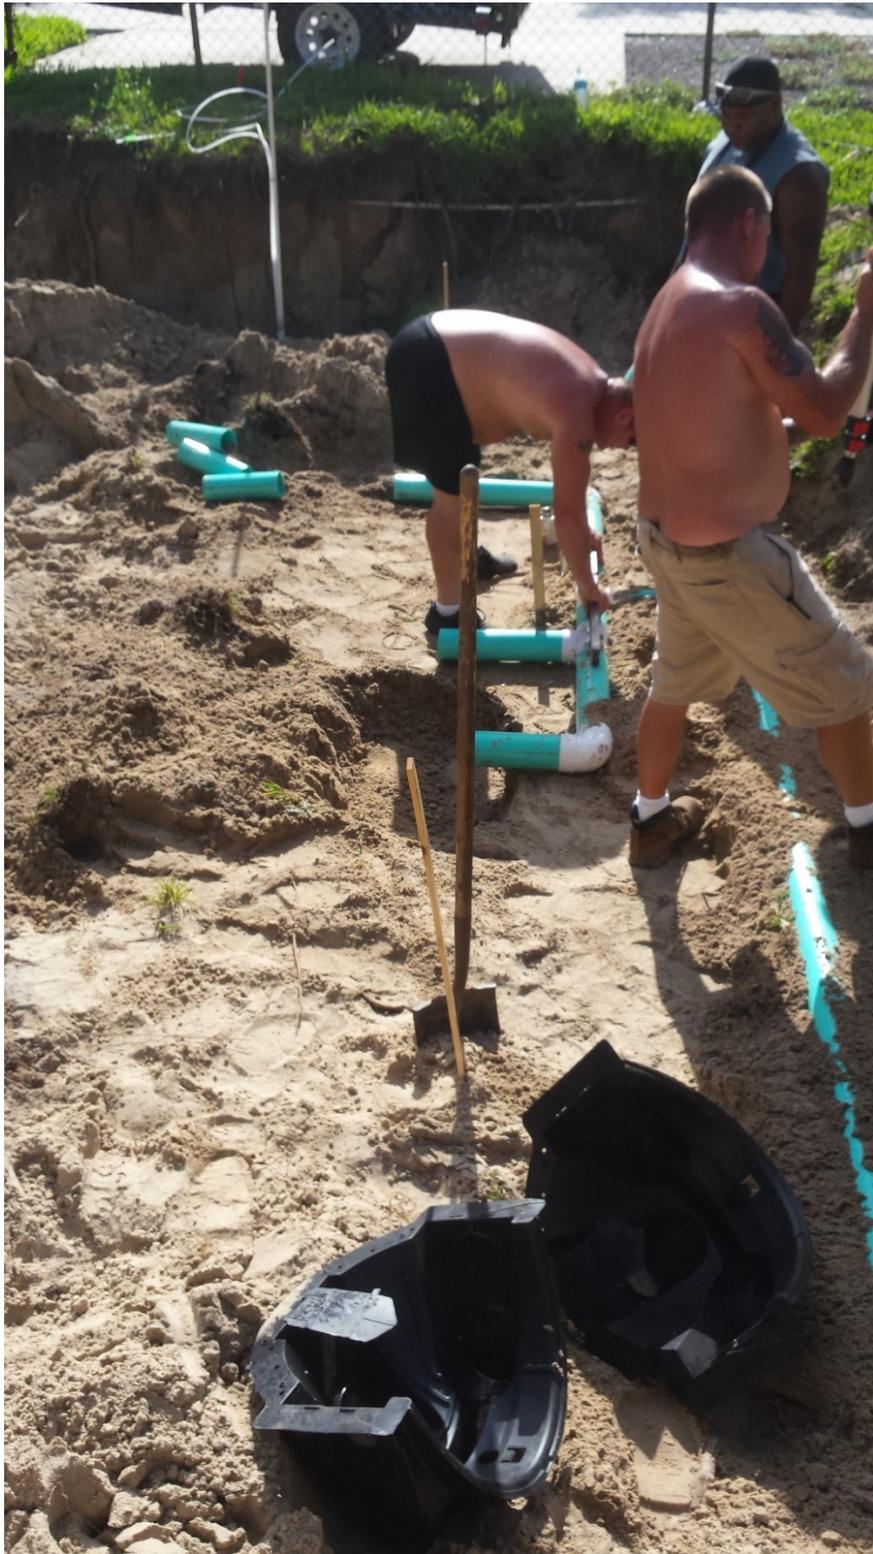
*Header installation*
