***Construction Summary: Assessment of the Nitrogen Removal and Viability of a Reactive Layer with Liner under a Conventional Septic System Drainfield***

***Division of Environmental Assessment and Restoration***

***Florida Department of Environmental Protection***

***August 2016***

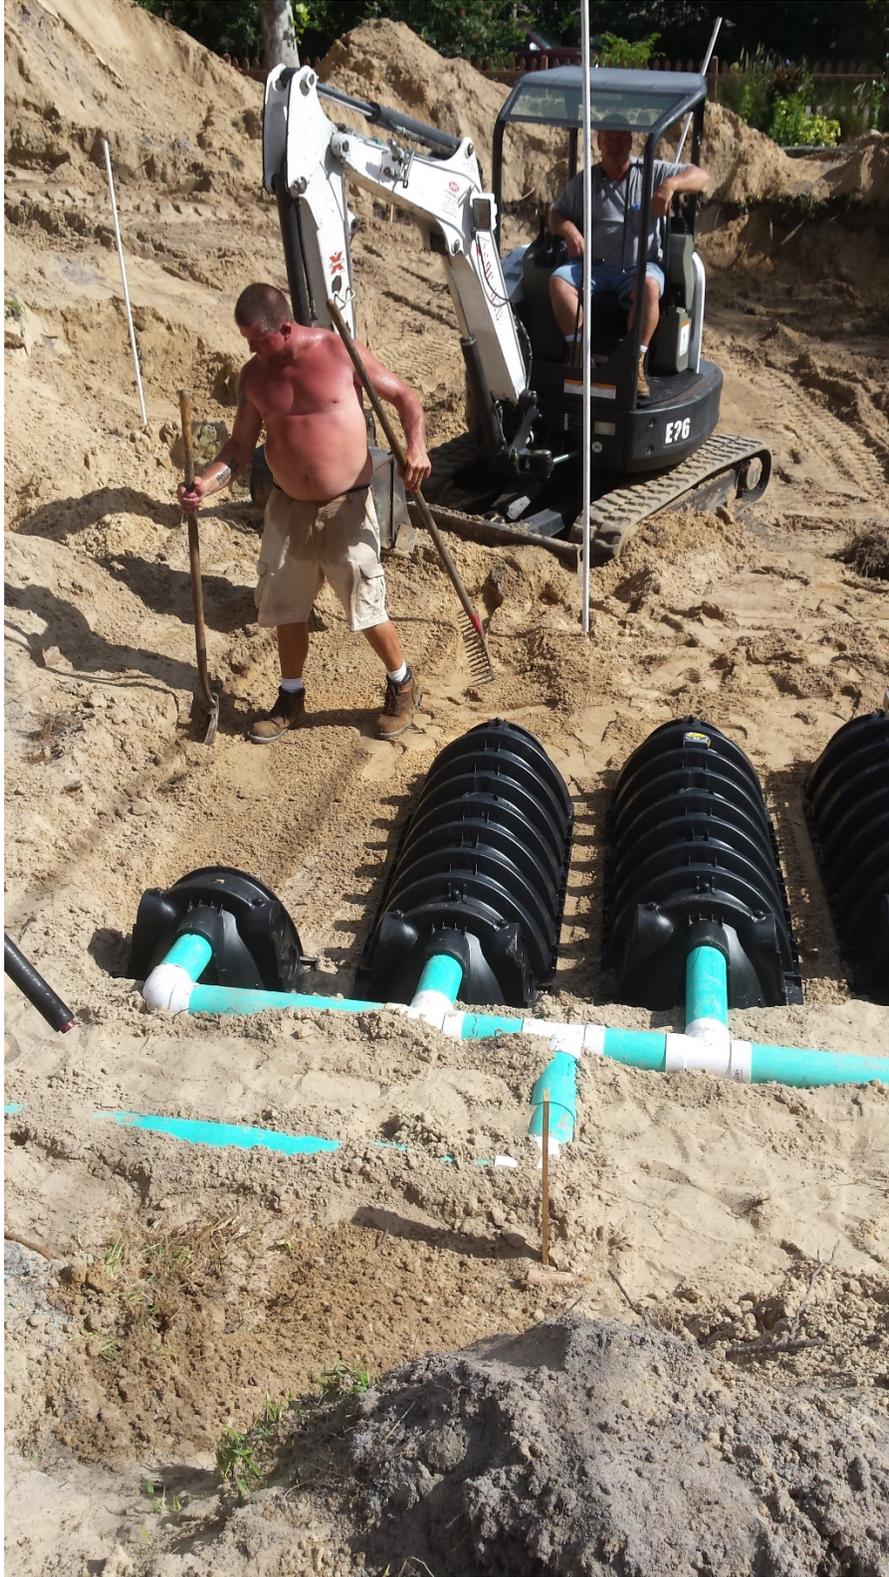
*Drainfield installation*

**6-Drainfield Installation:** The drainfield was constructed of 4 rows of infiltration chambers that were spaced approximately 6 inches apart. This drainfield is 9 feet wide by approximately 36 feet long and has 432 square feet of infiltrative surface. The drainfield was constructed of Infiltrator Quick 4 EQ36™ infiltration chambers that were covered by fabric prior to burial. The drainfield was oriented on top of the lined area so that a minimum of 3 feet of lined margin extended on all sides. Actual margin ranged from 3 feet 4 inches to 5 feet because the drainfield was 1 foot narrower than the design and had to be articulated slightly to accommodate piezometers that were installed earlier. The edge of the liner was marked by wooden stakes and PVC pipes that were placed to help locate the position of deep lysimeters to be installed after construction.

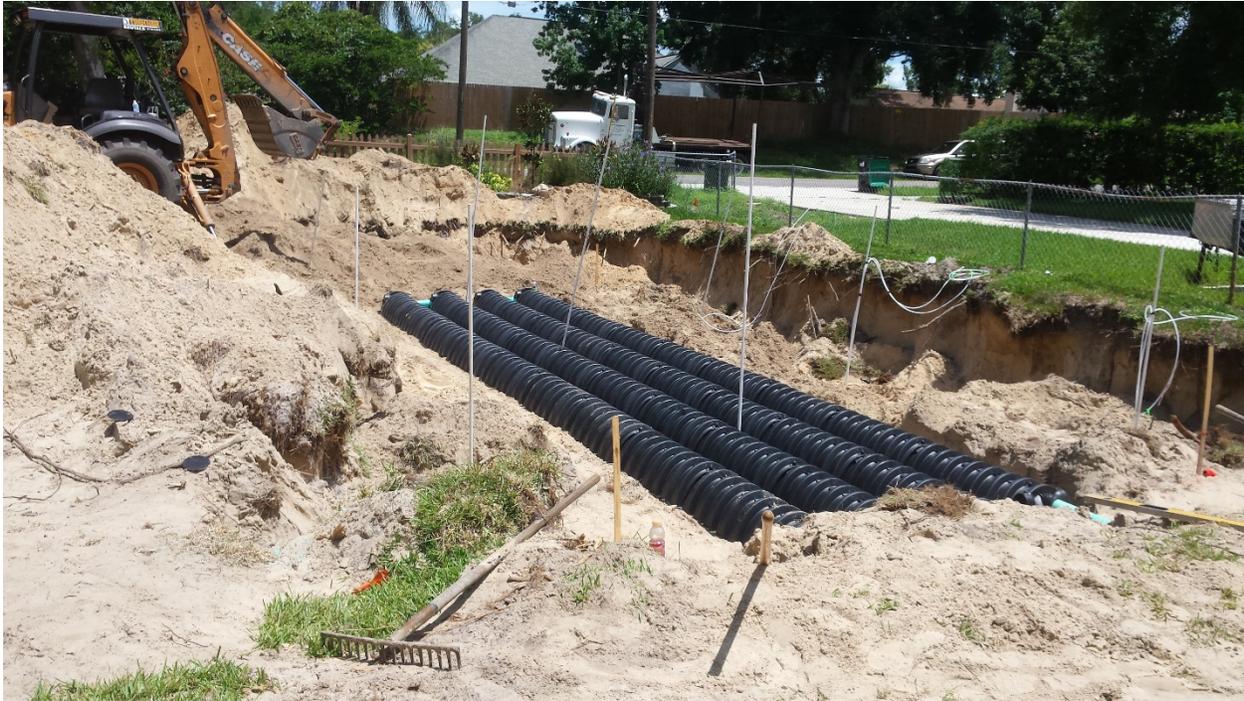
*Completed drainfield, piezometers between second and third rows. PVC pipes on edges mark edge of liner. Pipes between infiltrators are piezometers. Tubes go to horizontal wellpoints.*

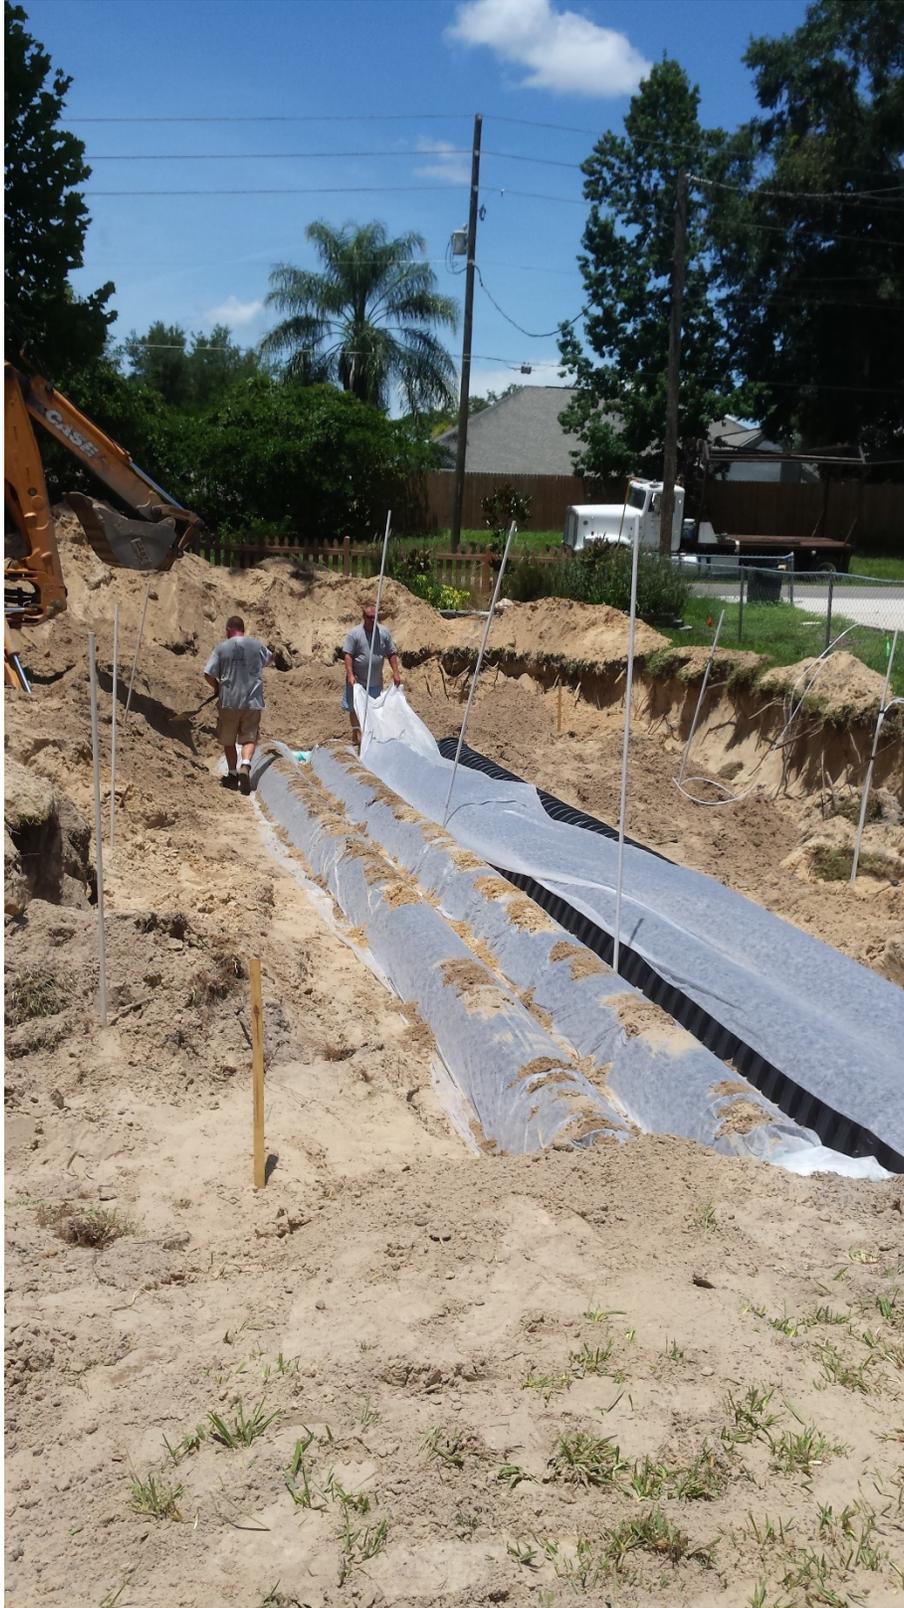
*Fabric cover being installed over infiltrators*

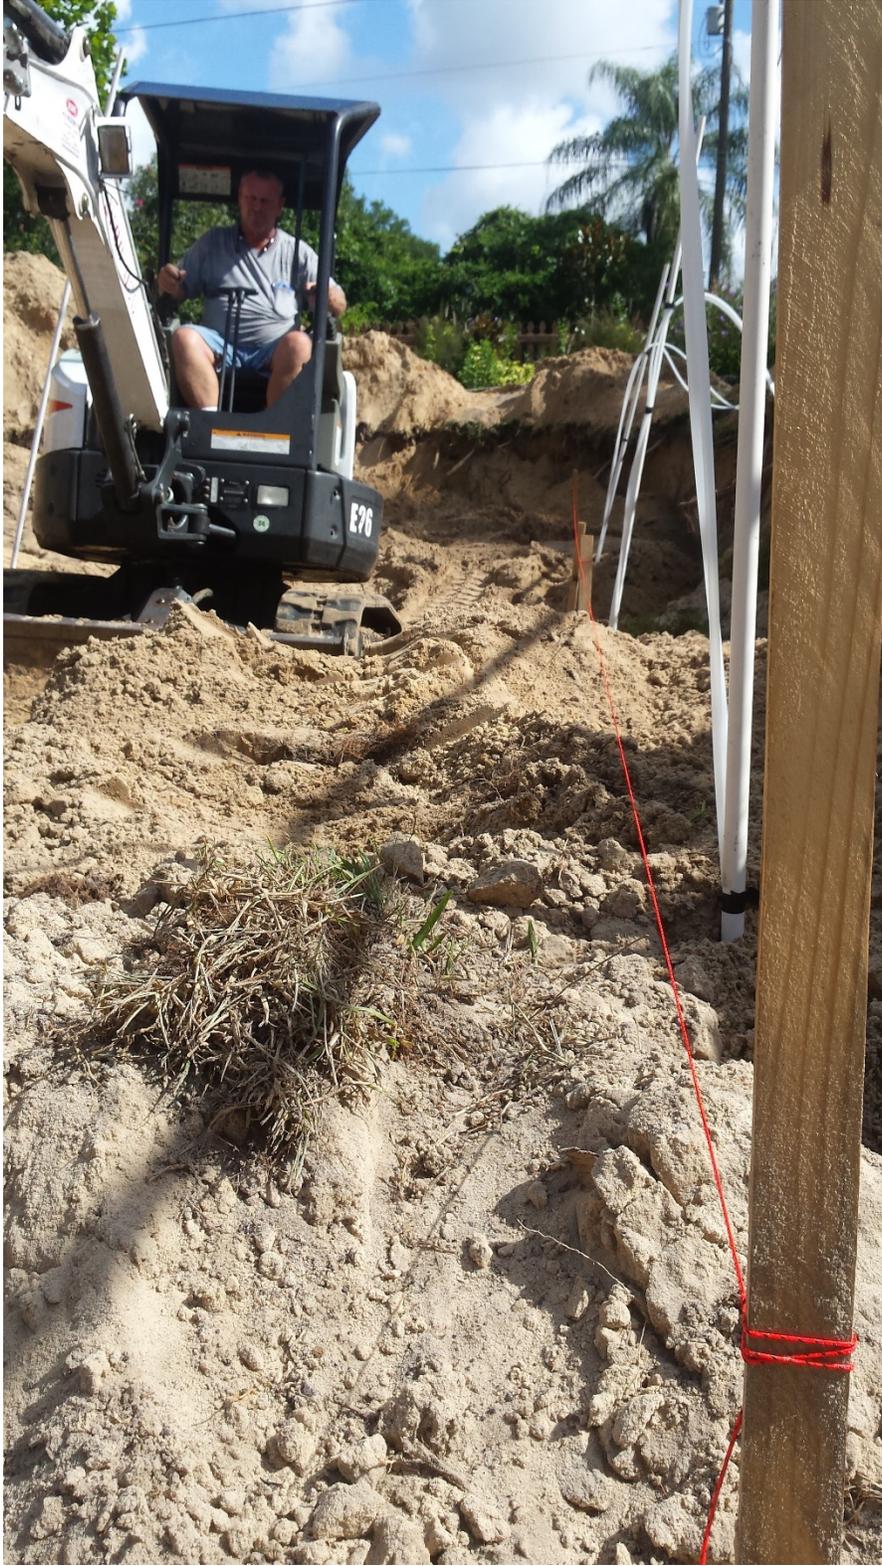
*Covering drainfield after inspection, string marks edge of liner*

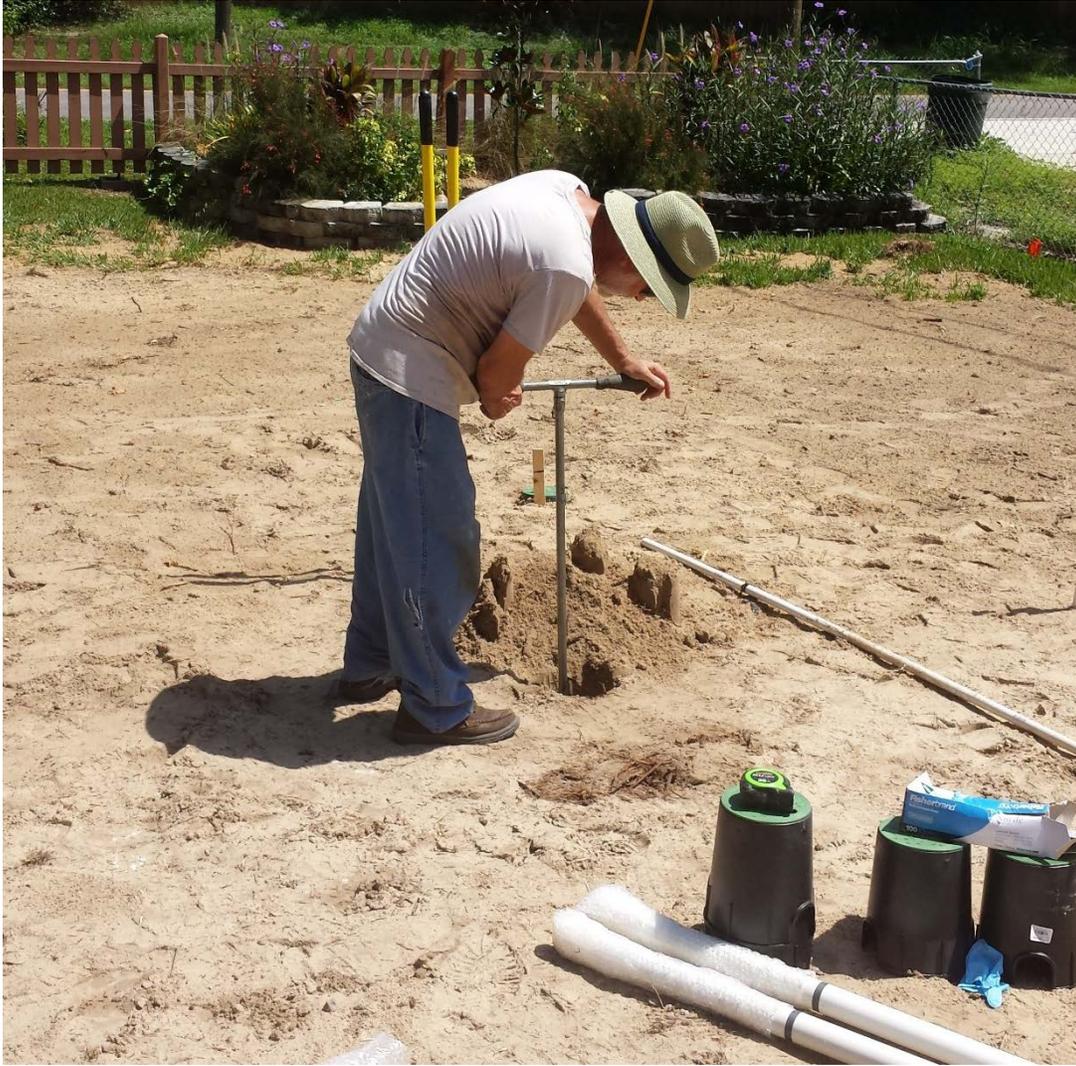
*Lysimeters installed in hand augered boreholes*

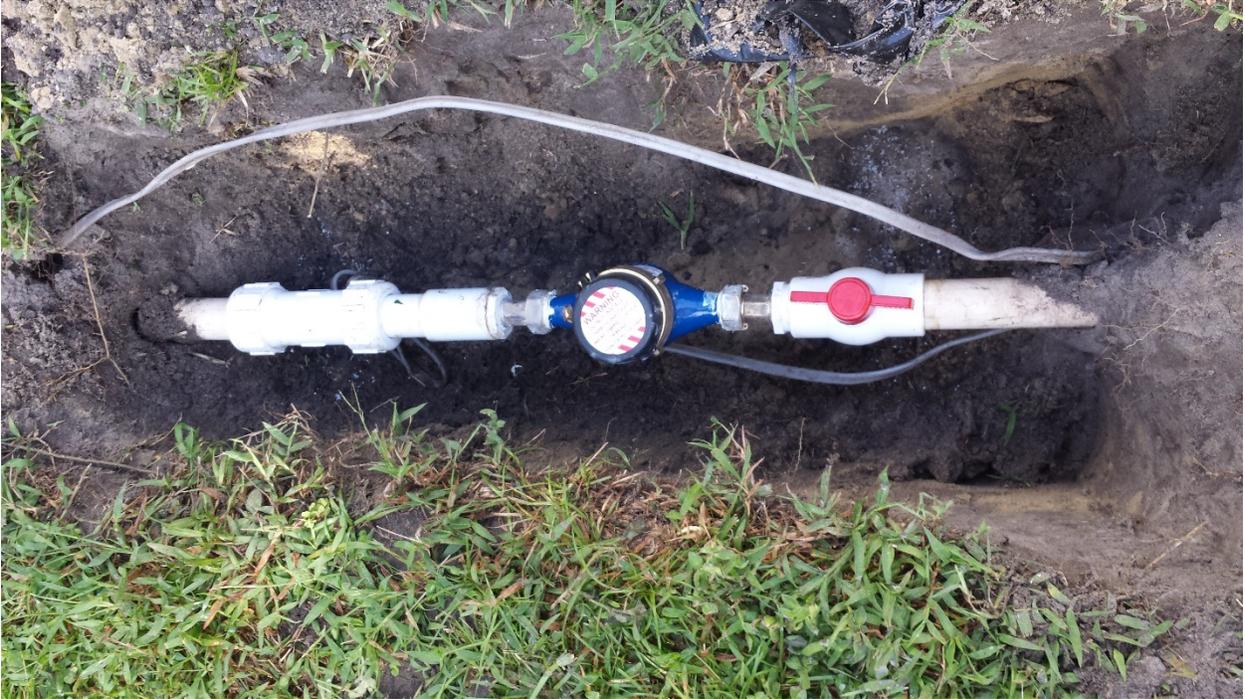
*Flow meter installed on supply line to house, next to water well. Irrigation line is separate.*

- Monitoring devices were installed to measure water quality in the effluent, infiltrating effluent above the mulch layer, water residing within the saturated zone on top of the liner, infiltrating treated water along the liner edges, and shallow ground water immediately adjacent to the experimental drainfield. Water levels will be measured to monitor mounding within the mulch layer and flow to the system will be measured with a flow meter installed on the water supply line to the residence.

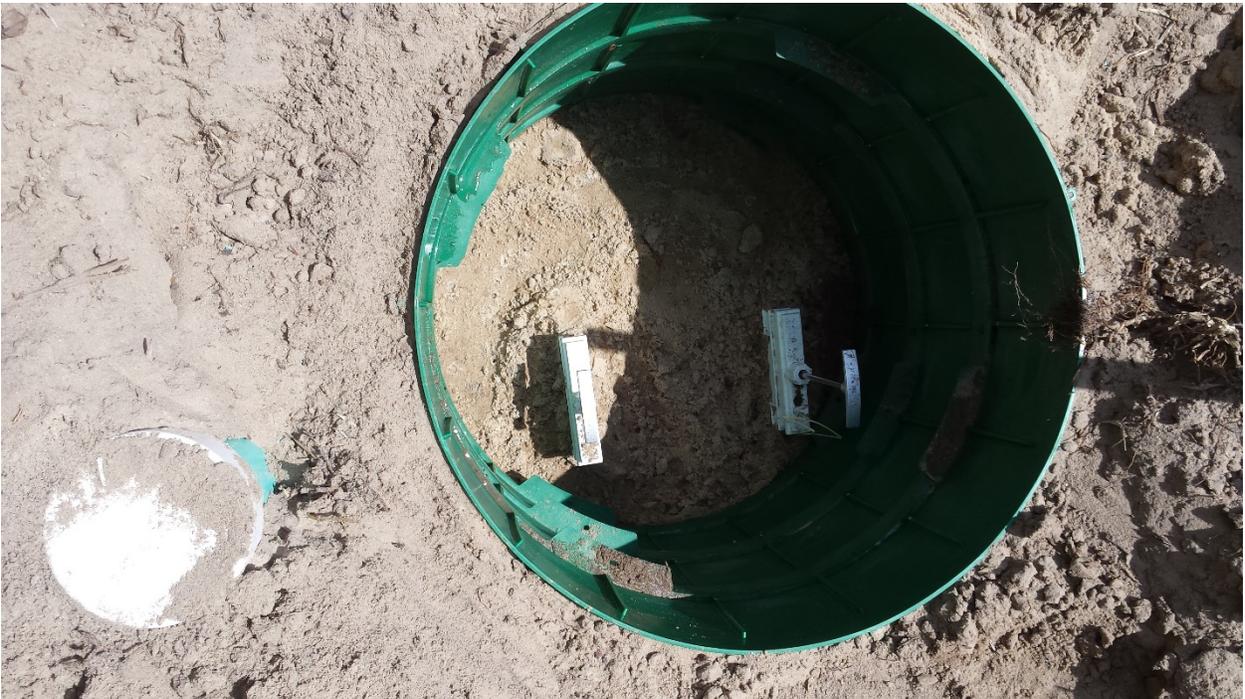
*Valve to experimental drainfield opened after flow meter installed*
