Florida Onsite Sewage Nitrogen Reduction Strategies Study

Evaluation of Full Scale Prototype Passive Nitrogen Reduction Systems (PNRS) and Recommendations for Future Implementation - Volume II of II

August 2015

**Installation Report for Passive Nitrogen Reduction System
B-HS1**

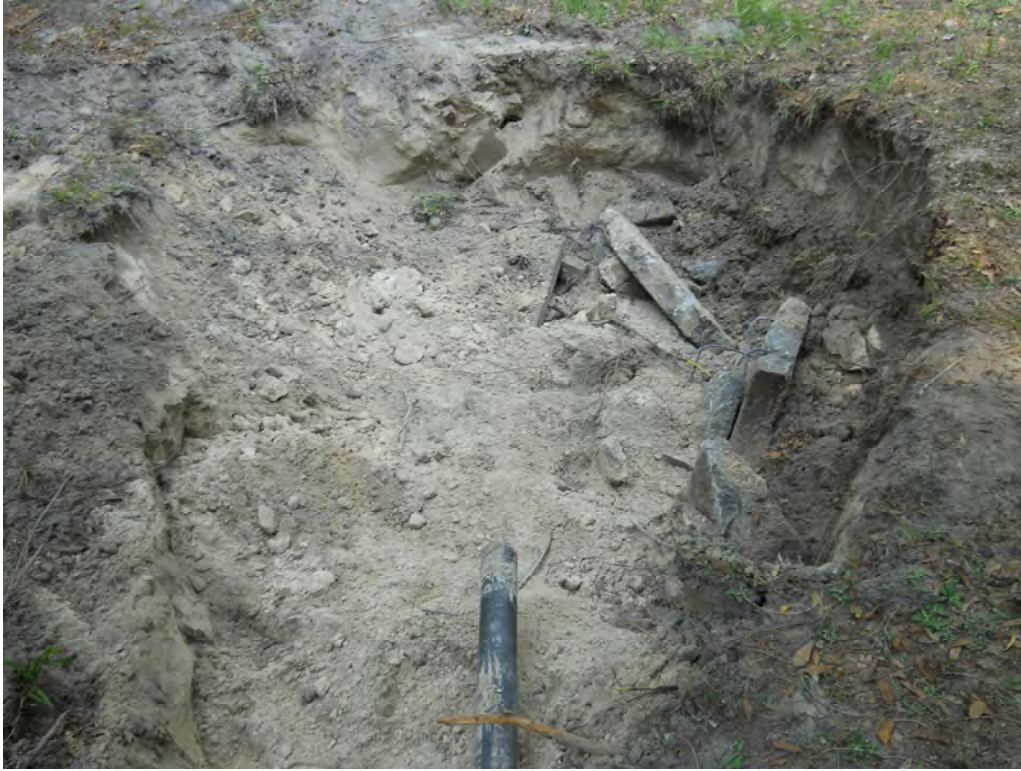
Figure 2
Old Septic Tank Crushed and Filled

Installation of the system commenced June 7, 2011 and was completed on June 10, 2011. The installation began with a pump out and abandonment of the existing conventional septic system. After the pump out was completed, the old septic tank was crushed and filled with a backhoe (Figure 2).

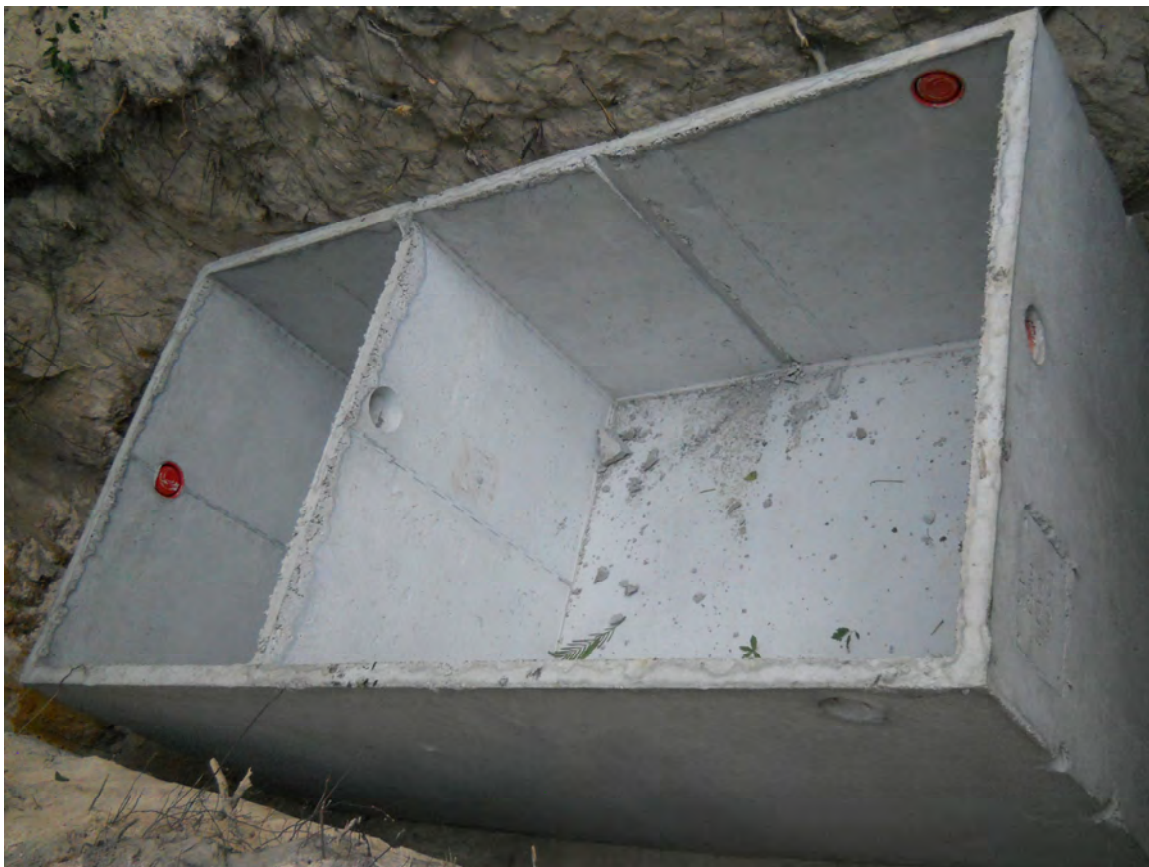
Figure 3
1,500 Gallon Two Chamber Primary Tank

A 1,500 gallon, two compartment tank was installed next to the abandoned tank. The first larger chamber (1,000 gallon) serves as a primary receiving tank, receiving the raw sewage from the household. The second smaller (500 gallon) chamber serves as the pump chamber (Figure 3). Care was taken to assure the tank was installed level. The sewer pipe from the house was plumbed into the side hole at the bottom of Figure 3.

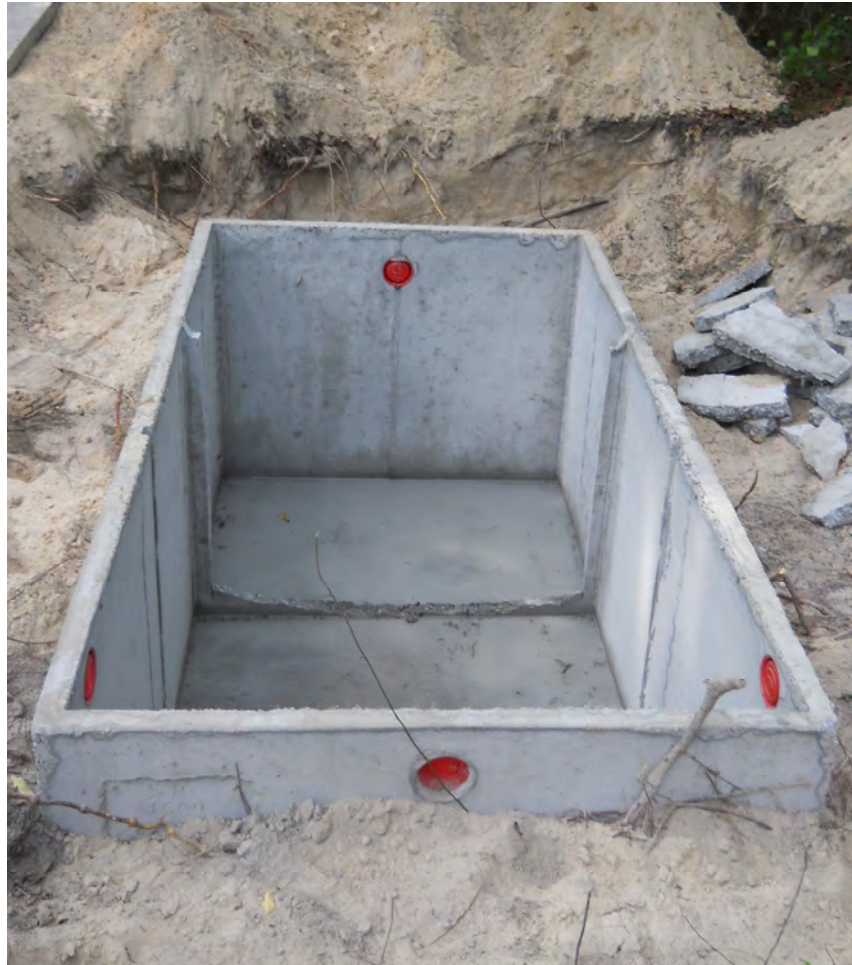
Figure 4
1,500 Gallon Single Chamber Nitrex Tank

A single chamber (1,500 gallon) concrete tank was then installed towards the back of the property near the planned area of the future drainfield. The purpose of this tank was to hold the Nitrex media. The tank manufacturer delivered a two chamber tank by mistake; therefore the baffle wall was removed using a concrete saw to create a one chamber tank (Figure 4).

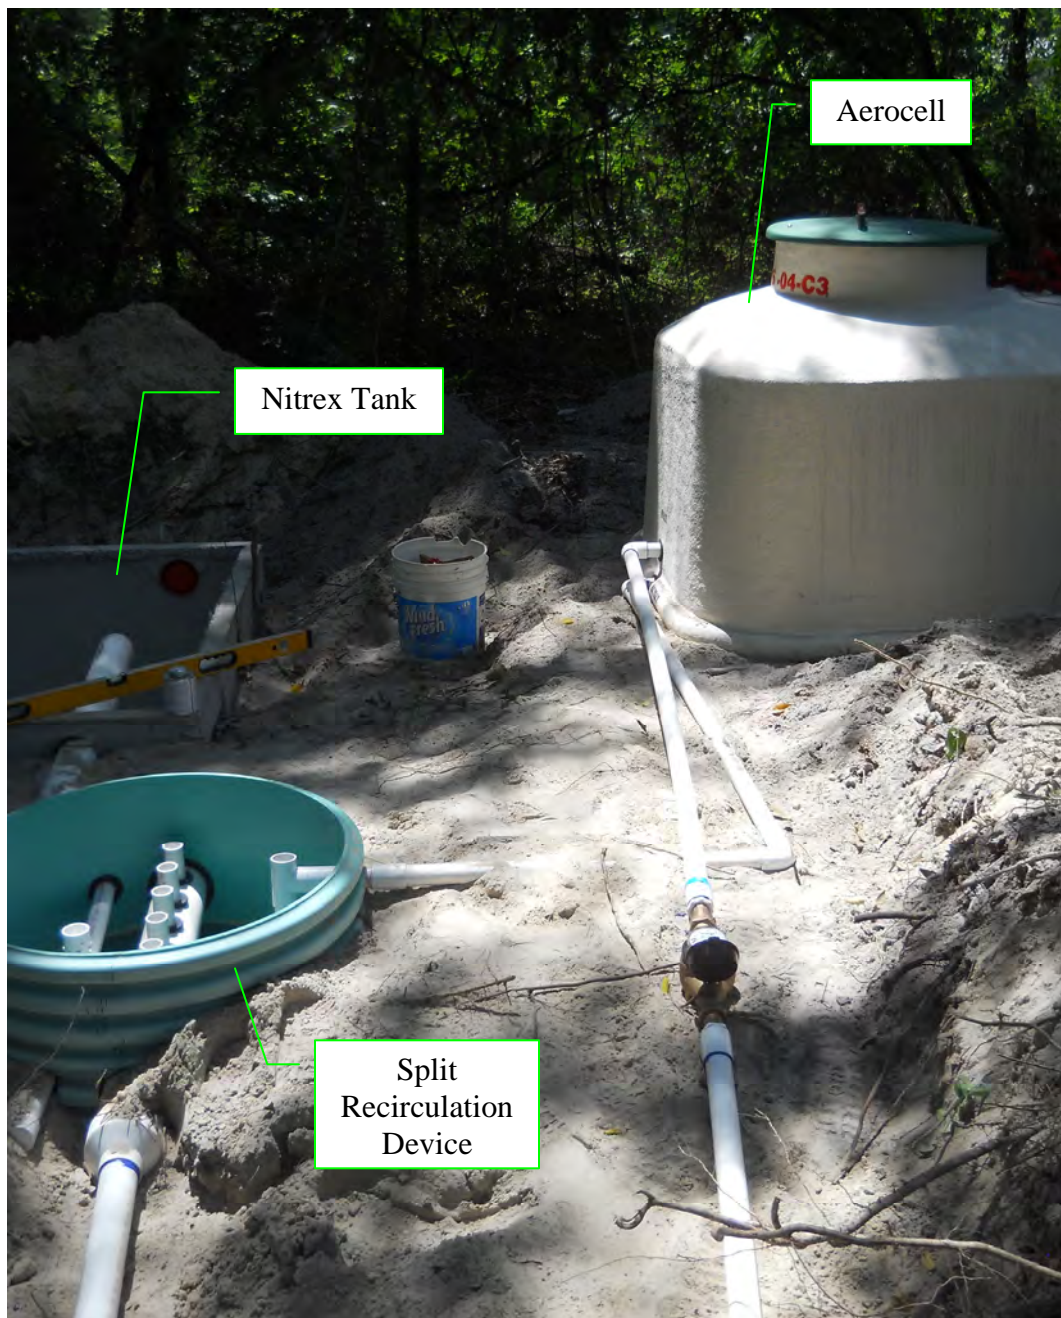
The Aerocell chamber and the split recirculation device were installed adjacent to the Nitrex tank and leveled. Copper sulfate was applied to the soil underneath these two components to prevent root growth from causing the Aerocell and split recirculation device to become unlevelled. Once the Nitrex tank, Aerocell chamber, and the split recirculation device were installed and leveled, plumbing connections were installed (Figure 5). An inline flow meter was installed prior to the Aerocell chamber to record the cumulative flow in gallons pumped from the 2nd chamber of the primary tank (Figure 6). At this location, the flowmeter measurement includes the forward wastewater flow and the recirculation flow. Figure 5 shows the line leading into the Aerocell chamber with water meter, the line coming out of the Aerocell chamber into the split recirculation device, the line from the split recirculation device to the Nitrex tank, and the line from the split recirculation device back to the 2nd chamber of the two chambered primary tank. Flow from the split recirculation device is by gravity to both the Nitrex tank and the 2nd chamber of the primary tank.

Figure 5
Layout and Plumbing of the Nitrex Tank, Aerocell Chamber and Split Recirculation Device

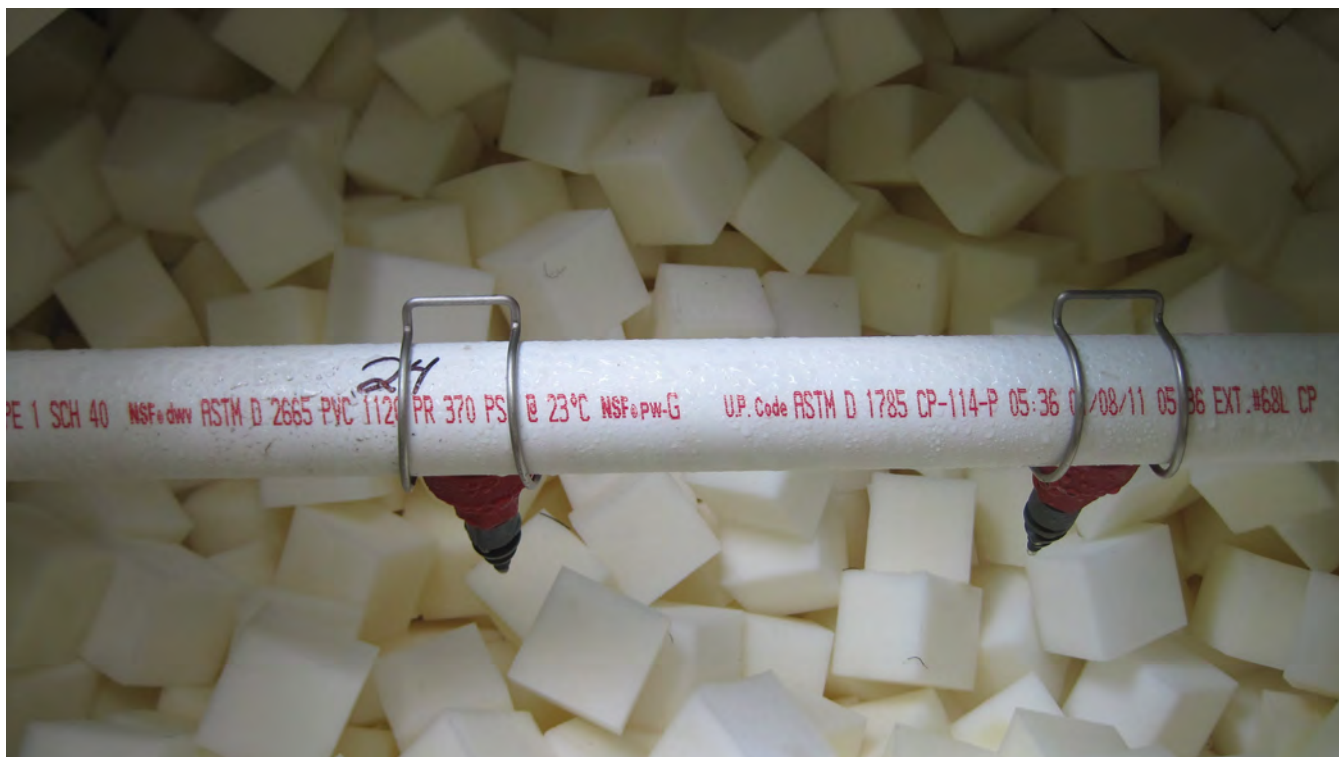
Figure 7
Spray Nozzles and High Density Foam Cubes Inside One Side of Aerocell Chamber

The Aerocell chamber is a single chamber filled with high density foam cubes. Effluent is applied to the top of the Aerocell high density foam cubes (Figure 7) by four spray nozzles located above the cubes. Not shown are the pressure gauge and the ball valve which allows the pressure of the pumped effluent to be adjusted. The target pressure is between 5 and 10 PSI, with 7 PSI being optimal. The spray nozzles are removable for cleaning in the event clogging occurs despite the filter in the STE tank, the pump tank filter, and the filter installed following the pump (Figure 8).

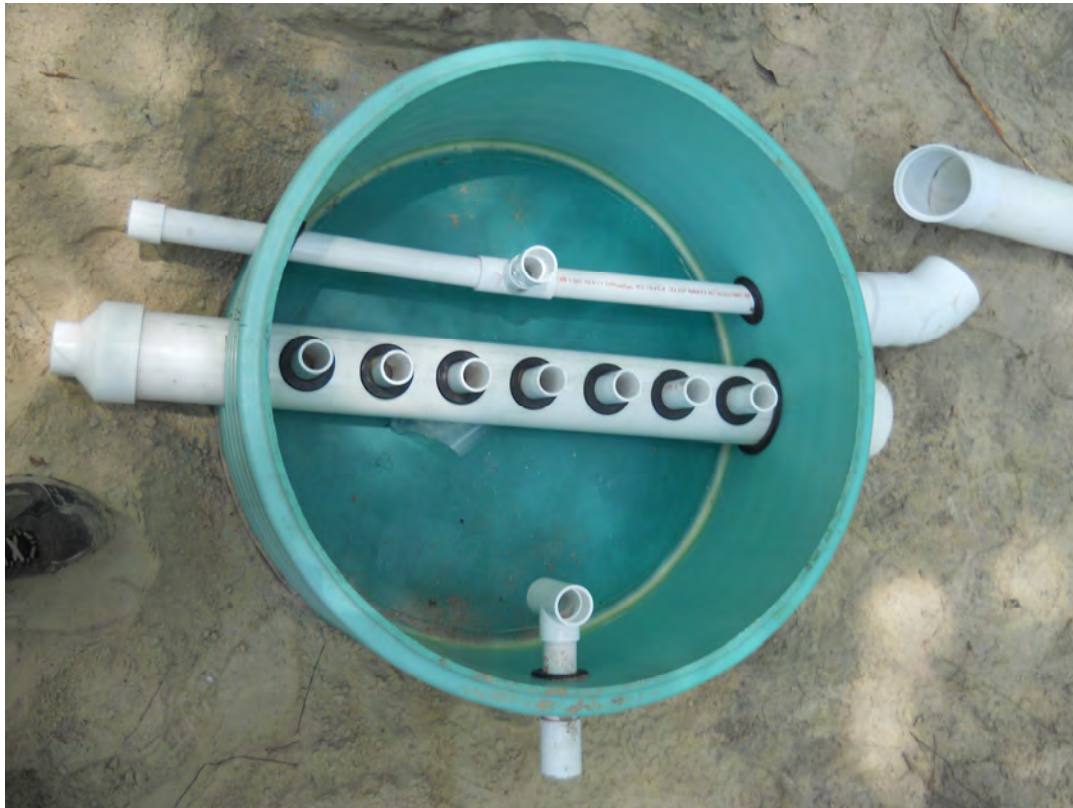
Figure 9
Split Recirculation Device

Although Figure 1 indicates a 5 to 1 split recirculation device, the device installed is capable of a 7 to 1 split. The amount of recirculation is adjustable from 7 parts recirculation back to the 2nd chamber of the primary tank and 1 part going to the Nitrex tank, down to no recirculation to the 2nd chamber. The split recirculation device consists of 7 adjustable PVC pipes that deliver effluent back to the two chamber tank and one fixed PVC pipe that delivers effluent to the Nitrex tank. To reduce the amount of effluent recirculated back to the two chamber tank, one or more of the 7 PVC pipes are simply raised above the water line. The inlet pipe from the Aerocell chamber is shown with a PVC tee. This piece was left unglued so that it can be removed to gather an effluent sample from the Aerocell chamber (Figure 9).

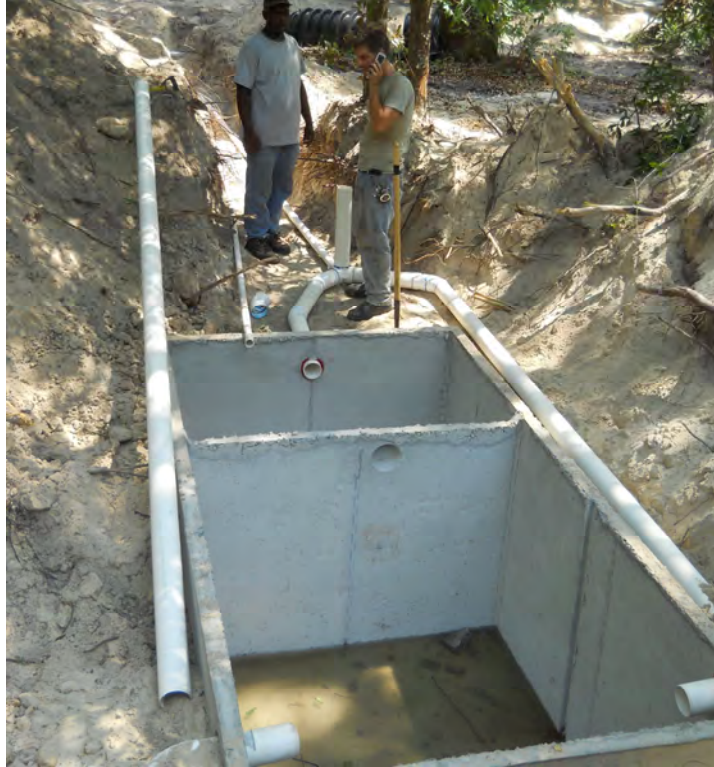
Figure 10
Split of Recirculation Pipe back towards the Two Chamber Tank

Figure 1 shows the recirculating effluent flowing back to the 1st chamber of the primary tank via a 2 inch pipe, however the design was modified. As installed, the 2 inch PVC pipe was increased to 4 inch PVC pipe which was fitted with a “Y” and a “bull run” valve (Figure 10 and 11). This gives the option of having the recirculation effluent flow to either the 2nd chamber or the 1st chamber of the primary tank. A riser pipe was installed to grade over the valve, so that the valve can be turned after installation is complete. The valve is turned with a wrench on a rod which is long enough to reach with the riser installed (Figure 11). The valve was initially set so the recirculation goes to the 2nd chamber. Not shown in Figure 10 is the screw cap covering the riser pipe. Shown in the lower left corner of Figure 10, is the sewer pipe from the home.

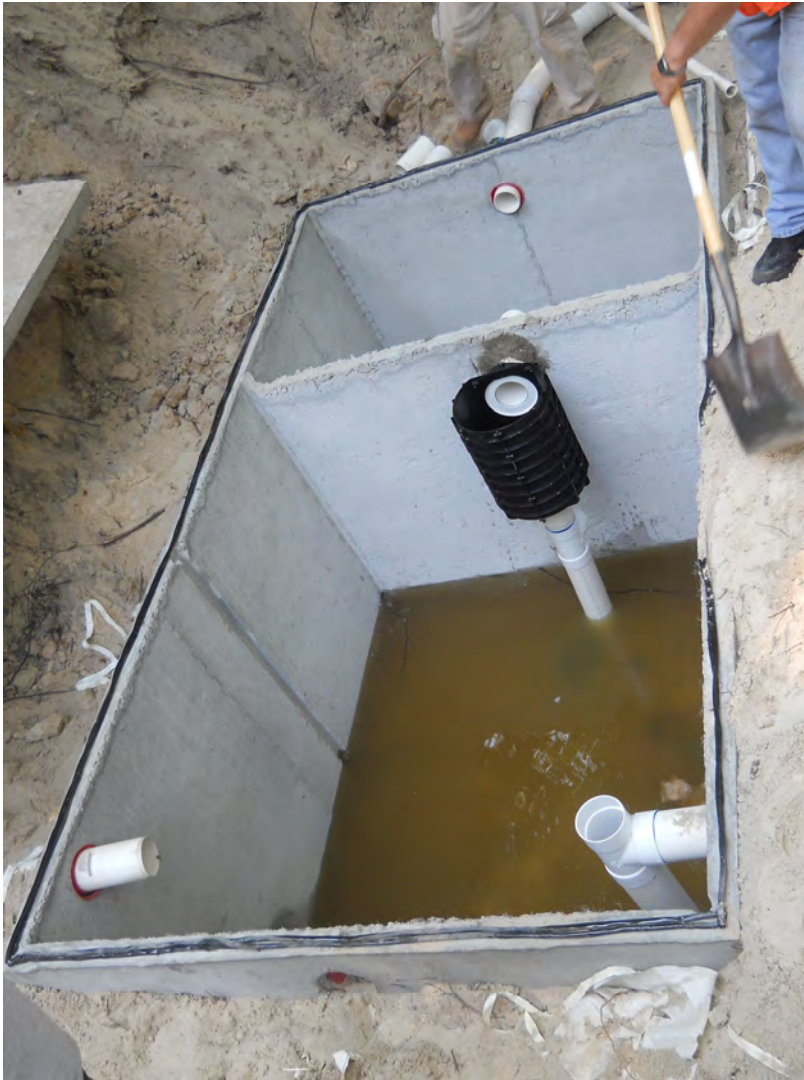
Figure 12
Filter between 1st Chamber and 2nd Chamber of Primary Tank

The 1st chamber filter was installed in the hole in the baffle separating the first and second chambers (Figure 12). Concrete was used to seal the pipe in the baffle wall. Effluent enters the filter from a 4 inch PVC tee located at the midpoint of the tank depth. The pipe shown extending from the tee downwards is to provide support for the filter. A 4 inch PVC tee was also installed on the recirculation line in the 1st chamber. The down leg of pipe was cut to the midpoint of the tank.

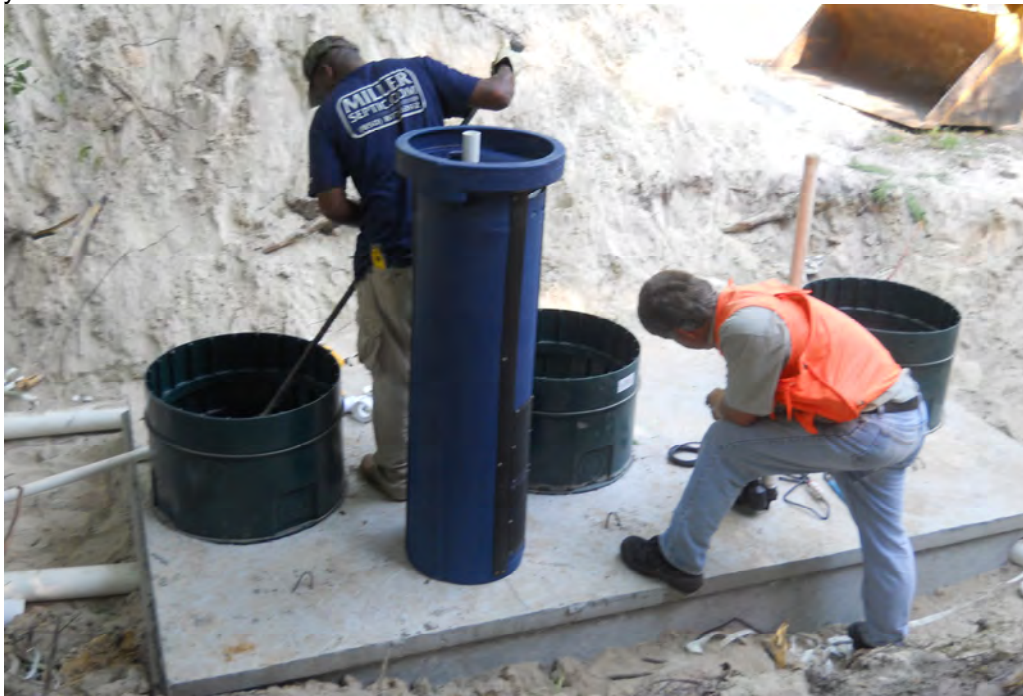
Figure 13
Primary Tank Lid and Pump Vault

The tank lid has three risers as shown in Figure 13. The riser to the right allows access to the 1st chamber, which provides the ability to pump out as needed. The middle riser allows the 1st chamber filter to be serviced. STE samples will also be taken from this riser. The riser to the left gives access to the 2nd chamber. The blue cylinder shown in Figure 13 is the pump vault. Figure 14 shows the installed pump vault, the valve for sample access, and the final filter on the pipe leading to the Aerocell chamber. Samples taken from the pump vault represent the water quality characteristics of Aerocell

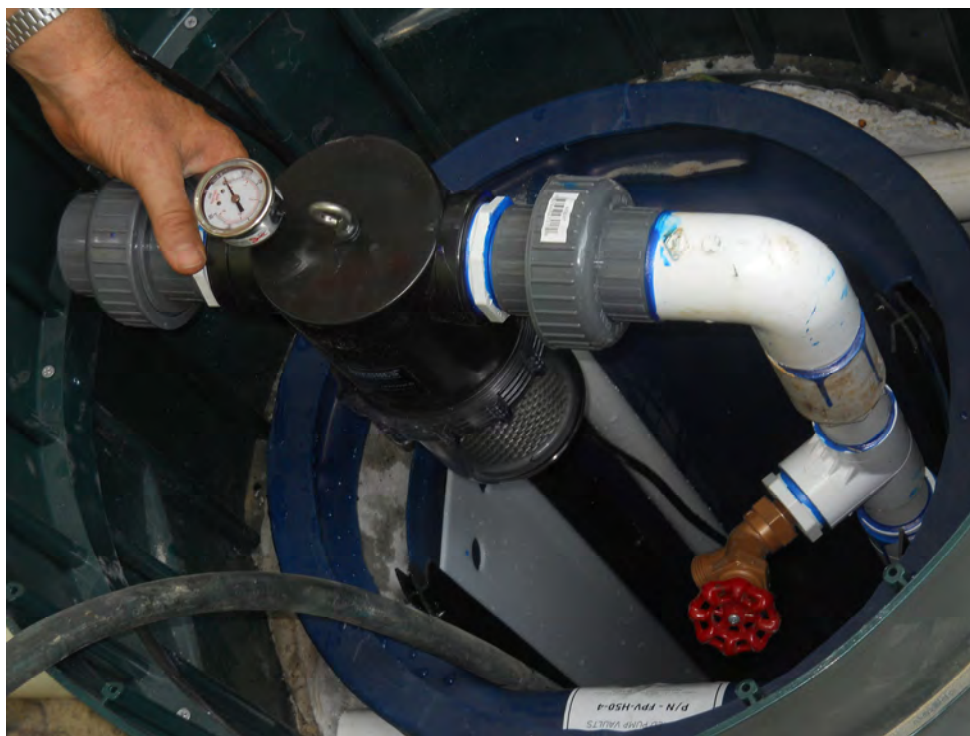
Figure 14
Plumbing and Filter installed in Pump Vault inside of 2nd Chamber

influent. The hose shown in Figure 14 was used to fill the 2nd chamber with potable water prior to testing the system.

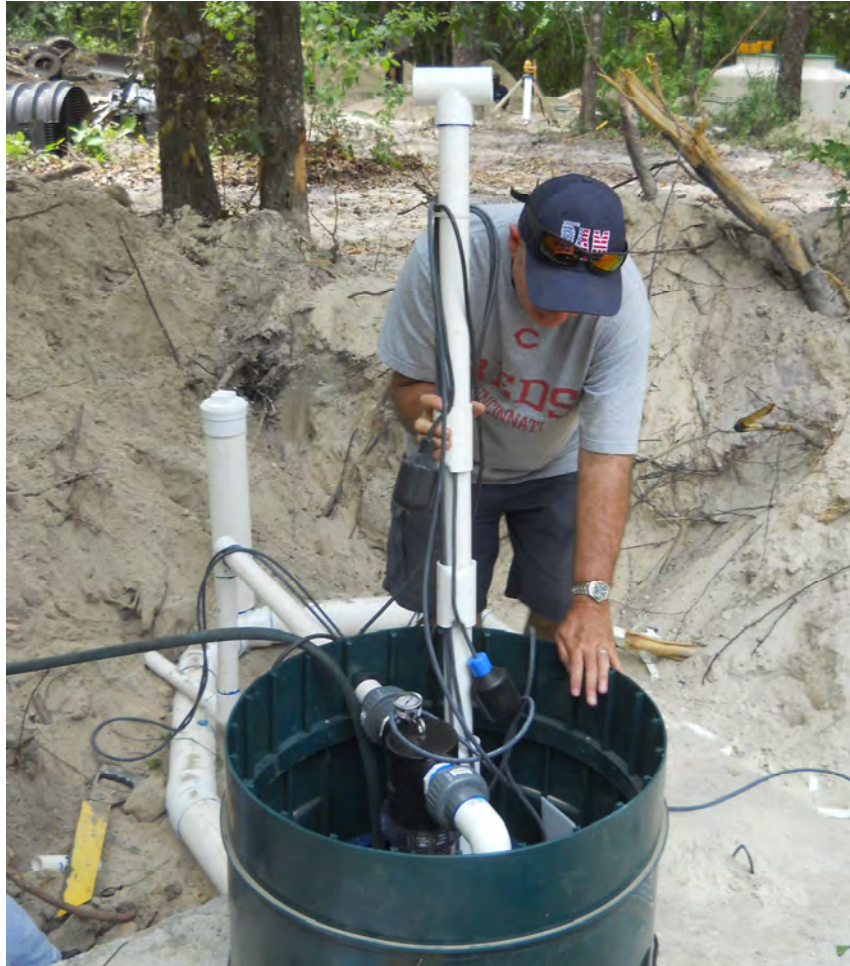
Figure 15
Placing Float Tree into the Pump Vault

Four float switches were installed to maintain the effluent level in the 2nd chamber of the primary tank and are attached to a “float tree” installed in the pump vault and connected to the control panel. The height of the floats is adjustable and once the proper heights were established, screws were used to secure the floats to the float tree. Figure 15 shows the float tree being placed into the pump vault after adjustment.

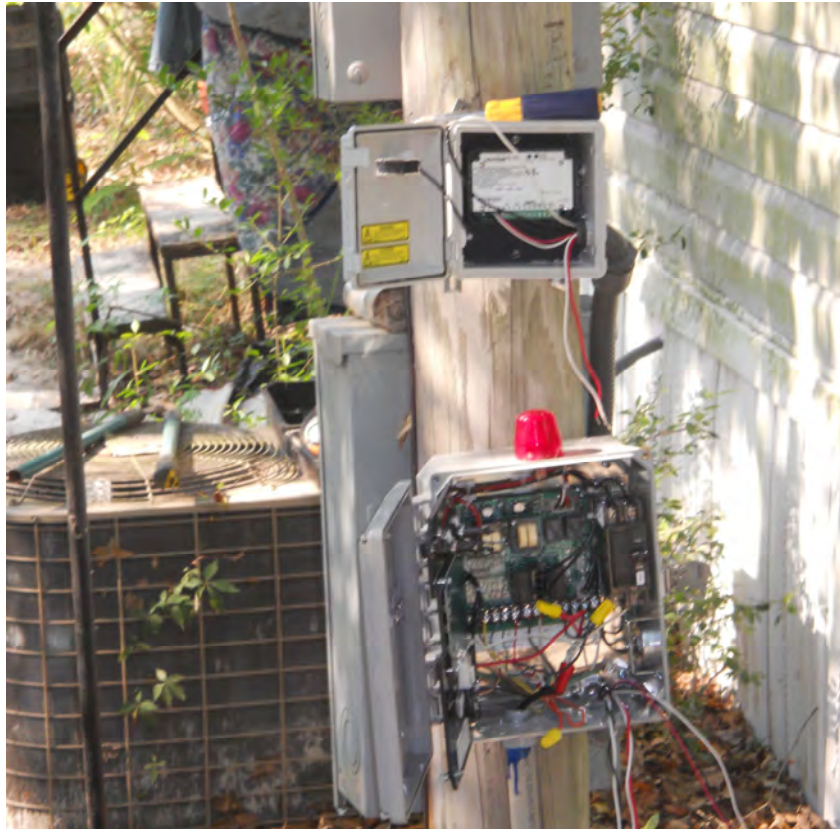
Figure 16
Control Panel and Power Meter

A power meter was installed between the main power box of the house and the control panel to record cumulative power usage of the pump in kilowatts. The equipment connected to the power meter are the recirculation pump and the control panel. Figure 16 shows the power meter located above the control panel.

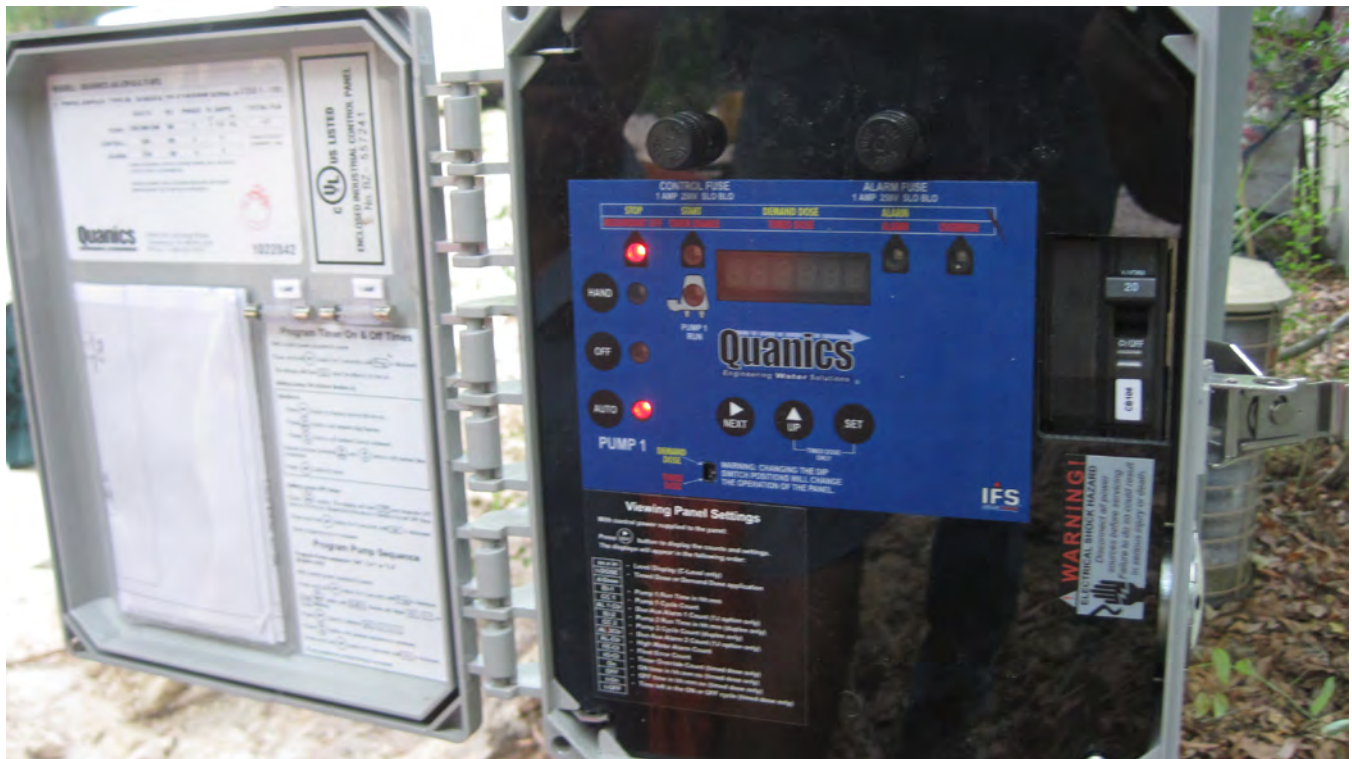
Figure 17
Control Panel

The system control panel (Figure 17) allows for a timed pump cycle which can be overridden if the effluent levels are too low or too high in the 2nd chamber of the primary tank. If the floats indicate a low effluent level in the tank, the timed cycle is turned off to protect the pump. If the floats indicate a high effluent tank level, then the pump cycles faster (off cycle reduced) until the water level reaches the optimal range. An alarm will indicate if the water level goes above a critical level.

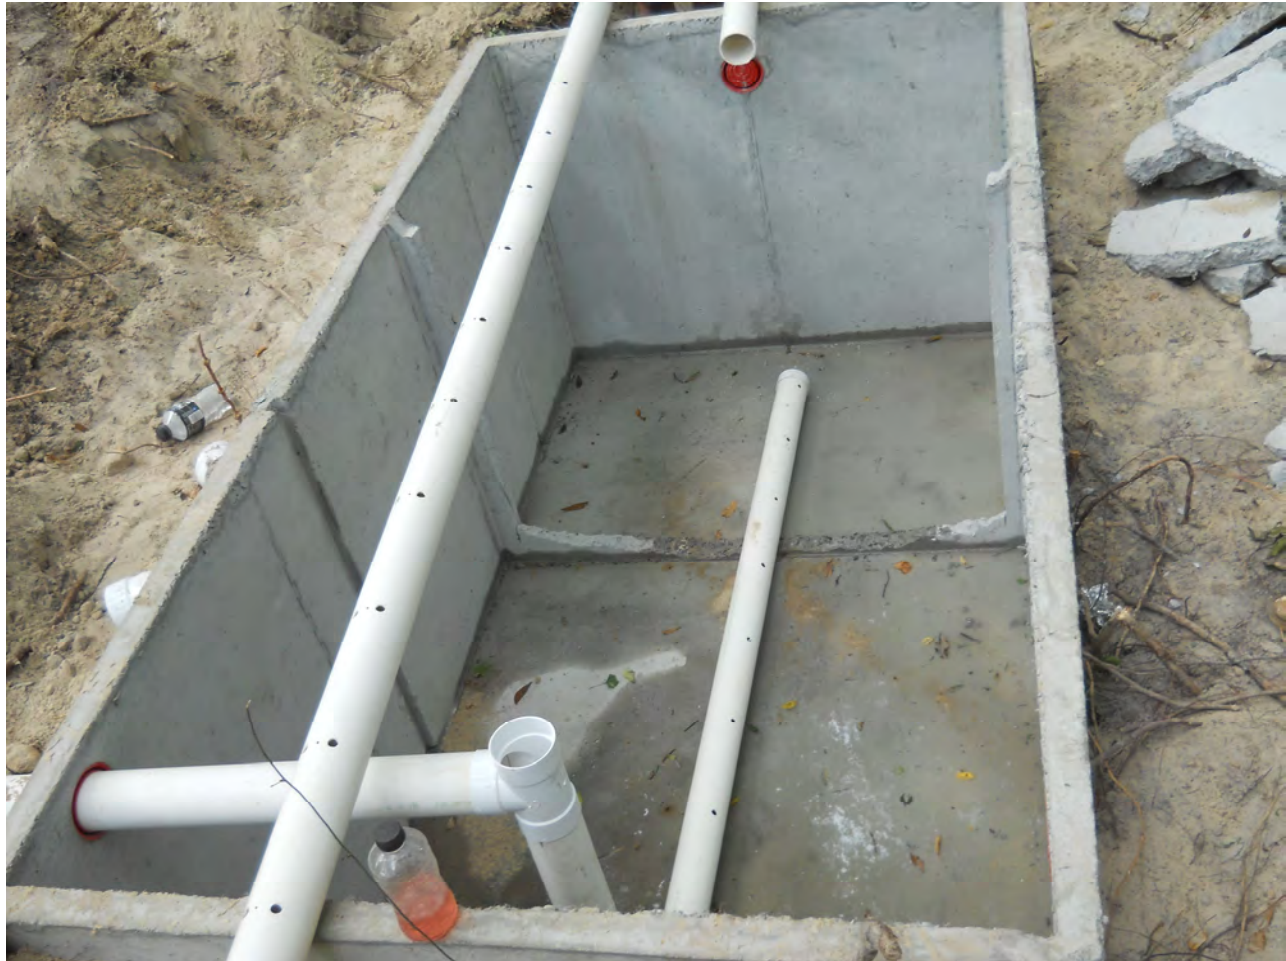
Figure 18
Inlet Pipe installed in the Nitrex Tank

The inlet pipe into the Nitrex tank was routed down to the bottom of the tank and a 90 degree bend was used to attach a 4 inch pipe with a row of drilled holes. This allows for the tank to be filled from the bottom in a uniform manner (Figure 18). The pipe shown across the top of the tank is the outlet pipe to be connected at the top.

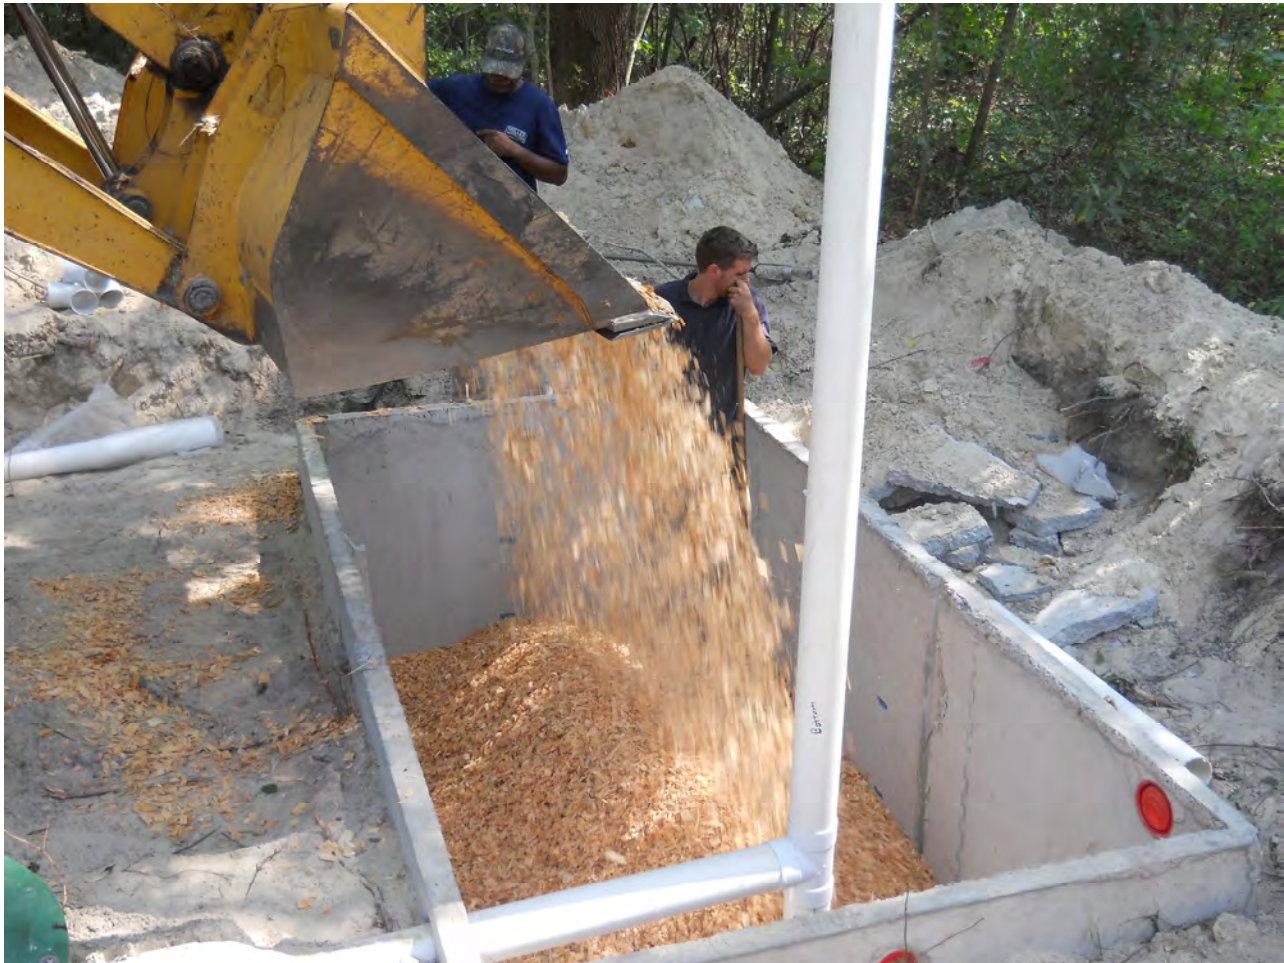
Figure 19
Filling the Nitrex Tank with Media

After the inlet pipe was in place, the tank was filled with the Nitrex media (Figure 19). This media consisted of pine wood chips and pine sawdust. The pipe extending upwards from the inlet tee was used temporarily during media filling to prevent media from entering the inlet pipe.

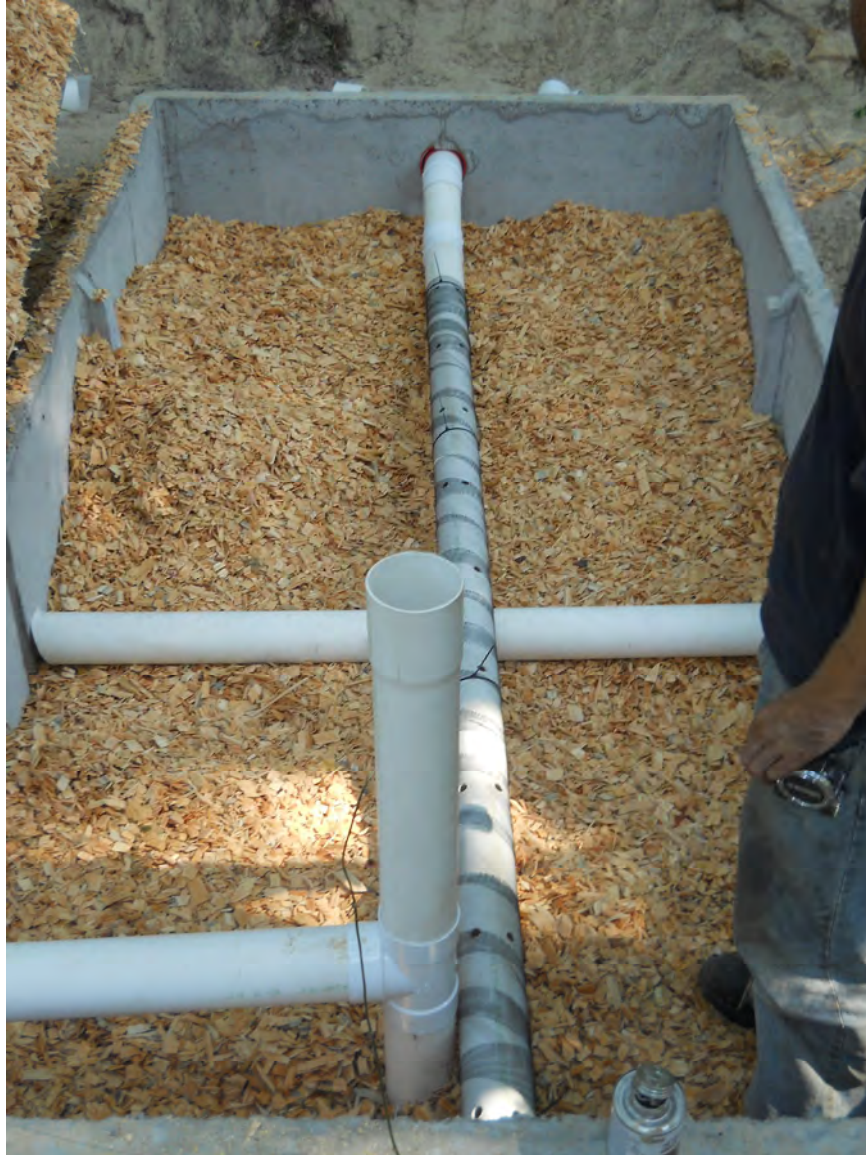
Figure 20
Outlet Pipe in the Nitrex Tank

After the media was installed to the desired height, the outlet pipe for the tank was installed (Figure 20). The outlet pipe which has two rows of drilled holes on the top and is wrapped with a plastic mesh to prevent wood chips from entering the pipe collects the wastewater for discharge to the drainfield. The PVC pipe underneath the outlet pipe shown in Figure 20 was used to level the pipe above the media.

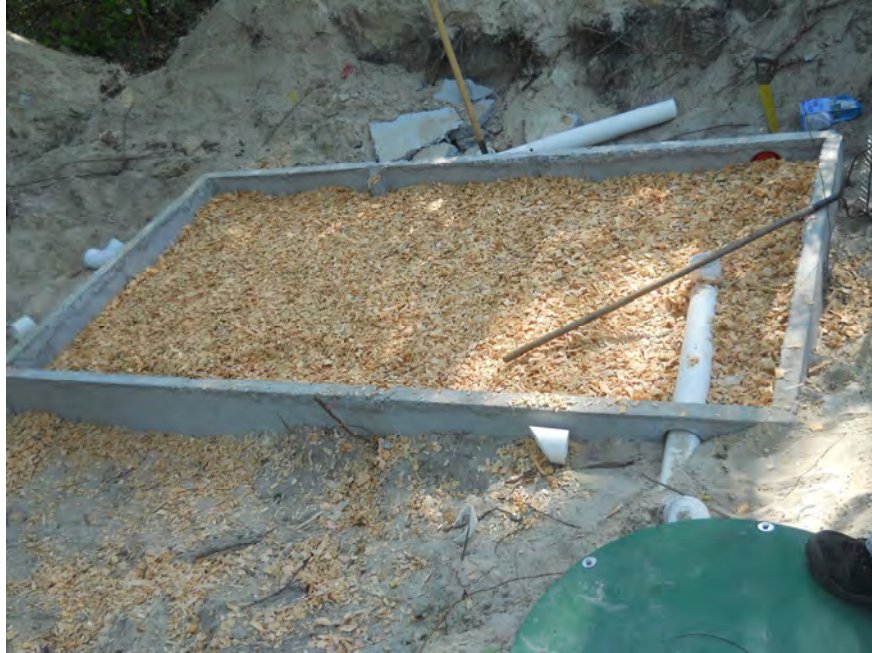
Figure 21
Nitrex Tank filled with Media

Following the outlet pipe install, additional media was used to fill the tank to the level of the influent pipe (Figure 21), and the lid was installed (Figure 22).

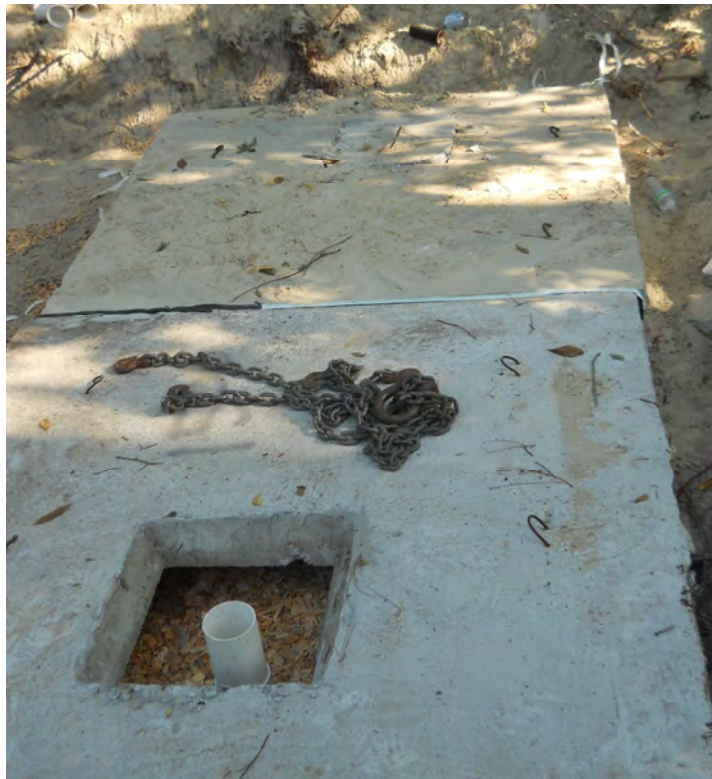
Figure 22
Nitrex Tank with Lid Installed

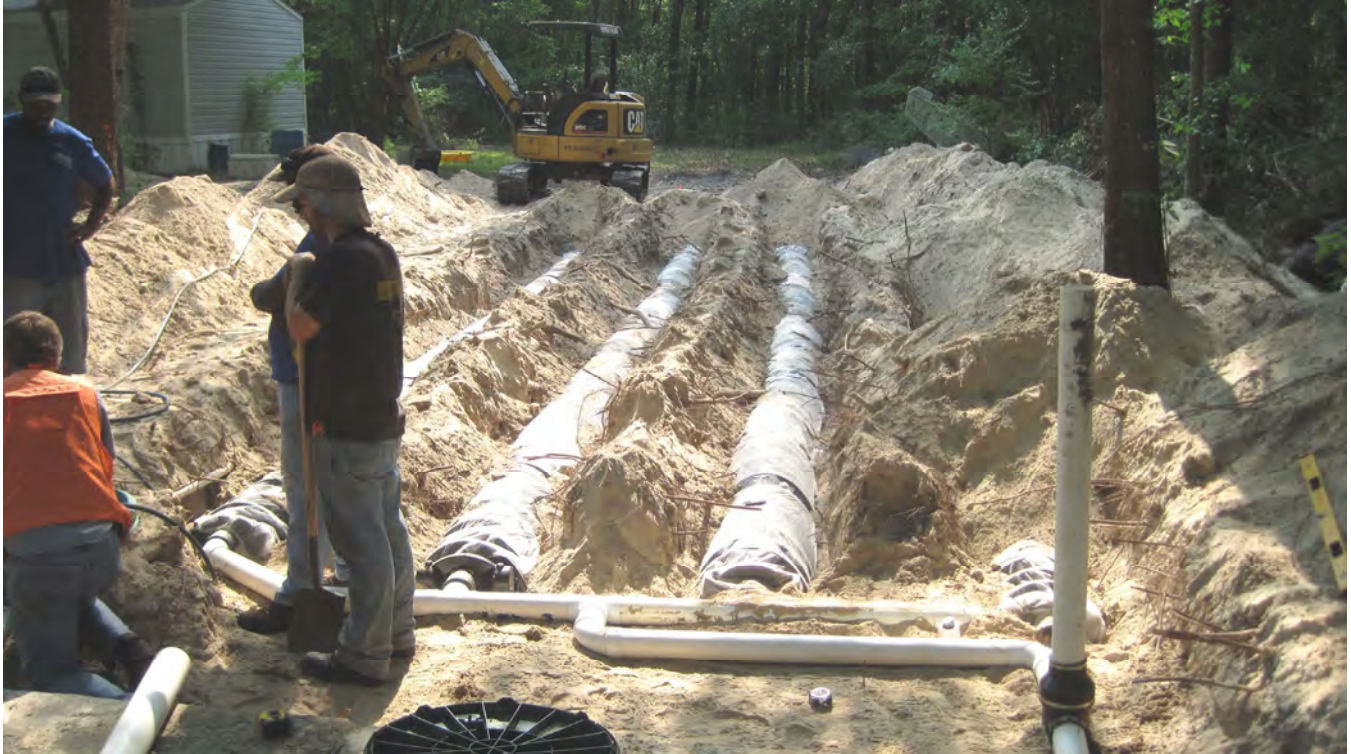
Two Risers were cemented over the tank openings and the drainfield was installed (Figure 23). The drainfield consists of Infiltrator chambers in 4 trenches spaced two feet apart. Three rows are 40 feet in length, and the fourth is 36 feet long. The original design shown in Figure 1 only showed three rows, two 44 feet long and the third shorter row being 40 feet long. However, in some areas of the drainfield, the clay layer was shallower than anticipated from the original soil borings, and the drainfield area was therefore enlarged. The chambers were covered in protective fabric to prevent sand from washing into and filling the chambers.

Figure 23
Four Rows of Infiltrator Drainfield Chamber

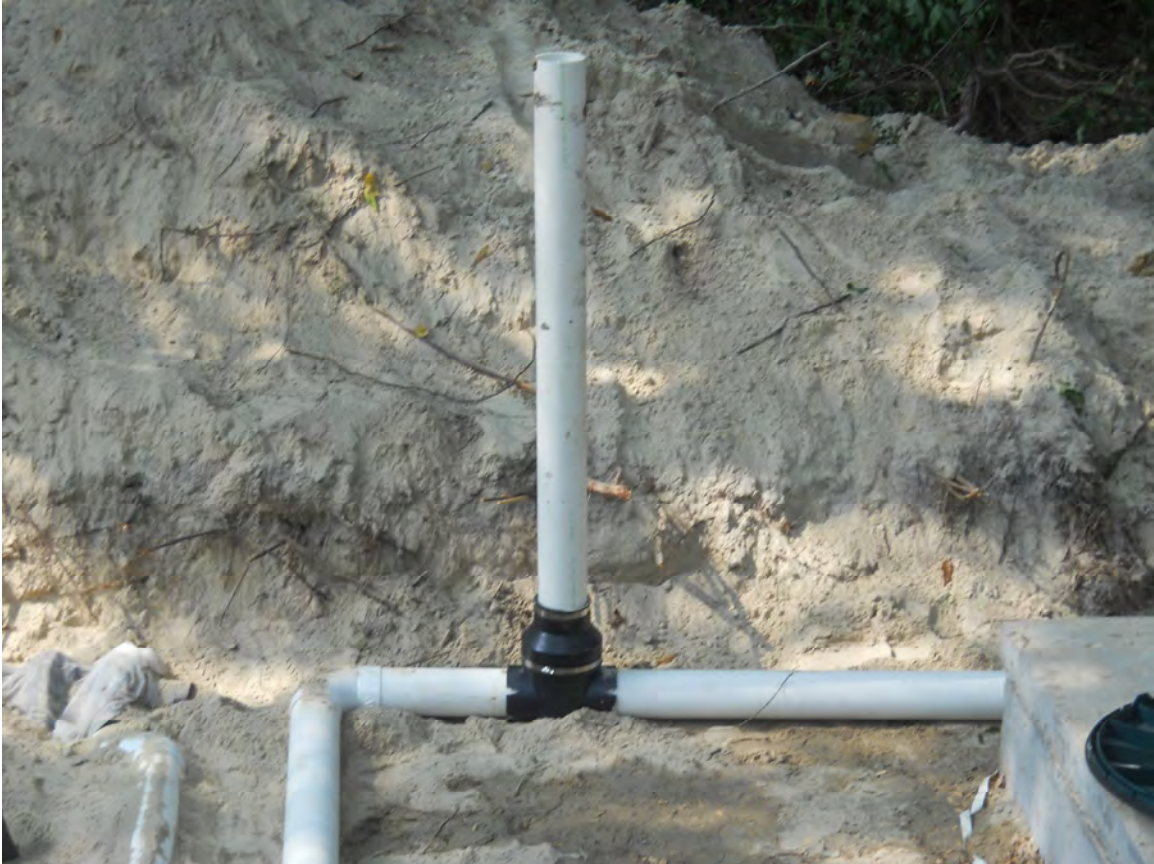
On the pipe between the Nitrex tank and the drainfield, a catch basin was installed so that the final effluent discharged to the drainfield can be sampled (Figure 24). The black piece extends into the ground approximately three inches. The riser pipe shown was cut at the final grade and capped with a screw cap.

Figure 24
Sampling Port for the Effluent being discharged to the Drainfield

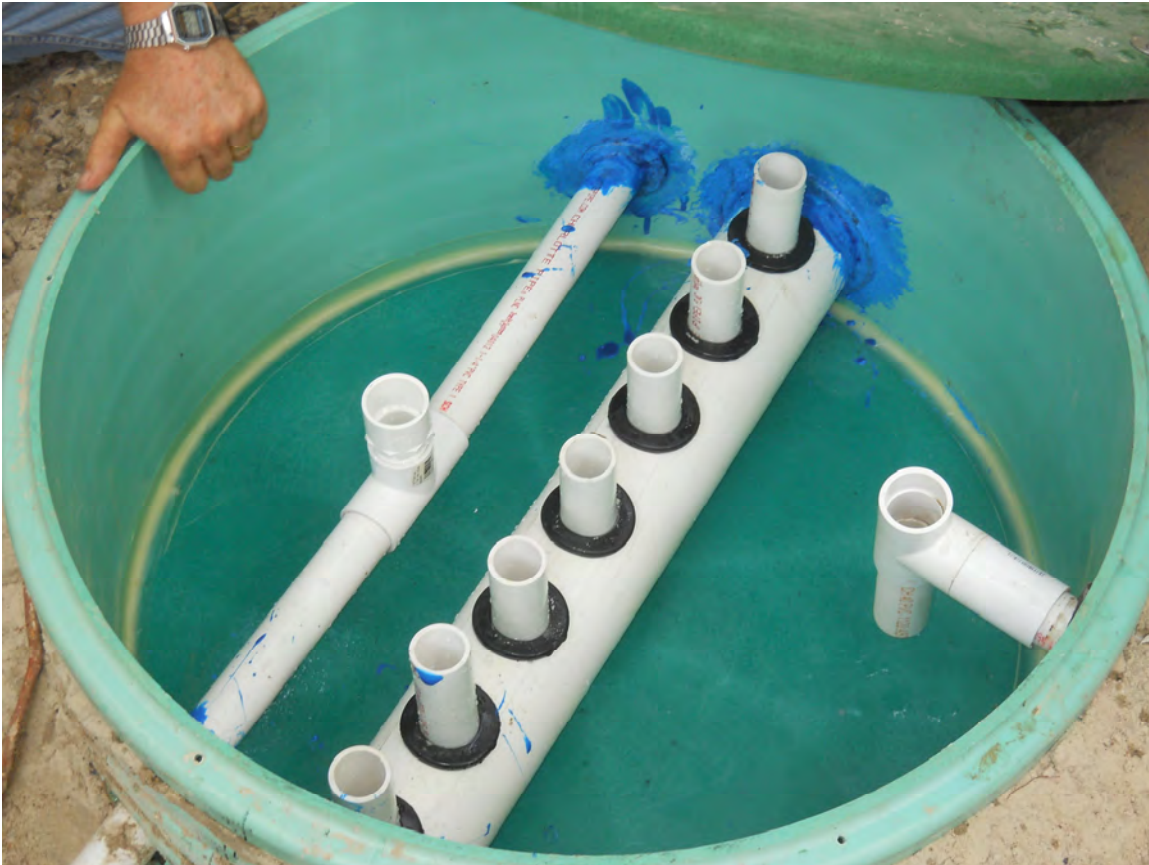
During final testing of the system, leaks were discovered from the split recirculation device around the grommets. The grommets were sealed with PVC glue (Figure 25). The drainfield trenches were filled and all disturbed areas on the property were graded. Sod will be laid after consulting the homeowner concerning placement of the sod.

Figure 25
Sealing Leaks around Grommets

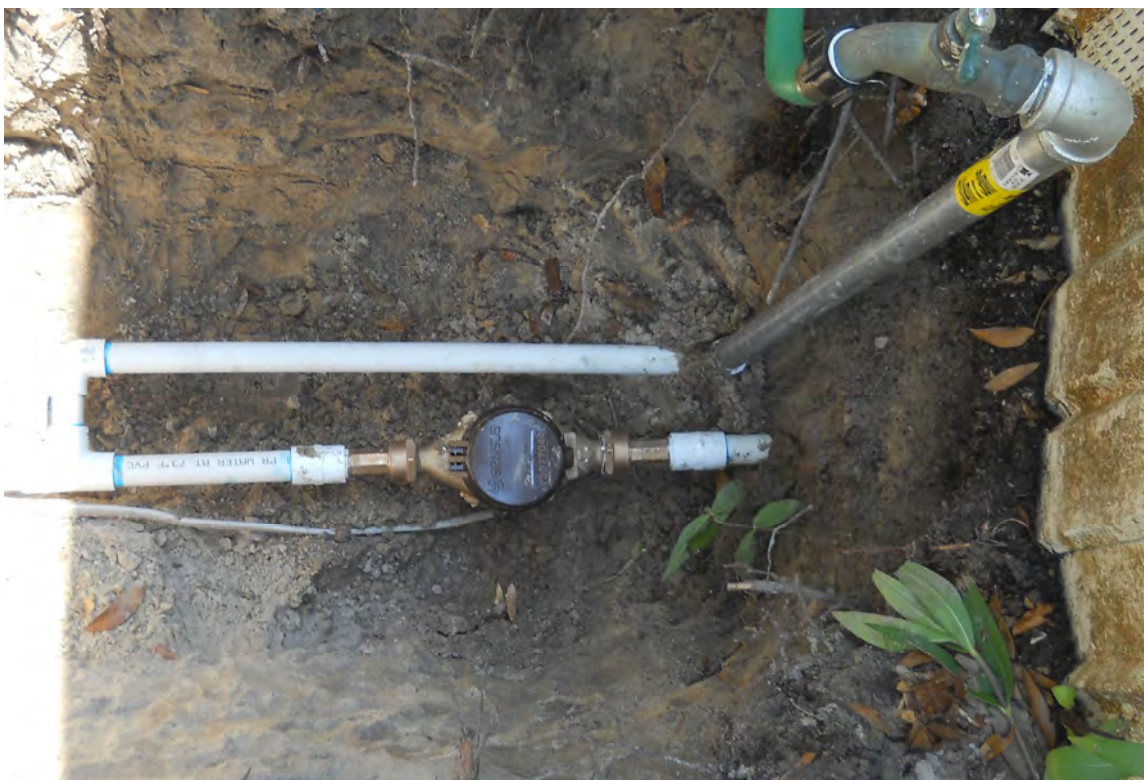
A water meter was installed on the water line from the household well. The water line for the one hose bib on the home was re-plumbed so that the junction came before the water meter. This allows for the measurement of the household water use independent of water use outside the home (Figure 26). So we will assume this represents flow to the treatment system.

Figure 26
Water Meter on line leading into the home, installed after junction for hose bib
