Florida Onsite Sewage Nitrogen Reduction Strategies Study

Evaluation of Full Scale Prototype Passive Nitrogen Reduction Systems (PNRS) and Recommendations for Future Implementation - Volume II of II

August 2015

**Installation Report for Passive Nitrogen Reduction System
B-HS1**

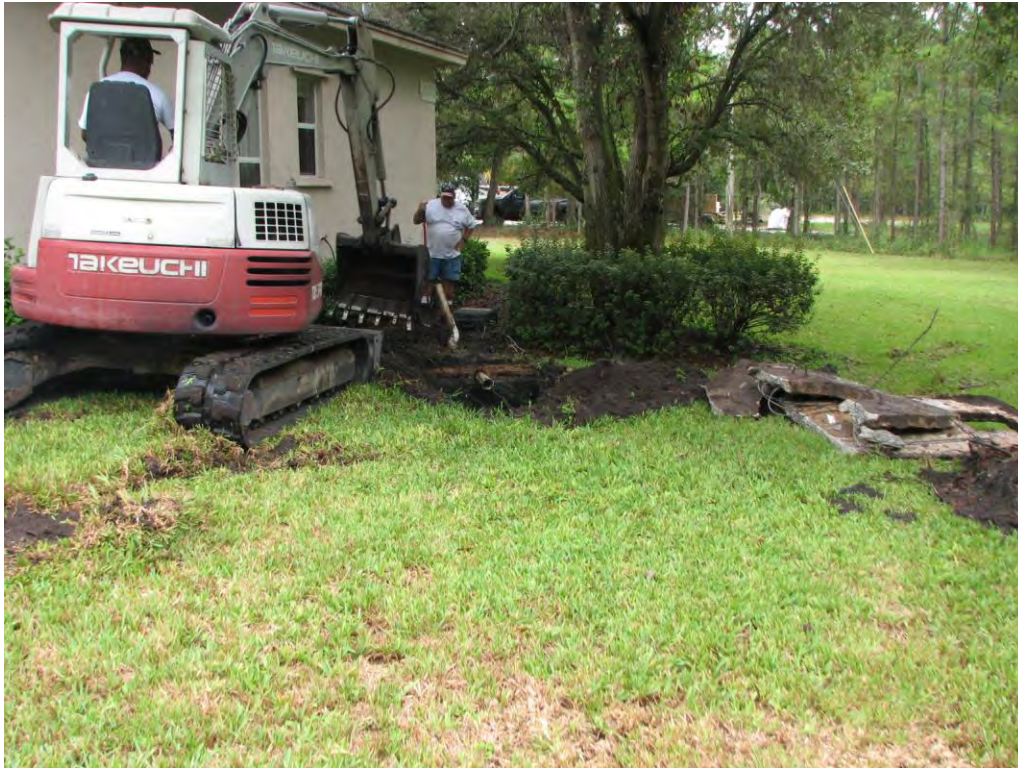
Installation of the system commenced September 10, 2012 and was completed on September 12, 2012. The installation began with a pump out and removal of the existing 1,050 gallon septic tank, which was found to be cracked during the system evaluation. After the pump out was completed, the old septic tank was removed (Figure 3).

Figure 3
Old septic tank removed

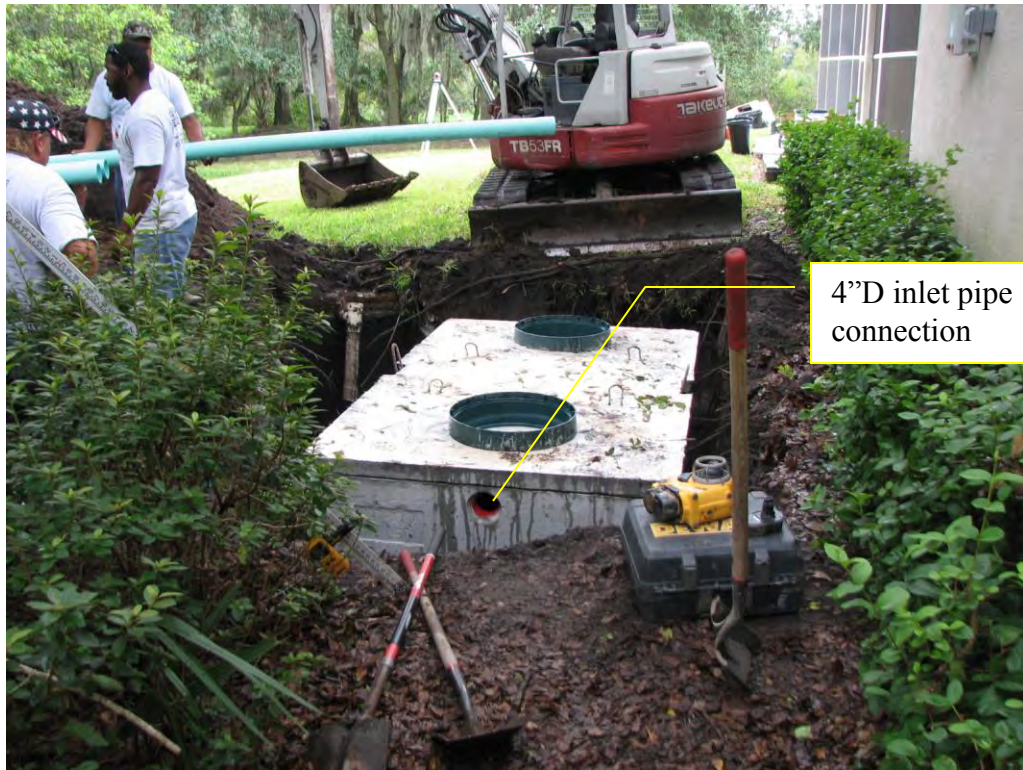
A 1,050 gallon, two compartment replacement concrete primary tank was installed. The first larger chamber serves as a primary receiving tank, receiving the raw sewage from the household. The sewer pipe from the house was plumbed into the 4"D (diameter) inlet hole shown in Figure 4. An effluent screen (Polylok™, PL-68) was installed in the outlet tee of the second chamber (Figure 5).

Figure 4
1,050 gallon, two chamber, primary Tank

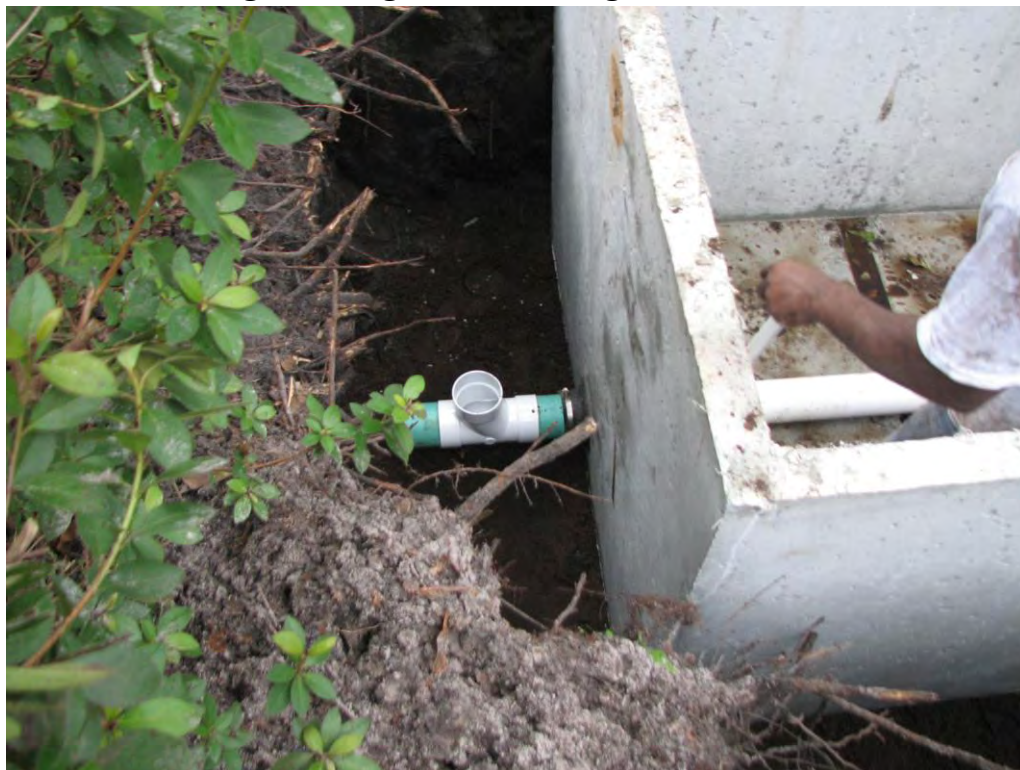
Figure 7
Stage 1 biofilter 4-inch diameter outlet pipe, with cleanout

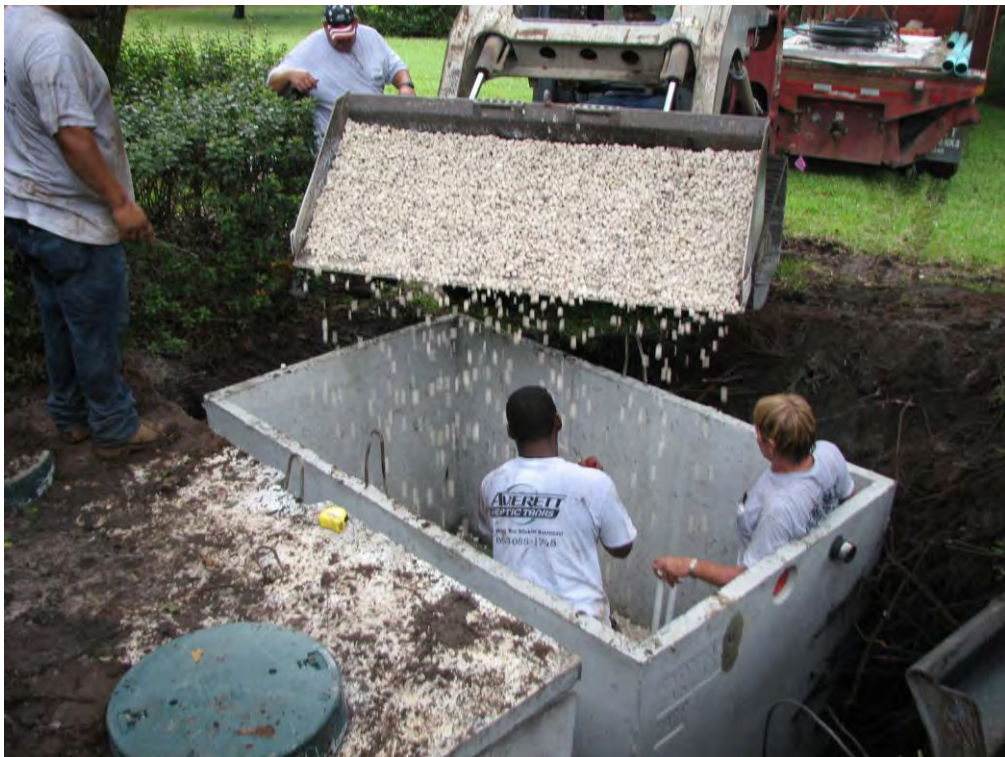
Figure 8
Stage 1 biofilter gravel underdrain

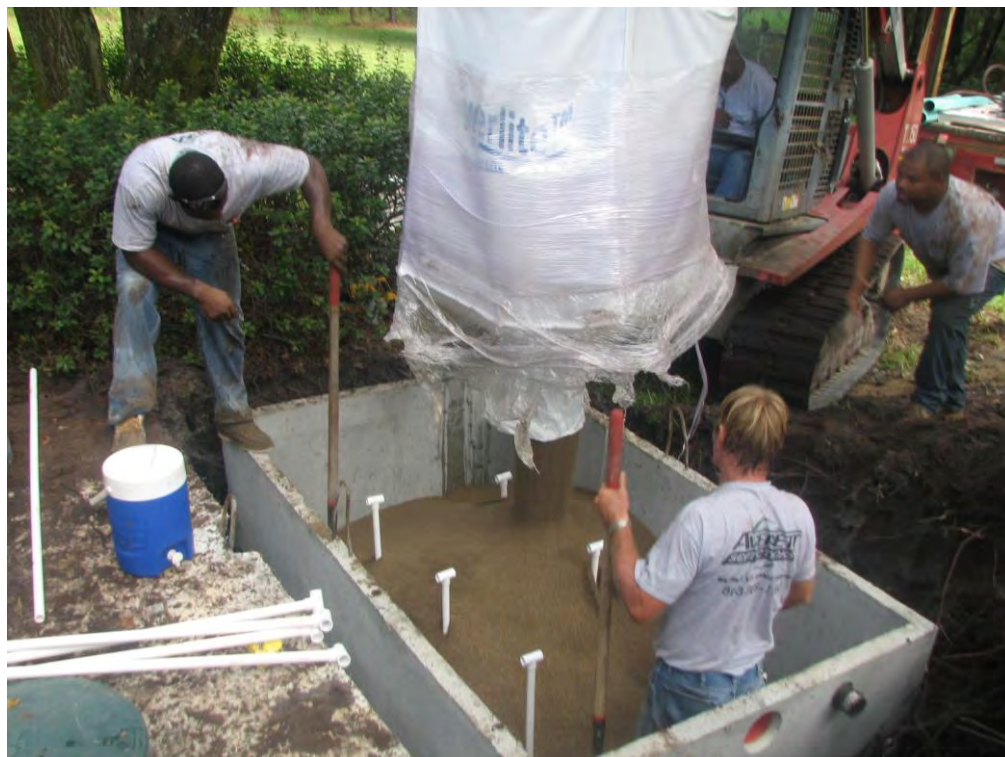
Figure 9
Stage 1 biofilter 20-inches of fine media (3/16 Riverlite™)

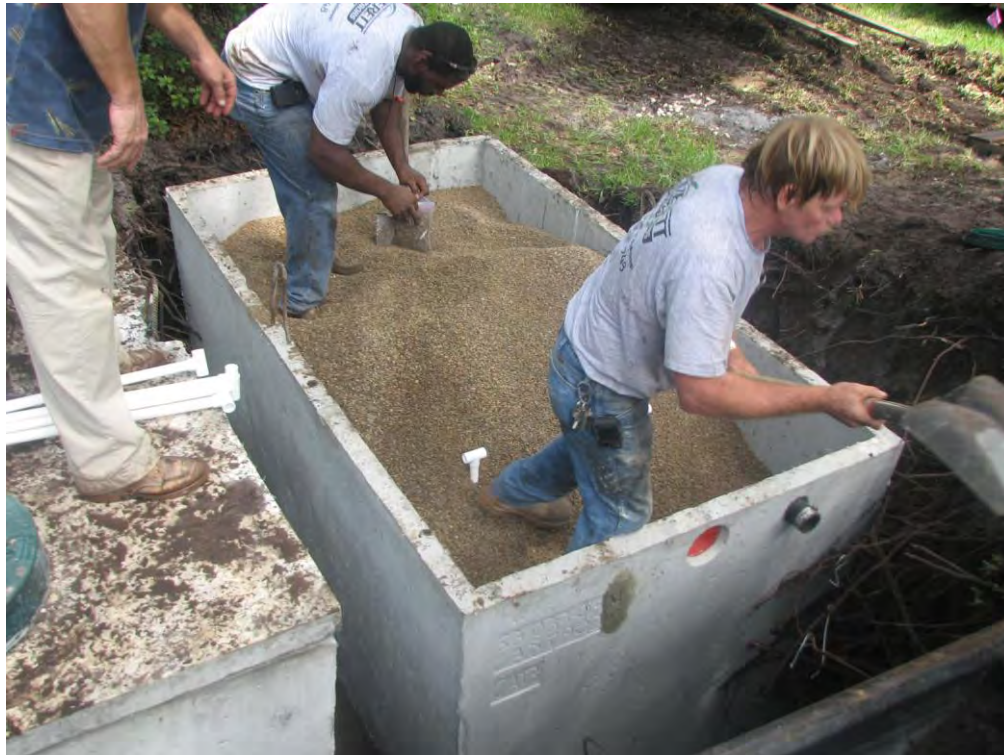
Figure 10
Stage 1 biofilter 10-inches of coarse media (1/4 Riverlite™)

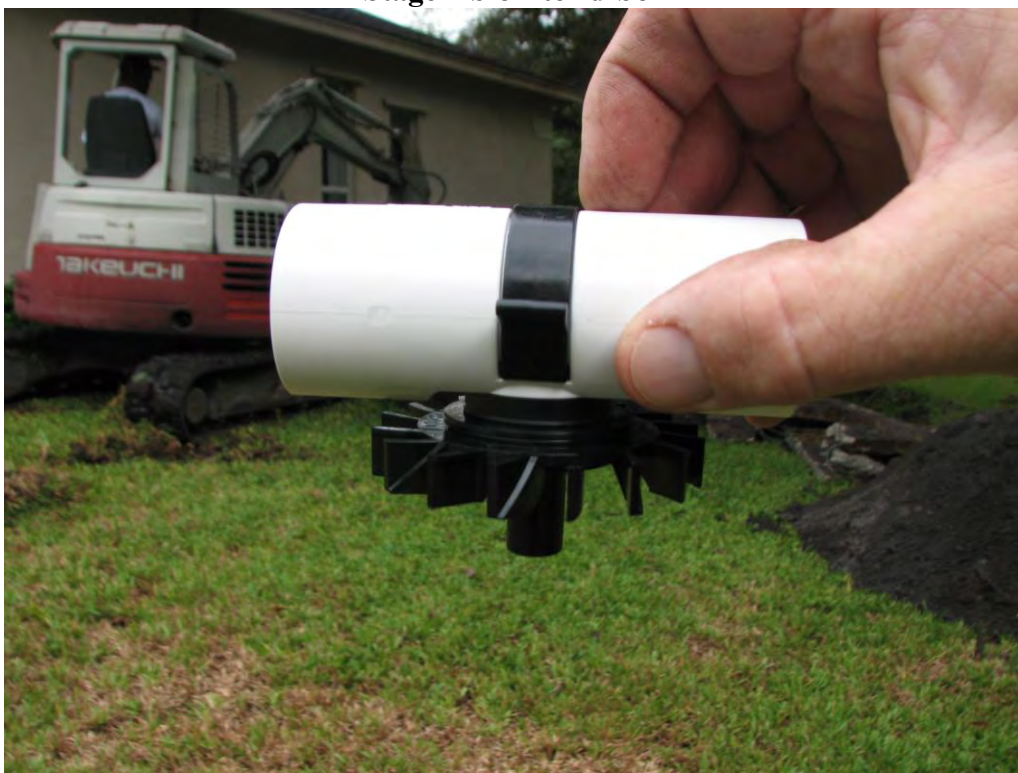
Figure 13
Removable spray nozzle

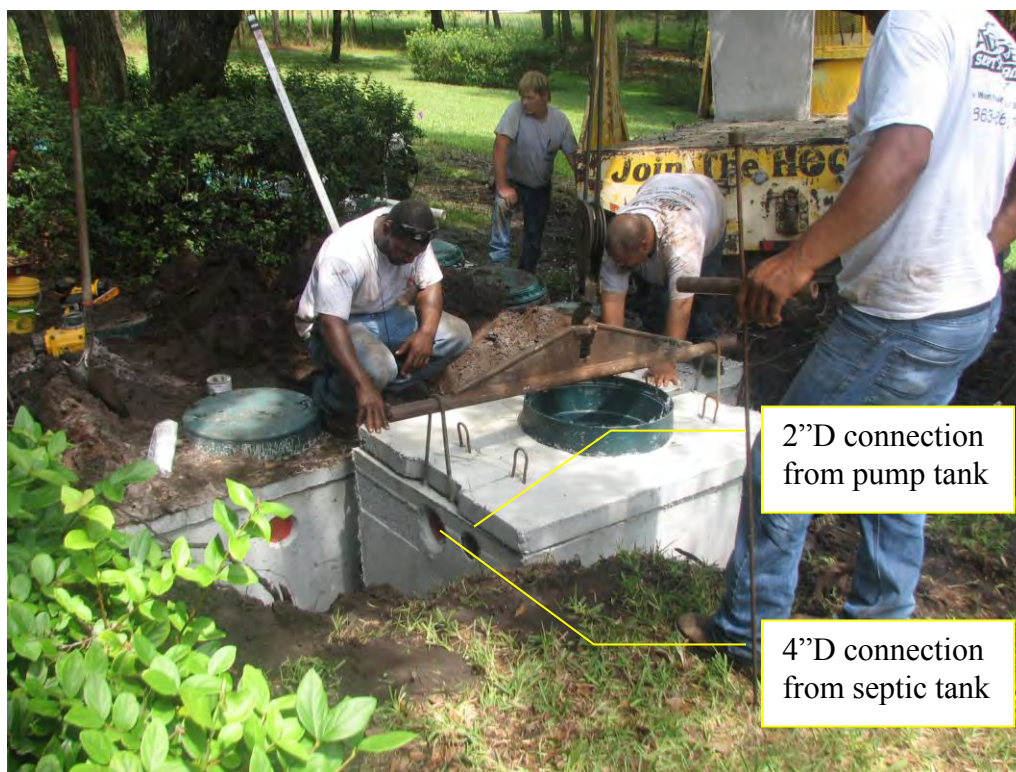
Figure 14
300 gallon recirculation tank

The 300 gallon concrete recirculation tank was then installed (Figure 14). The 4"D inlet is connected to the septic tank effluent discharge, and the 2" D inlet is connected to the recirculation pipe from the pump tank. A bull run valve™ (Figure 15) was installed following the septic tank outlet to allow the flow to either be completely directed to the new passive system (to the recirculation tank) or to the existing distribution box (to the existing drainfield). A riser pipe was installed to grade over the valve, so that the valve can be turned after installation is complete. The valve is turned with a wrench on a rod which is long enough to reach with the riser installed (Figure 15).

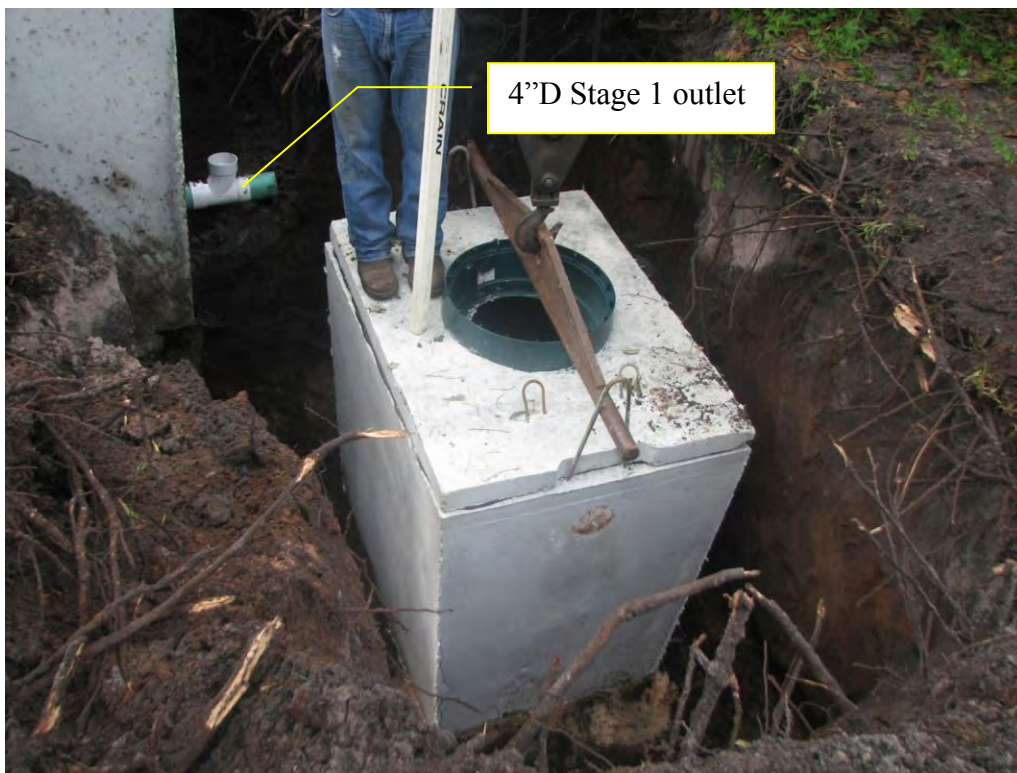
Figure 16
300 gallon pump tank

Next, the 300 gallon concrete pump tank was installed downgradient of the Stage 1 biofilter (Figure 16). The outlet pipe connection was plugged since the pump discharge pipe is installed through the riser. The pump was installed within a holding bracket which also supports the float tree (Figure 17). Three float switches were installed to maintain the effluent level in the pump tank and are attached to a float tree installed in the pump tank and connected to the control panel. The height of the floats is adjustable and once the proper heights were established, screws were used to secure the floats to the float tree.

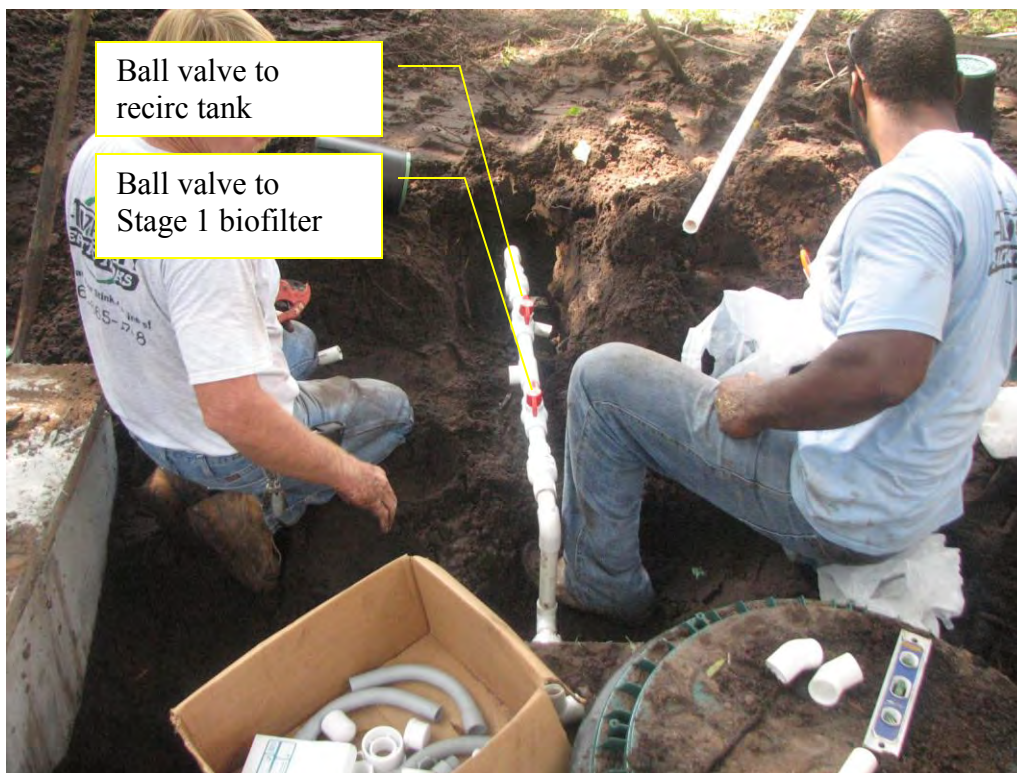
Two inline flow meters were installed following the pump discharge. The first inline flow meter was installed prior to the recirculation flow split, to record the cumulative flow in gallons pumped from the pump tank (Figure 18). At this location, the flowmeter measurement includes the forward wastewater flow (F) and the recirculation flow (R). Two throttling globe valves were installed to allow for the adjustment of F and R flow to achieve the target recirculation ratio (initially set at approximately 3:1). The second flowmeter installed downstream of the F globe valve measures the forward wastewater flow to the Stage 2 biofilter (Figure 18). As previously discussed, the design includes two modes of operation for the recirculation of Stage 1 effluent: 1) to the recirculation tank or 2) to the Stage 1 biofilter spray nozzles. Two ball valves were installed (Figure 19) which either shut on or off the recirculation mode desired (initially set so that all the recirculation flow returns to the recirculation tank).

Figure 19
Recirculation mode of operation flow split

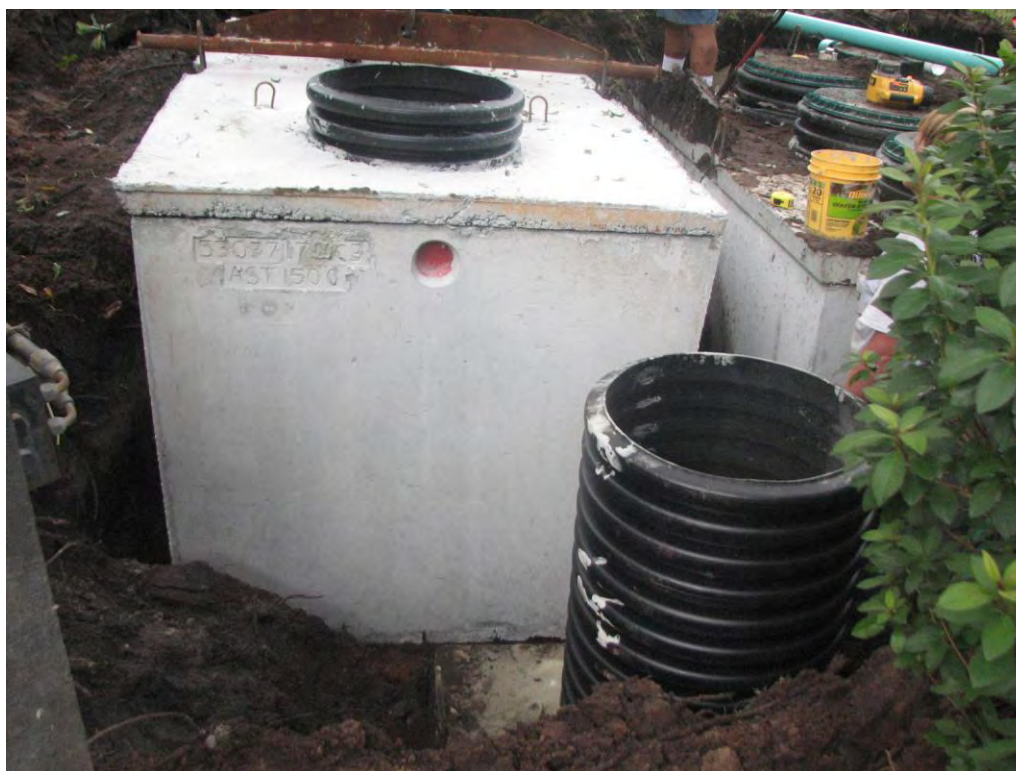
Figure 20
1,500 gallon stage 2 biofilter tank

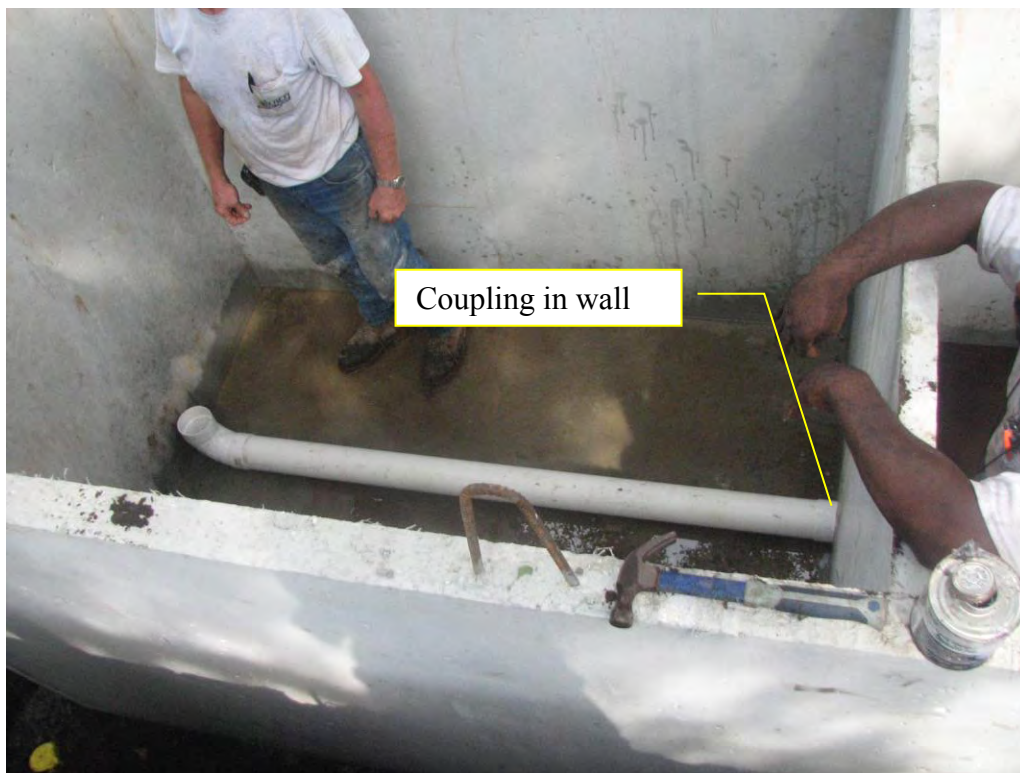
A 4"D underdrain pipe (perforated) with gravel surrounding was installed along the centerline of the bottom of the tank for transfer from the first chamber to the second chamber (Figure 21). The tank arrived with a coupling cast into the baffle wall near the bottom to connect both chambers of the tank. Following the underdrain gravel installation (Figure 22) and leveling, 24-inches of elemental sulfur and oyster shell media was installed and mixed (Figure 23) within the second chamber. A stainless steel drivepoint sampler tree (Figure 24) was installed for sampling at 3, 7, 12, and 18-inches above the bottom of the sulfur media mixture (Figure 23).

Figure 21
Stage 2 biofilter tank perforated pipe along bottom (lignocellulosic chamber)

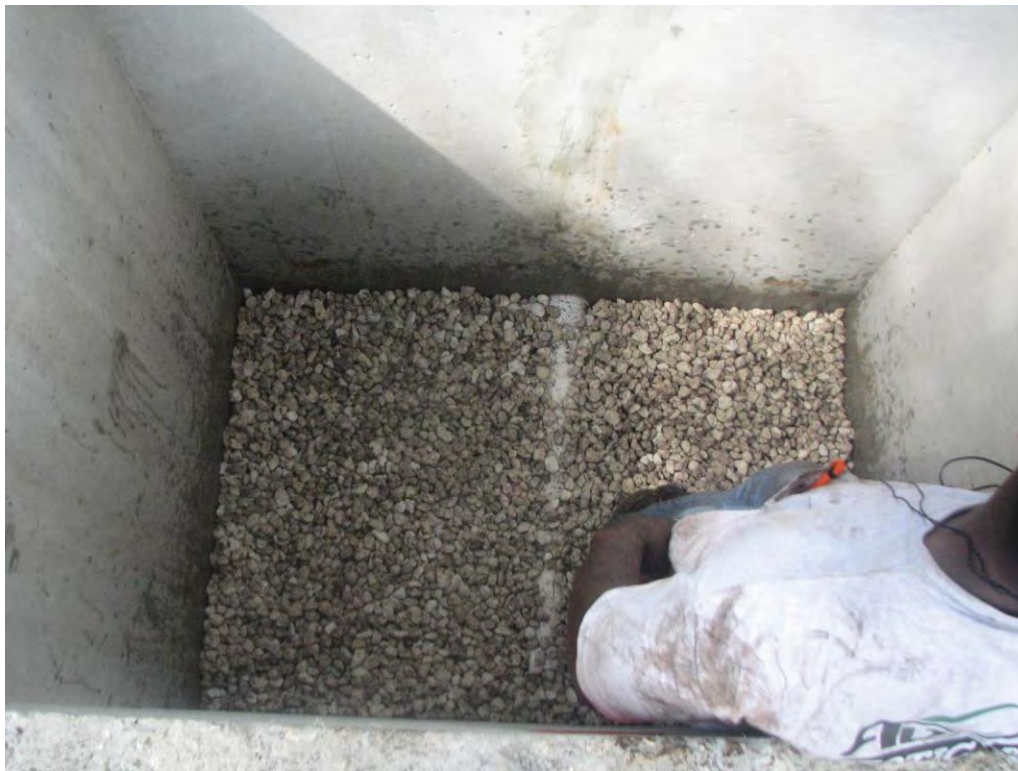
Figure 22
Stage 2 biofilter tank gravel underdrain (sulfur chamber)

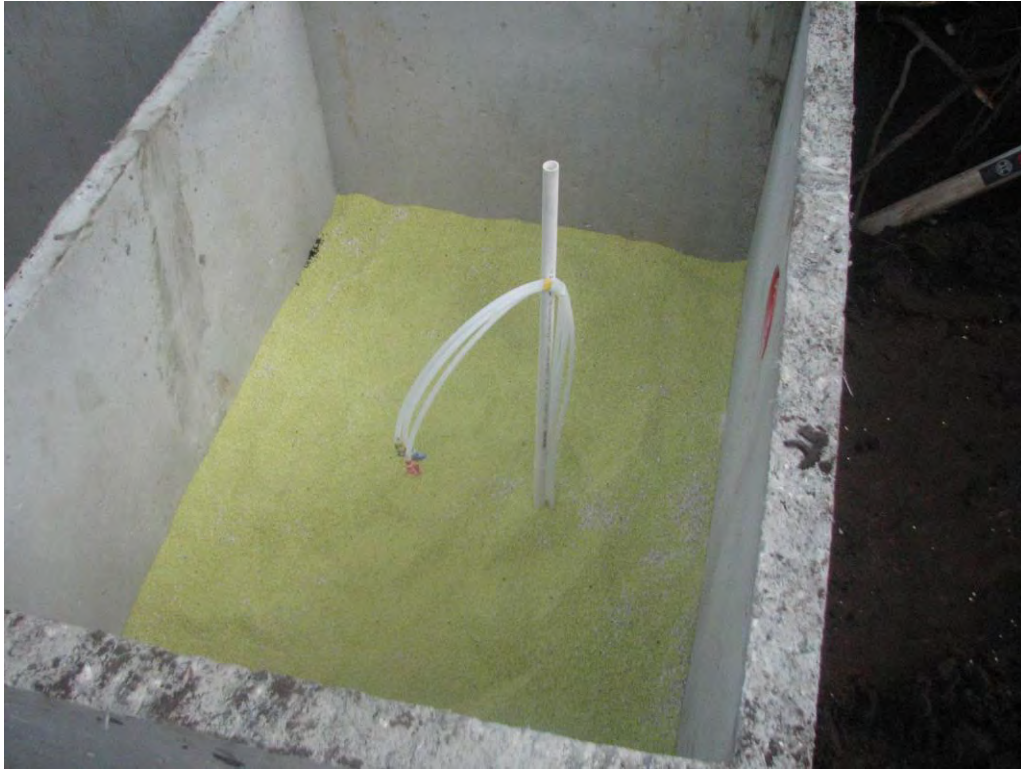
Figure 23
Stage 2 biofilter tank (sulfur mixed with oyster shell)

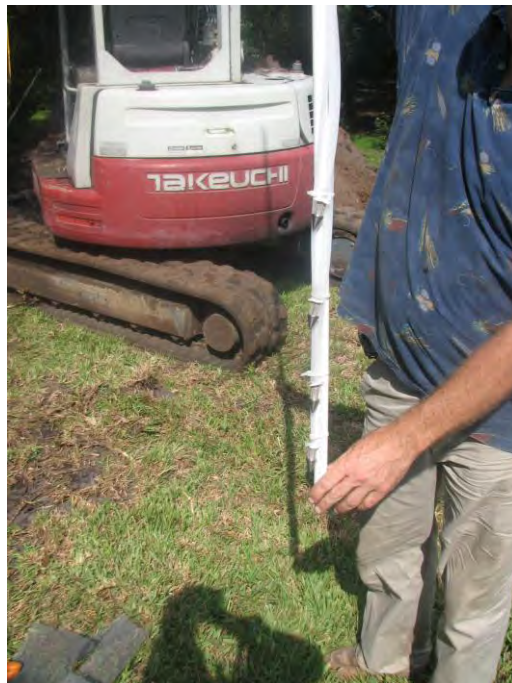
Figure 24
Stage 2 biofilter tank SST drivepoint sampler tree (sulfur chamber)

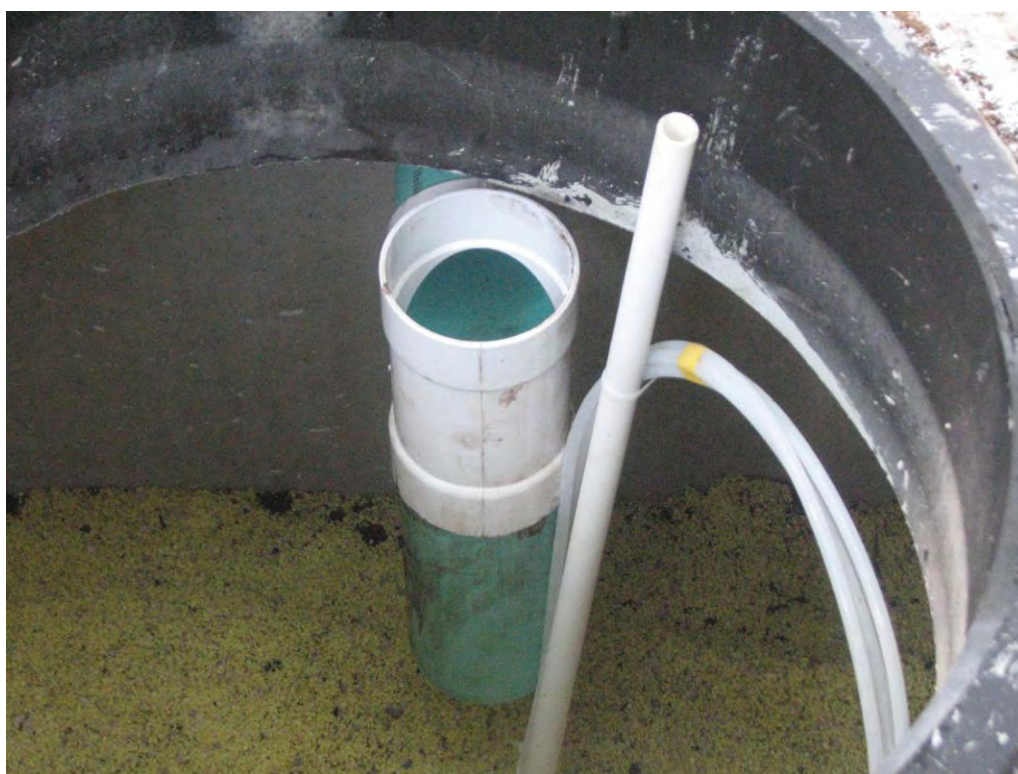
Above the gravel underdrain within the first chamber of the tank, 42-inches of lignocellulosic media was installed (Figure 25). A stainless steel drivepoint sampler tree was installed for sampling at 0, 6, 12, 18, 24, 30, and 36-inches above the bottom of the lignocellulosic media. A 4"D perforated pipe was connected to the inlet of the tank for effluent dispersal above the lignocellulosic media. A 4"D tee was installed at the outlet of the tank which allows for saturated operating conditions across the biofilter (Figure 26). The 4"D outlet is connected to the distribution box to the existing drainfield.

Figure 26
Stage 2 biofilter tank outlet tee

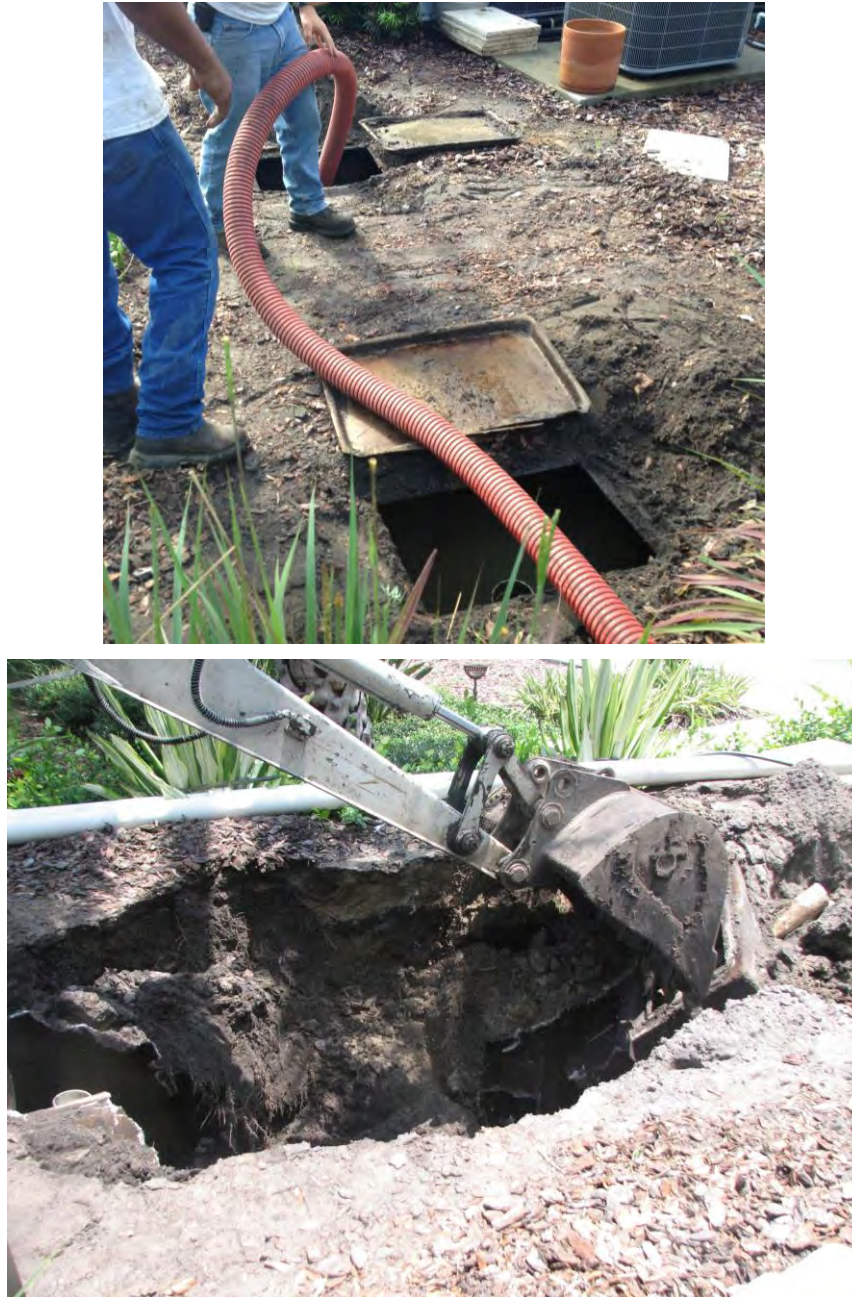
Figure 3
Old septic tank pumped out and removed

Installation of the system commenced June 17, 2013 and was completed on June 28, 2013. The installation began with a pump out and removal of the existing 1,050 gallon fiberglass septic tank. After the pump out was completed, the old septic tank was removed (Figure 3).

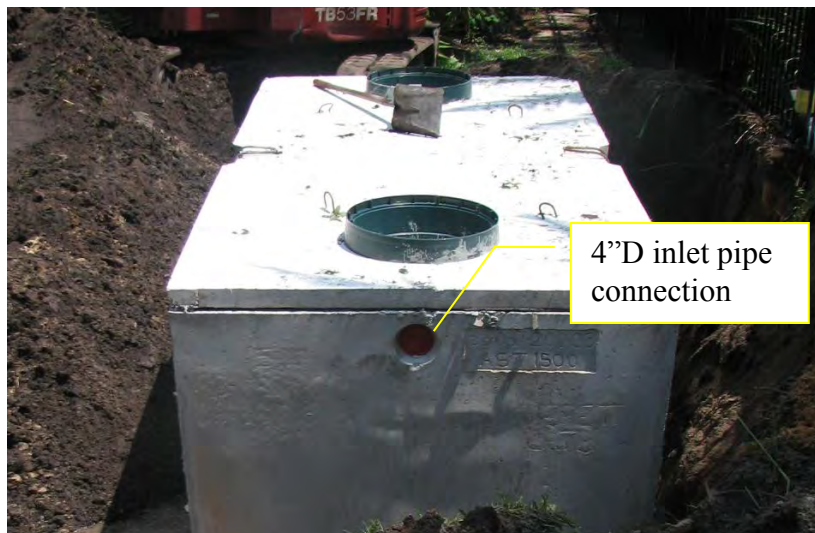
A 1,500 gallon, two compartment replacement concrete primary tank was installed. The first larger chamber serves as a primary receiving tank, receiving the raw sewage from the household. The sewer pipe from the house was plumbed into the 4"D (diameter) inlet hole shown in Figure 4. An effluent screen (Polylok™, PL-68) was installed in the outlet tee of the second chamber (Figure 5).

Figure 4
1,500 gallon, two chamber, primary Tank

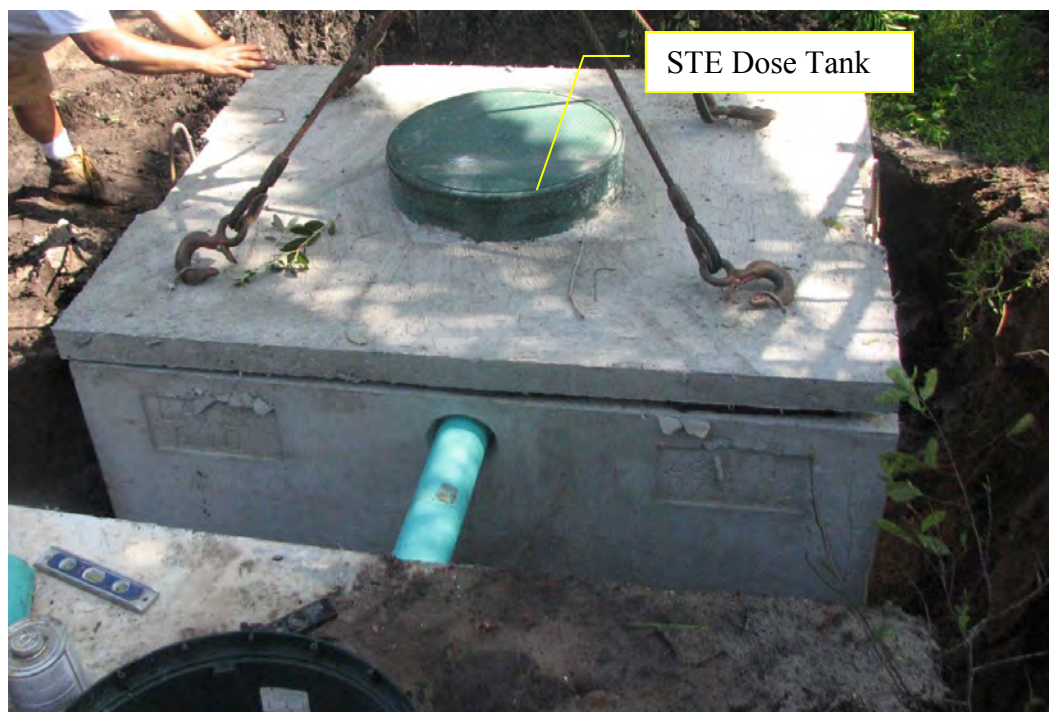
Figure 6
600 gallon, single chamber, STE Dose Tank

Following the primary tank installation, the remaining passive nitrogen reduction system components were installed (Table 1). A STE dose tank (600 gallon) concrete tank was installed beside the primary tank (Figure 6). The purpose of this tank is to hold the septic tank effluent to be pumped to the Stage 1 lined drip area. The 4"D inlet of the STE dose tank is connected (gravity flow) to the primary tank discharge. The 2"D outlet is connected to the pump. The 2"D outlet (Figure 7) is located near the bottom of the tank.

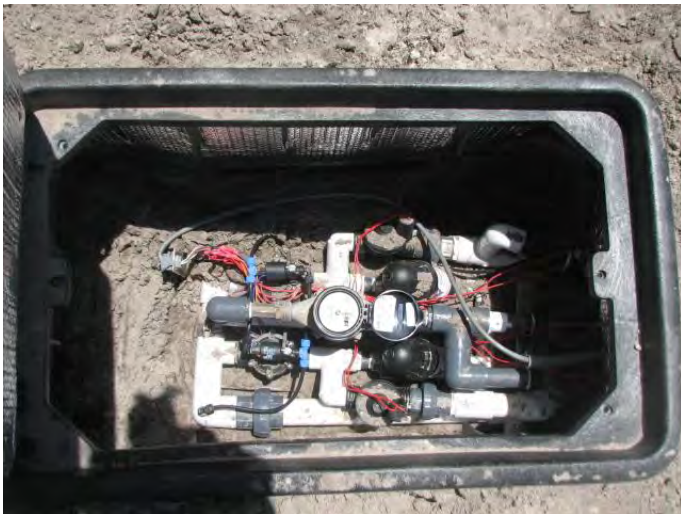
Figure 9
Drip system hydraulic unit

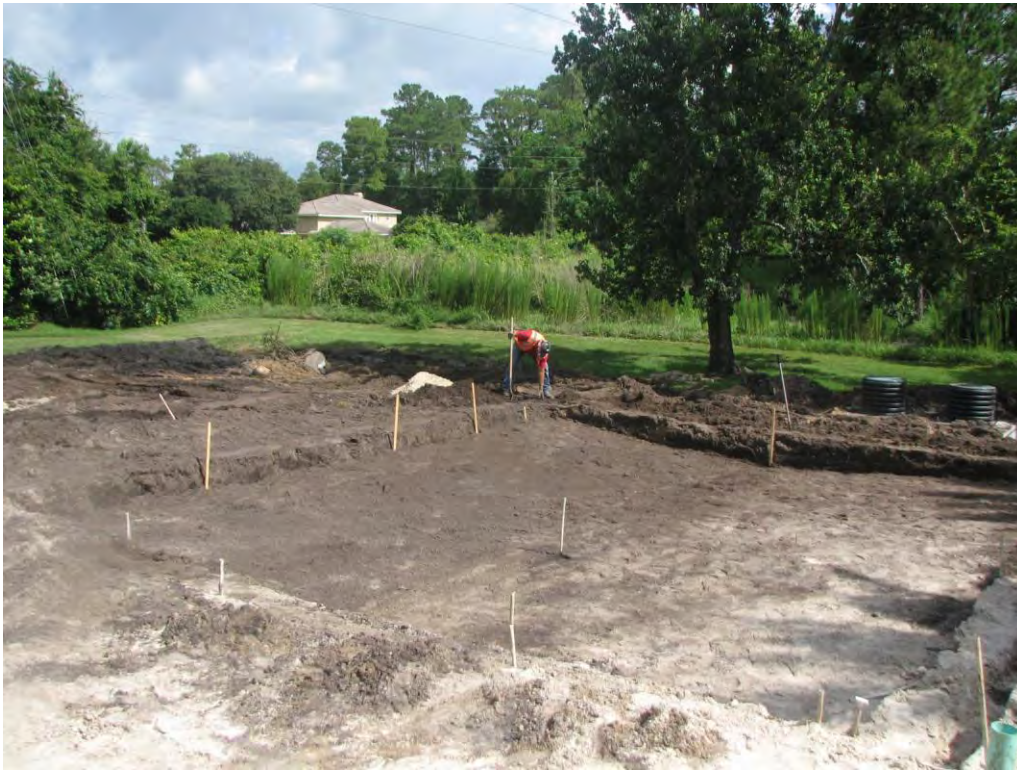
Figure 10
Stage 1 liner area preparation

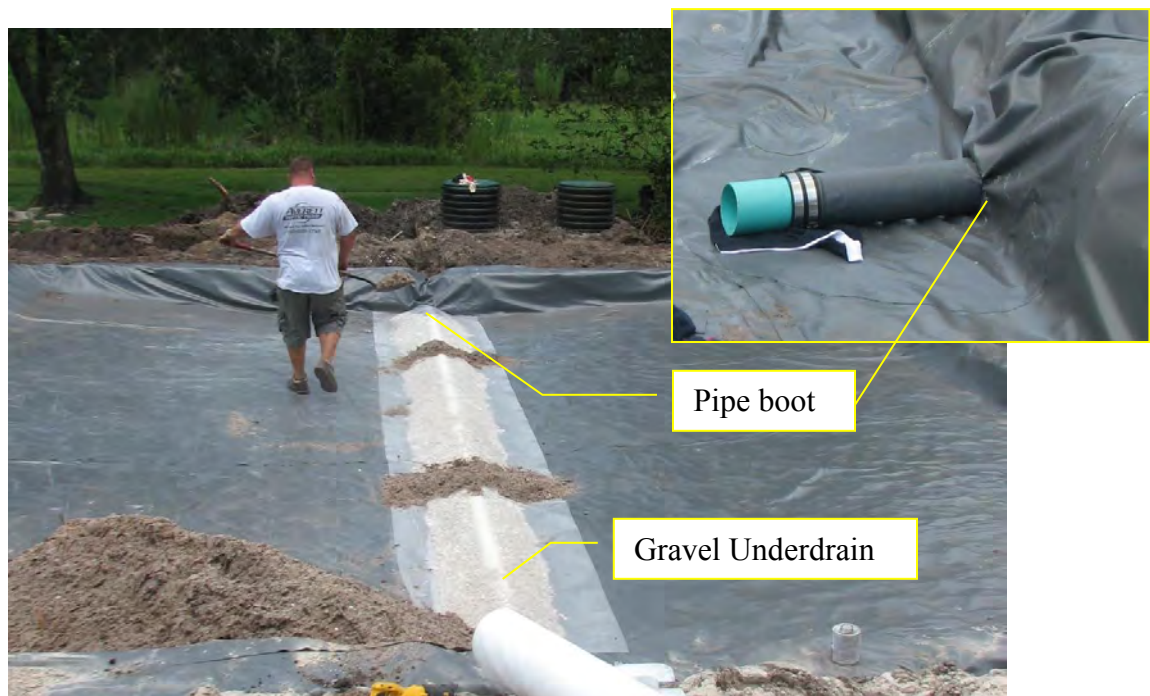
Figure 11
Stage 1 Liner

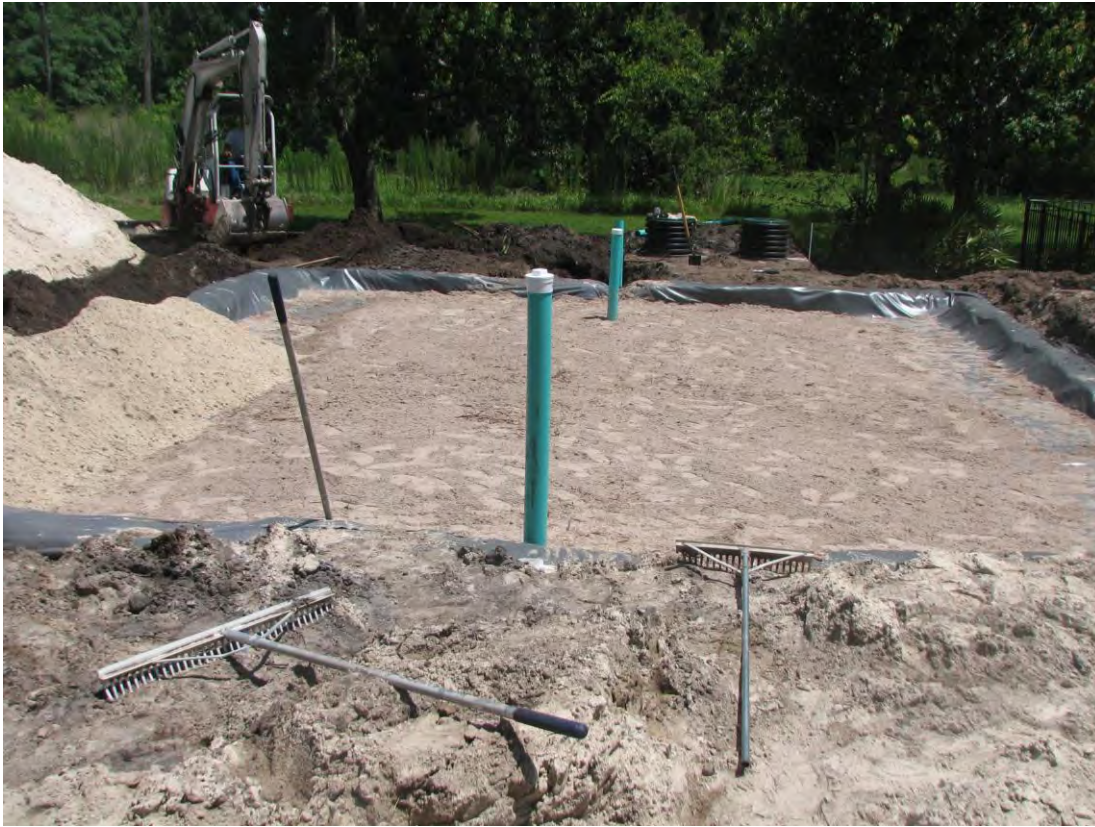
Figure 12
Lignocellulosic and sand mixture above liner

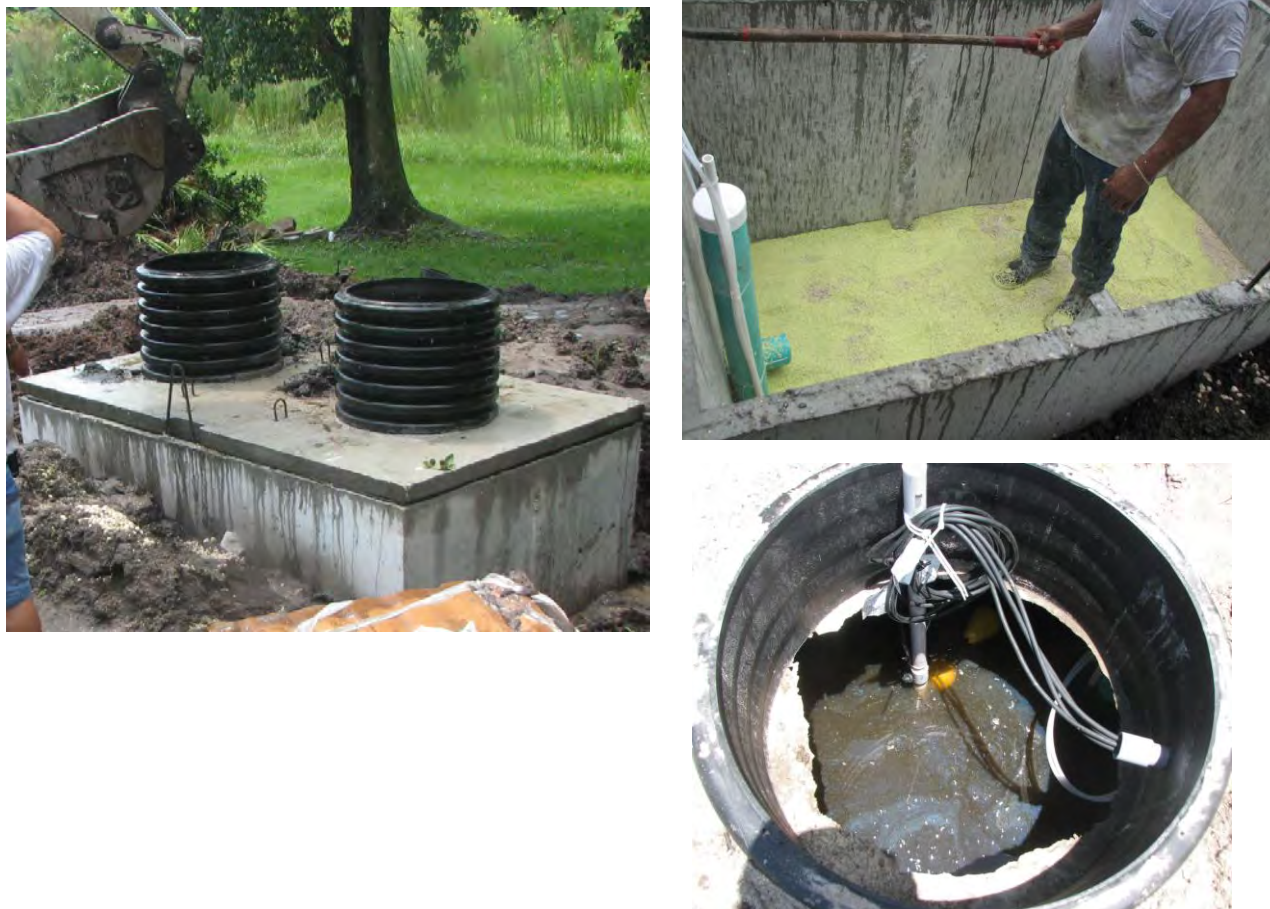
Figure 14
Stage 2 Biofilter

The liner effluent is conveyed to a Stage 2 biofilter (1,050 gallon) containing elemental sulfur reactive media (Figure 14) for additional treatment (denitrification). The denitrified effluent is pumped through the drip system hydraulic unit (Figure 9) and discharged to the reclaimed water drip system (Zone 2) (Figure 15). The denitrified effluent is discharged to the natural soil. A flow schematic of the system is shown on Figure 2.

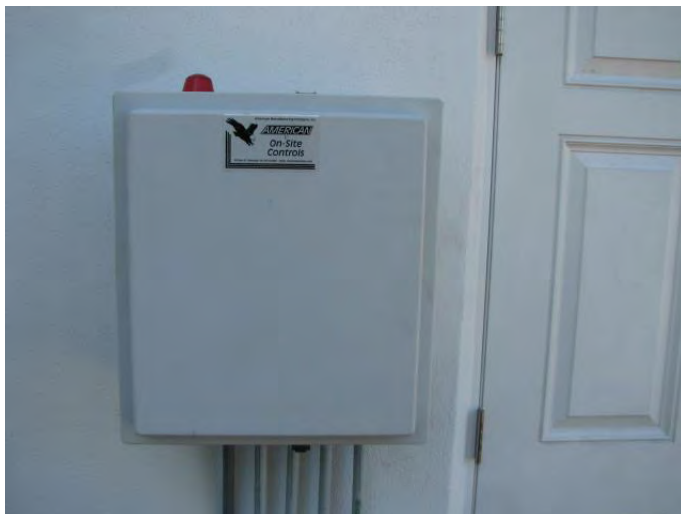
Figure 16
Control Panel

A power meter was installed between the main power box of the house and the control panel to record cumulative power usage of the system in kilowatts. The equipment connected to the power meter are the drip system dose pump and the control panel. Figure 16 shows the power meter installed inside the control panel.

The system control panel (Figure 16) allows for a timed pump cycle which can be overridden if the effluent levels are too low or too high in the dose tanks (STE dose tank and Stage 2 Biofilter). If the floats indicate a low effluent level in the tank, the timed cycle is turned off to protect the pump. If the

floats indicate a high effluent tank level, then the pump cycles faster (off cycle reduced) until the water level reaches the optimal range. An alarm will indicate if the water level goes above a critical level. The control panel is connected to a phone line which transmits data for monitoring.

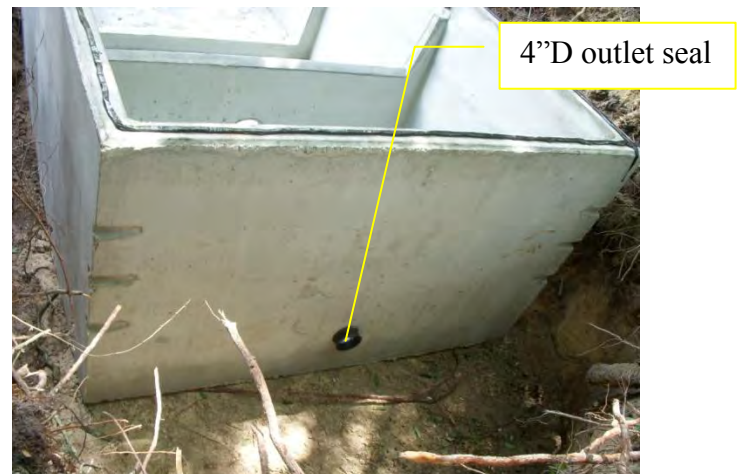
Figure 7
2,800 gallon, single chamber, stage 1 biofilter tank

Tank Volume (gal)	Surface Area (ft ²)	Media
Primary Tank	1,200	47.5	none
Stage 1 Biofilter	2,800	113.3	<ul style="list-style-type: none"> • 10" Riverlite 1/4 • 20" Riverlite 3/16
Stage 2a Biofilter, downflow	1,000 (1,500 total)	36 (54 total)	42" lignocellulosic (Southern yellow pine)
Stage 2b Biofilter, upflow	500 (1,500 total)	18 (54 total)	18" Elemental sulfur (90%) & oyster shell mixture (10%)

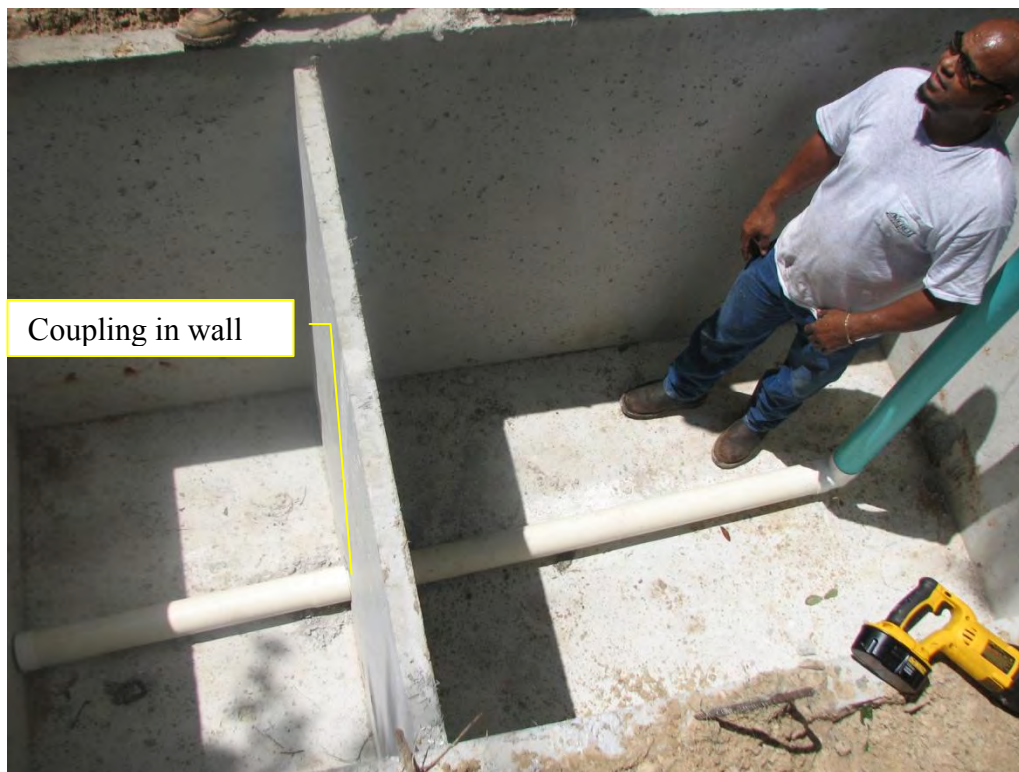
A 4"D perforated underdrain pipe (Figure 13) with gravel surrounding (Figure 14) was installed along the centerline of the bottom of the tank for transfer from the first chamber to the second chamber. The tank arrived with a coupling cast into the baffle wall near the bottom to connect both chambers of the tank. Following the underdrain gravel installation (Figure 14) and leveling, 18-inches of elemental sulfur and oyster shell media was installed and mixed (Figure 15) within the second chamber. A stainless steel drivepoint sampler tree (Figure 15) was installed for sampling at 6 and 12-inches above the bottom of the sulfur media mixture.

Figure 13
Stage 2 biofilter perforated pipe through wall

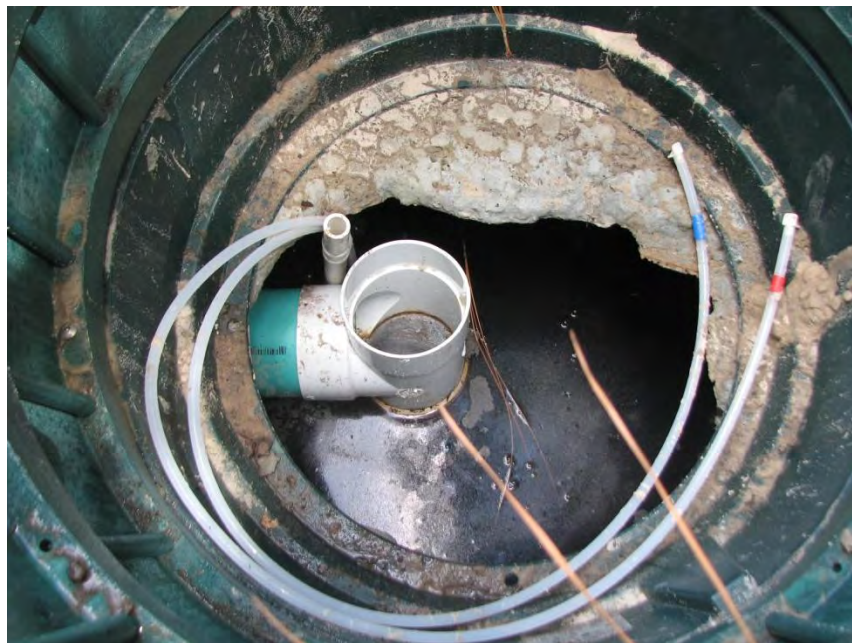
Figure 17
Stage 2 biofilter outlet tee
