Florida Onsite Sewage Nitrogen Reduction Strategies Study

Evaluation of Full Scale Prototype Passive Nitrogen Reduction Systems (PNRS) and Recommendations for Future Implementation - Volume II of II

August 2015

**Installation Report for Passive Nitrogen Reduction System
B-HS1**

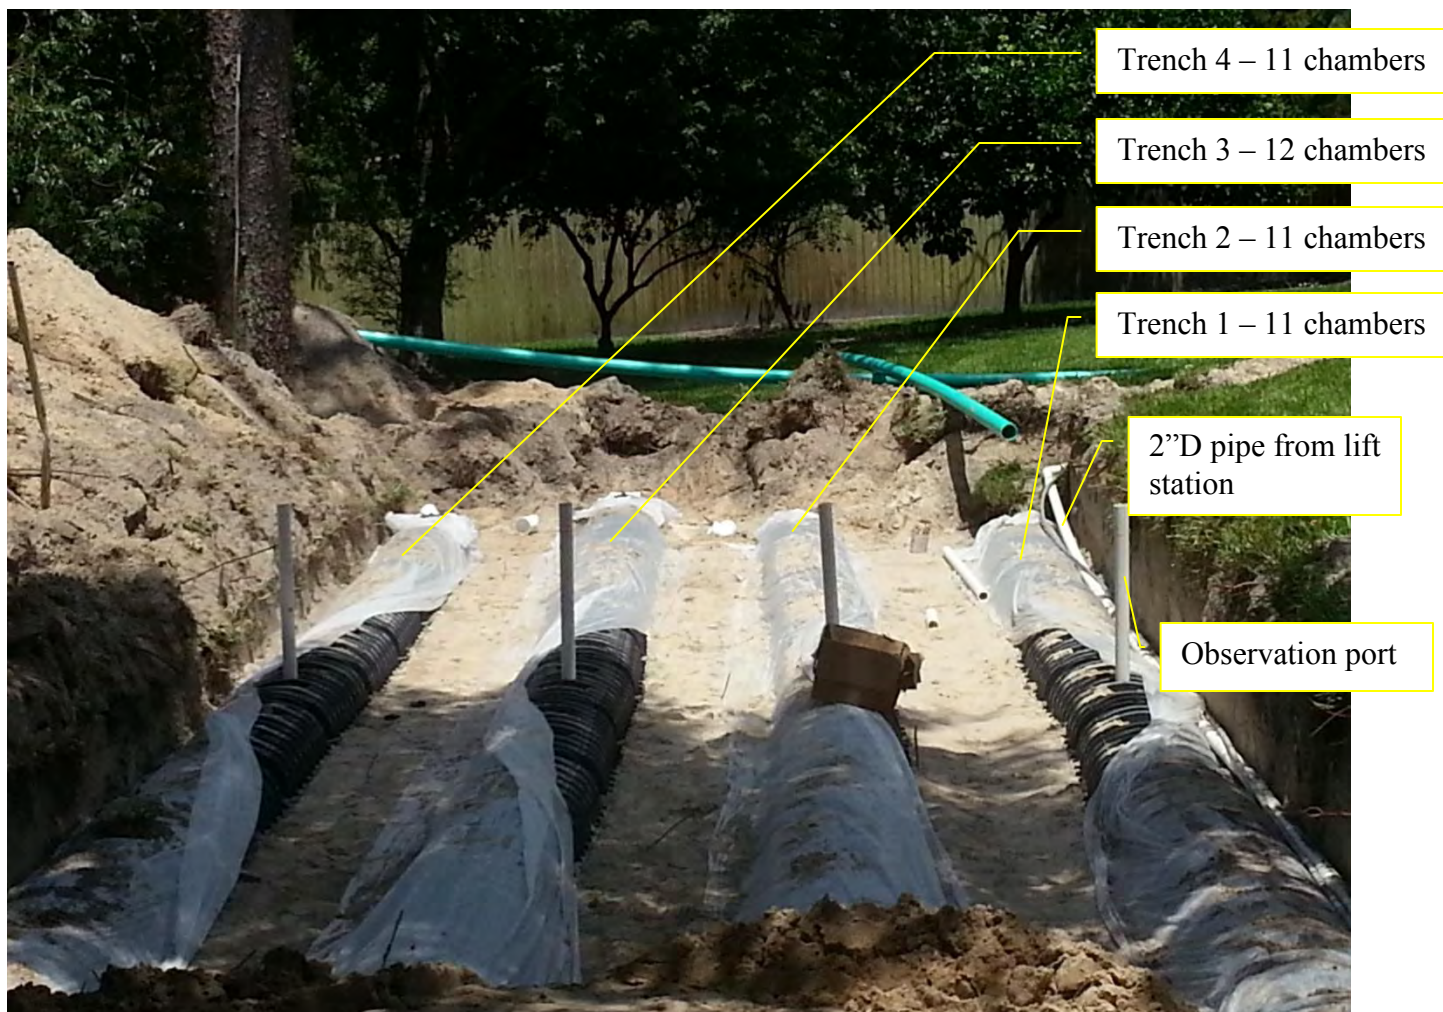
The Stage 2 biofilter effluent is discharged into the soil via a new drainfield. The effluent is split between four low-profile Infiltrator chamber trenches by a concrete distribution box (Figure 18). Three of the trenches have 11 chambers and one trench has 12 chambers (Figure 19).

Figure 19
Drainfield trenches

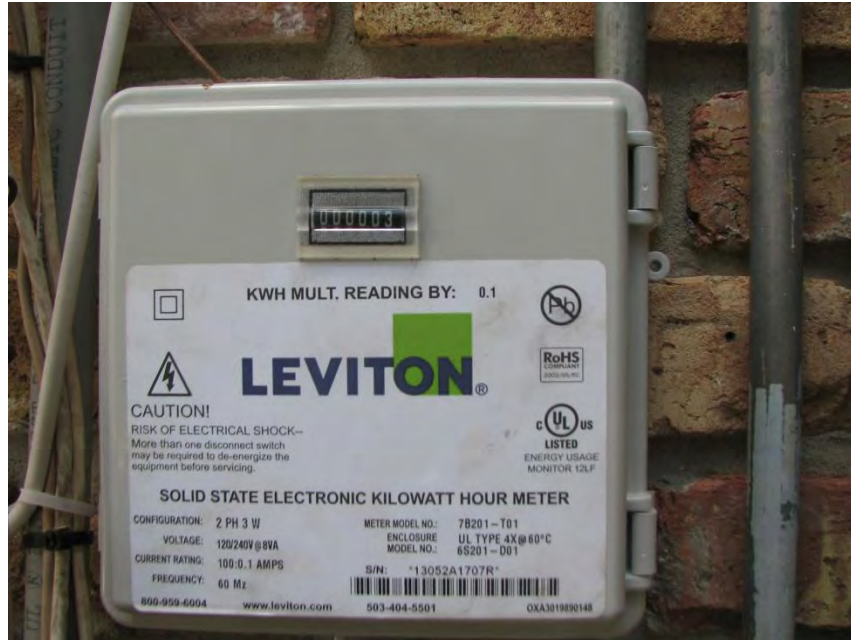
Figure 20
Power meter inside outdoor enclosure

A power meter was installed between the main power box of the house and the grinder pump to record cumulative power usage of the pump in kilowatts. Figure 20 shows the power meter installed inside an outdoor enclosure. Figure 21 shows the electrical outlet that was installed for the pump to plug into.

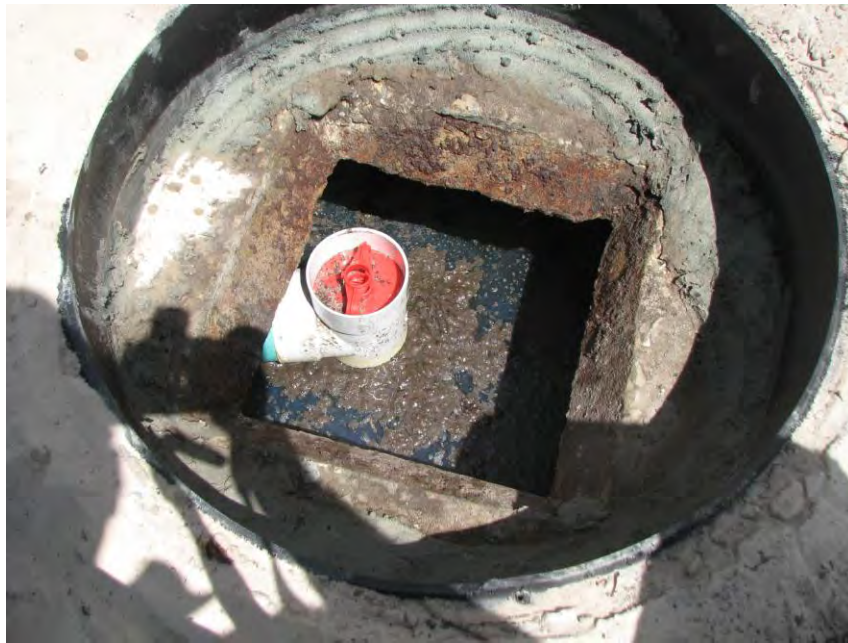
An effluent screen (Polylok™, PL-68) was installed in the outlet tee of the second chamber (Figure 6).

Figure 6
1,350 gallon, primary Tank effluent screen

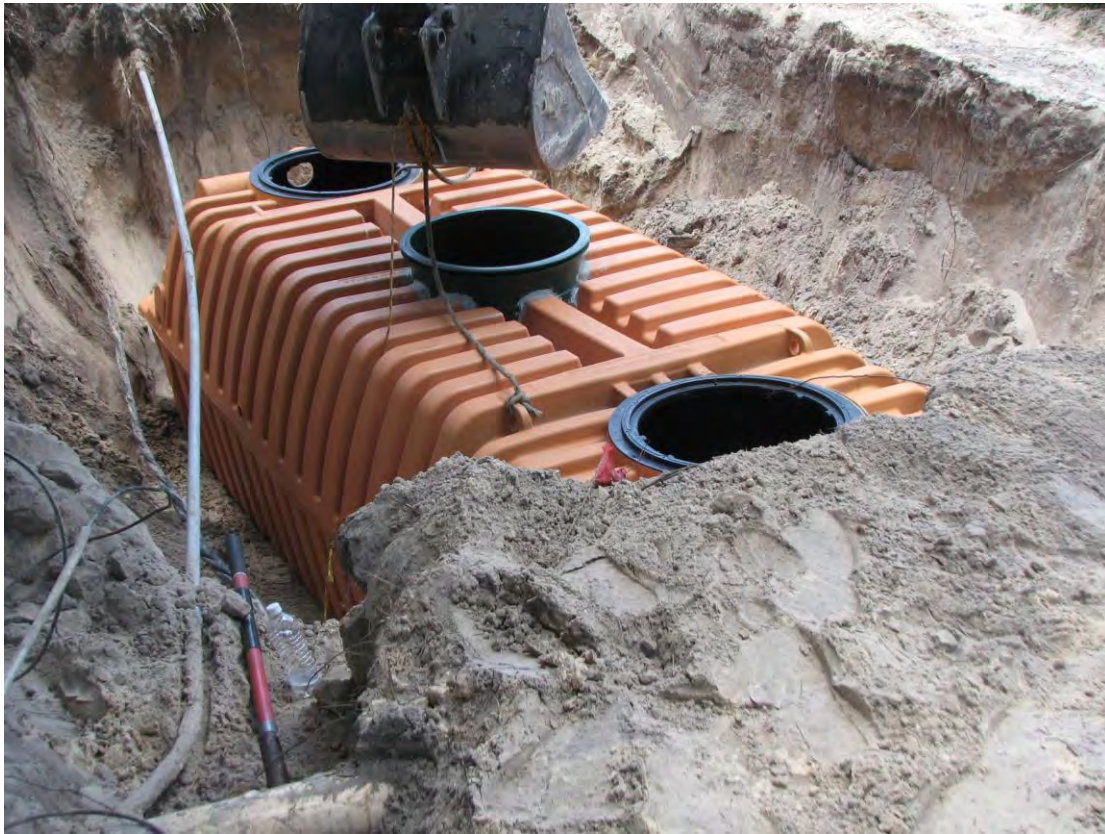
Figure 7
1500 gallon, single chamber, stage 1 biofilter tank

The remaining passive nitrogen reduction system components were installed (Table 1). A single chamber (1,500 gallon) plastic Infiltrator™ tank was installed beside the primary tank (Figure 7). The purpose of this tank is to hold the Stage 1 expanded clay media. The 4"D inlet of the tank is connected (gravity flow) to the septic tank outlet. The 1"D inlet, installed through the standard outlet, is connected (pressurized flow) to the recirculation pipe from the pump tank (Figure 8). The 3"D outlet (Figure 8) of the pipe is located near the bottom of the tank to allow for unsaturated operation. Following gravel installation and leveling (Figure 9), 21-inches of fine (3/16 Riverlite™) expanded clay media was installed (Figure 10). Above the fine media, 12-inches of coarse (1/4 Riverlite™) expanded clay media was installed (Figure 11). Following media installation and leveling, the influent distribution network was installed (Figure 11). The 4"D influent pipe, connected to the septic tank discharge, discharges into a distribution box which flows to two 3"D perforated pipes across the top of the media (Figure 11). The 1"D influent pipe was installed along the centerline with five spray nozzles attached to distribute the recirculated effluent (Figure 12). The spray nozzles are removable for cleaning in the event clogging occurs (Figure 12).

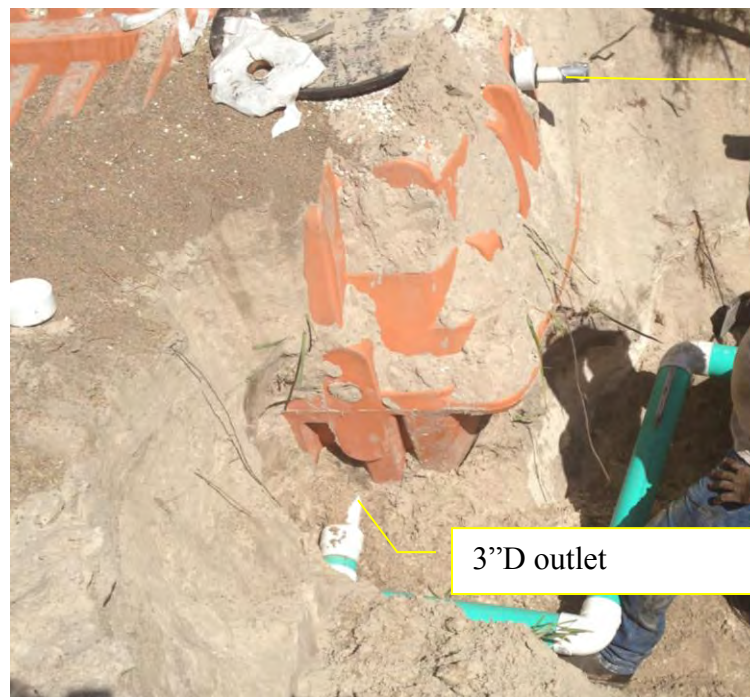
Figure 8
Stage 1 biofilter 3"D outlet pipe, with cleanout

1"D inlet (recirc)

3"D outlet

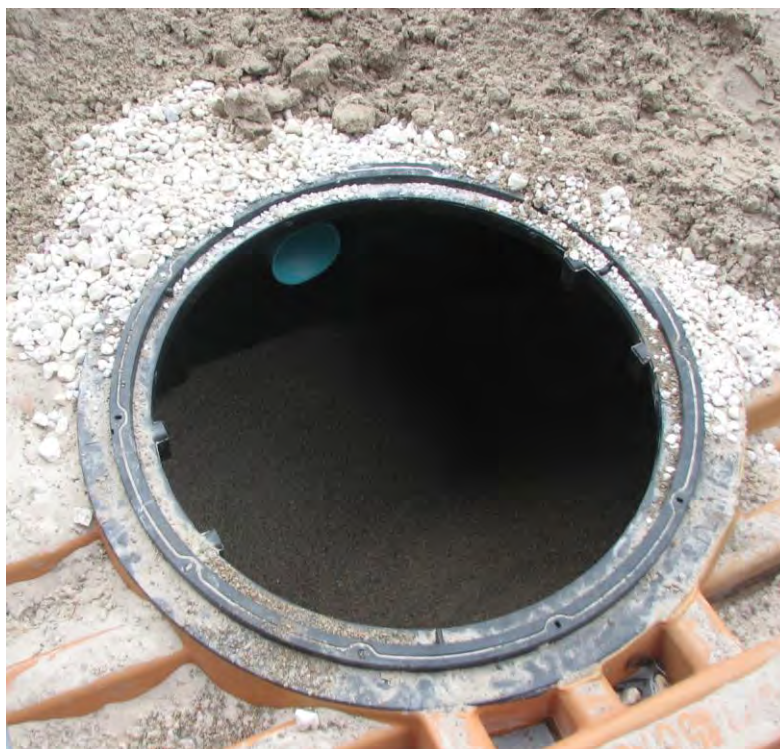
Figure 10
Stage 1 biofilter 21-inches of fine media (3/16 Riverlite™)

Tank Volume (gal)	Surface Area (ft ²)	Media
Primary Tank	1,350	55	none
Stage 1 Biofilter	1,500	78	<ul style="list-style-type: none"> • 12" Riverlite 1/4 • 21" Riverlite 3/16
Pump Tank	300	12	none
Stage 2a Biofilter, downflow	1,000 (1,500 total)	36 (54 total)	42" lignocellulosic (Southern yellow pine)
Stage 2b Biofilter, upflow	500 (1,500 total)	18 (54 total)	18" Elemental sulfur (90%) & oyster shell mixture (10%)

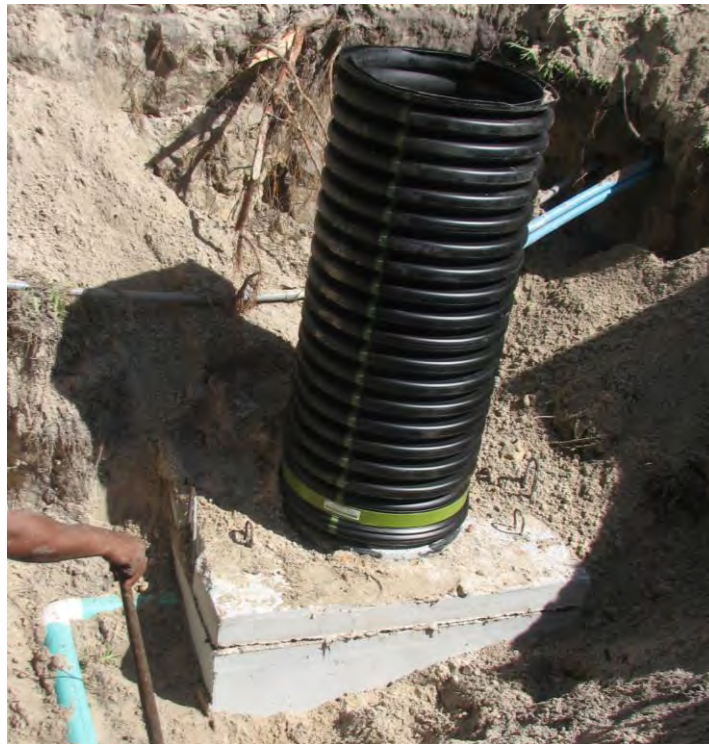
Figure 13
300 gallon pump tank

Next, the 300 gallon concrete pump tank was installed downgradient of the Stage 1 biofilter (Figure 13). The standard outlet pipe connection was plugged since the pump discharge pipe is installed through the riser. The pump was installed within a holding bracket which also supports the float tree (Figure 14). Three float switches were installed to maintain the effluent level in the pump tank and are attached to a float tree installed in the pump tank and connected to the control panel. The height of the floats is adjustable and once the proper heights were established, screws were used to secure the floats to the float tree.

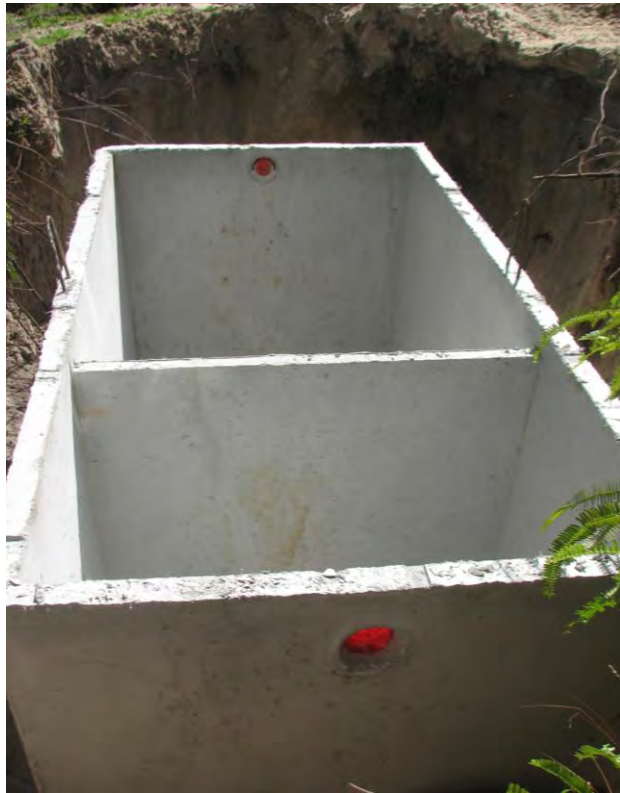
Figure 16
1,500 gallon stage 2 biofilter tank

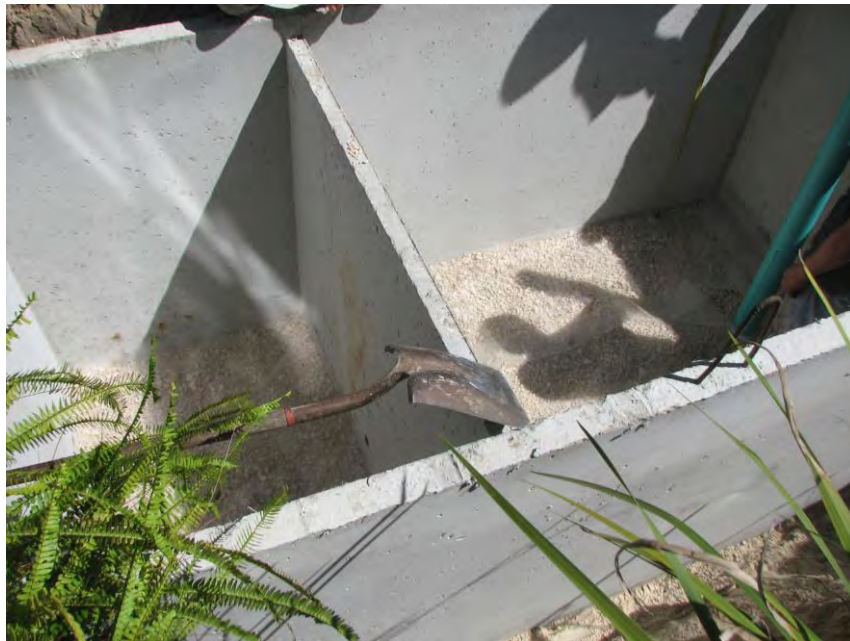
Figure 17
Stage 2 biofilter tank gravel underdrain covering perforated pipe along bottom

A 4"D underdrain pipe (perforated) with gravel surrounding was installed along the centerline of the bottom of the tank for transfer from the first chamber to the second chamber. The tank arrived with a coupling cast into the baffle wall near the bottom to connect both chambers of the tank. Following the underdrain gravel installation (Figure 17) and leveling, 18-inches of elemental sulfur and oyster shell media was installed and mixed (Figure 18) within the second chamber. A stainless steel drivepoint sampler tree (Figure 19) was installed for sampling at 6 and 12-inches above the bottom of the sulfur media mixture.

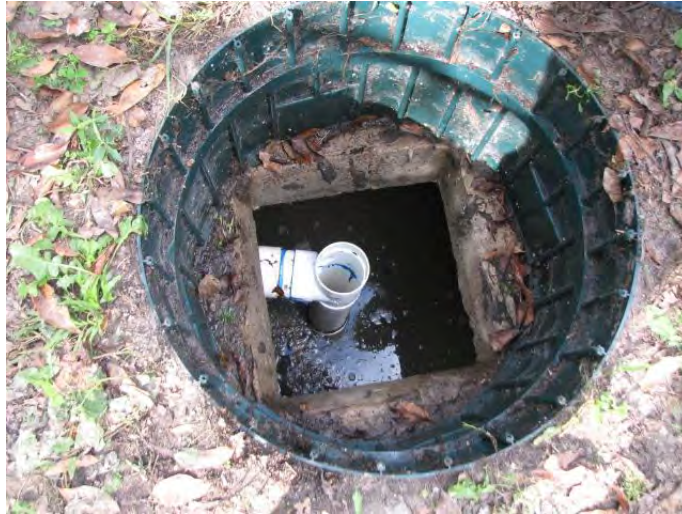
Figure 3
Primary tank vented tee between chambers

Installation of the system commenced November 5, 2013 and was completed on November 6, 2013. As previously discussed, the existing 1,500 gallon septic tank will continue to provide primary treatment. A vented tee was installed between the chambers (Figure 3) and the effluent screen was moved to the outlet (Figure 4).

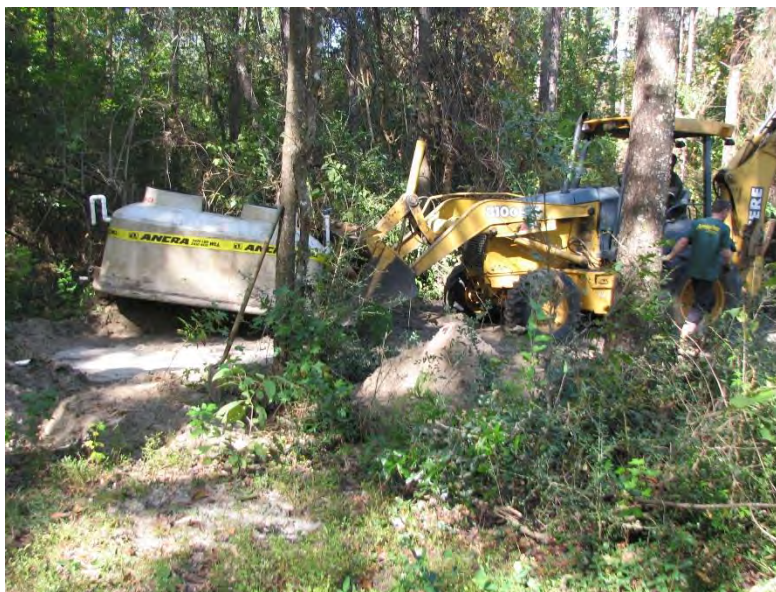
Figure 5
Aerocell™ unsaturated media filter chamber removal

Following the primary tank modifications, the previously installed passive nitrogen reduction system components were removed. The previously installed Aerocell™ unsaturated media filter chamber (Figure 5), Nitrex™ media (Figure 6) and split recirculation device (Figure 7) were removed from the system.

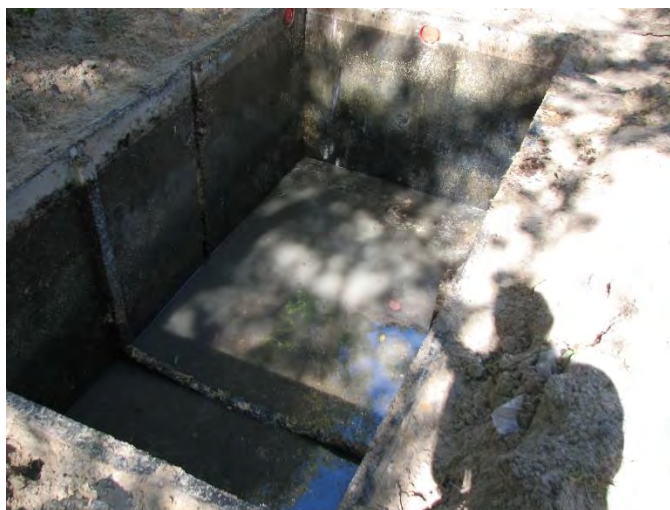
Figure 17
Cleaned Stage 2b tank (1500 gallon)

The 1,500 gallon concrete tank that previously contained the Nitrex™ media (Figure 17) was converted to the new Stage 2b tank containing 90% pastille-shaped elemental sulfur (GreenSun® ES-99) and 10% oyster shell media (Remington Feed) mixture. The volume of sulfur media required for treatment is significantly less than lignocellulosic media; therefore a cinder block wall (3 blocks in height) was installed inside the tank to create two chambers. The inlet chamber created with the wall holds the sulfur media mixture and is approximately one-third of the tank volume (Figure 18). The 4" D pipe from the Stage 1 and 2a biofilter connects to a perforated pipe along the bottom of the inlet chamber (Figure 18). Above the perforated pipe, 12-inches of elemental sulfur and oyster shell media was installed and mixed (Figure 18). The outlet pipe is connected to the existing drainfield and contains a new sample port (Figure 19).

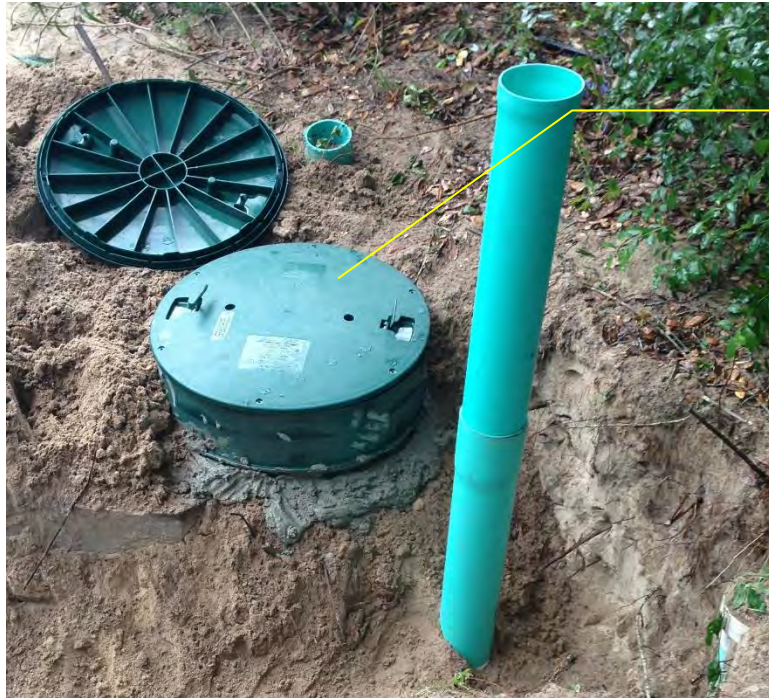
Figure 3
Primary tank access riser and cover

Installation of the system commenced November 13, 2013 and was completed on November 18, 2013. As previously discussed, the existing 900 gallon septic tank will continue to provide primary treatment. An access riser was installed above the second chamber of the primary tank (Figure 3) to allow for ease in maintenance of the existing outlet effluent screen. A two-way valve (Bull Run™) (Figure 4) was installed following the septic tank outlet to allow the flow to either be completely directed to the new passive system (to the pump tank) or to the existing drainfield. A riser pipe was installed to grade over the valve, so that the valve can be turned after installation is complete. The valve is turned with a wrench on a rod which is long enough to reach within the riser installed.

primary tank cover

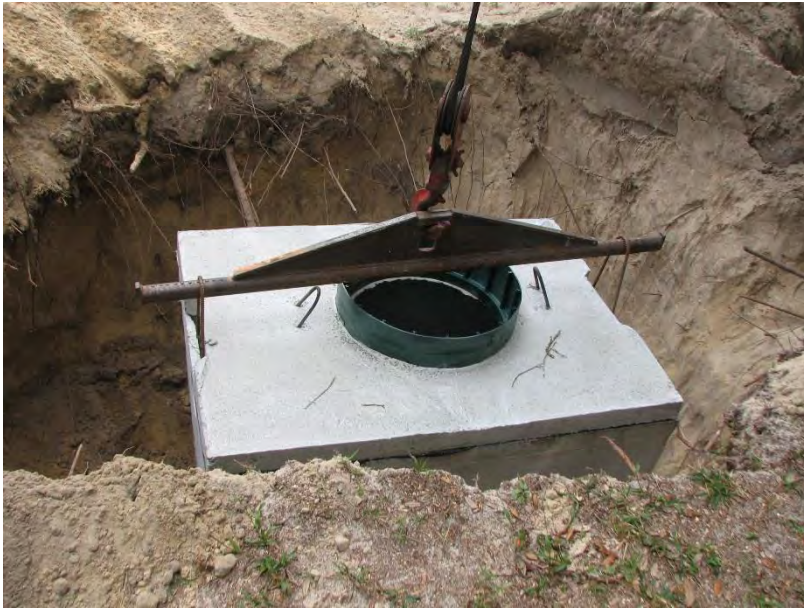
Figure 5
Pump tank (300 gallon)

The 300 gallon concrete pump tank was installed downgradient of the primary tank (Figure 5). The standard outlet pipe connection was plugged since the pump discharge pipe was installed through the riser. A Liberty LE51A-2 submersible pump was installed (Figure 6). One wide-angle piggyback float switch attached to the pump controls the effluent level in the pump tank. The height of the float is adjustable to calibrate a target dose volume. An additional float switch is connected to an audible/visual alarm (Figure 7) installed next to the power meter box to alarm for a high water level in the pump tank (pump failure). One inline flowmeter was installed following the pump discharge (Figure 8) with a bypass for maintenance/cleaning of the flowmeter.

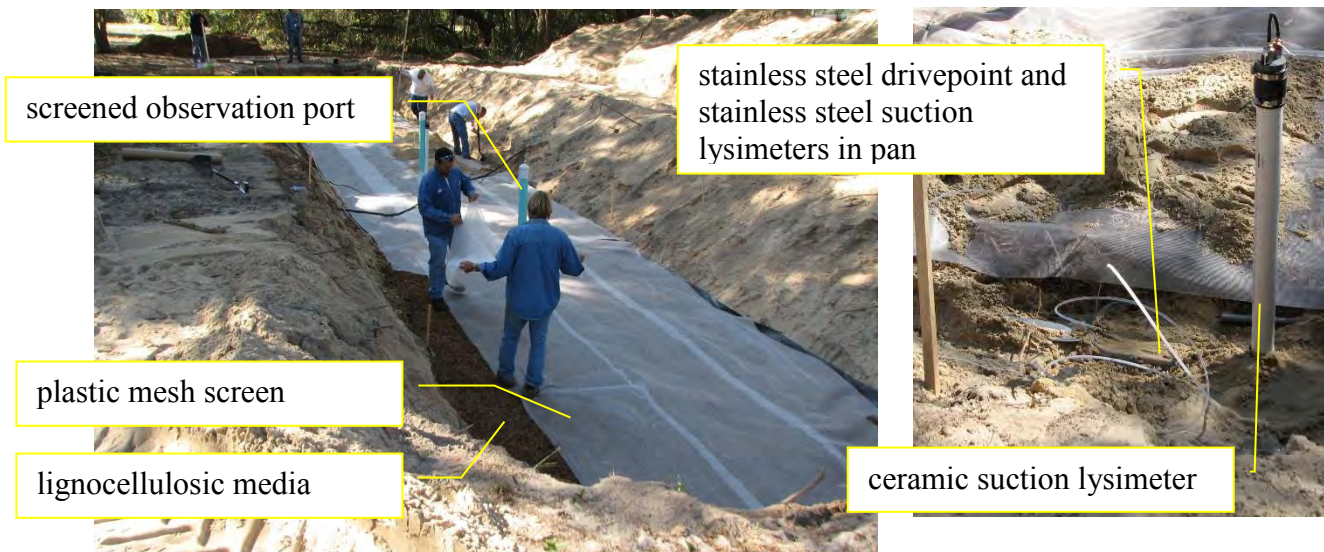
Figure 10
Lignocellulosic media monitoring equipment

The new treatment drainfield area was prepared for the 30 mil PVC liner installation (Figure 9). The liner was installed with a 6 inch lip around the outside perimeter. Above the liner, approximately a ½-inch sand layer (Figure 9) was installed to protect the liner during construction. Above the liner a 12-inch layer of lignocellulosic media, a blended urban waste wood from Wood Resource Recovery, Ocala, FL, was installed (Figure 9). Monitoring equipment surrounding the liner lip and inside the lignocellulosic media were installed (Figure 10). The various types of monitoring equipment installed

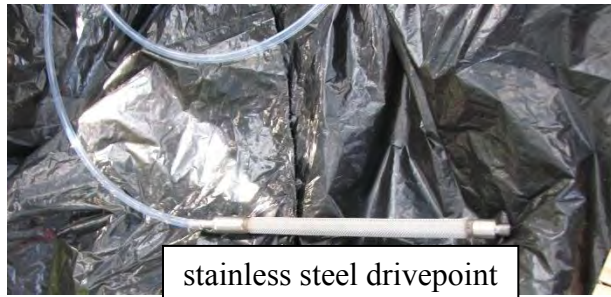
include: stainless steel drivepoints, stainless steel suction lysimeters and ceramic cup suction lysimeters (Figure 11). To separate the top of the lignocellulosic media and bottom of the native sand layer a plastic mesh screen (1/16-inch) was installed above the lignocellulosic media (Figure 10). Following placement of the plastic mesh screen, a 24-inch native sand layer was installed (Figure 12). Ceramic cup suction lysimeters were installed above the mesh screen to represent water quality just after downward passage through the sand layer.

stainless steel drivepoint

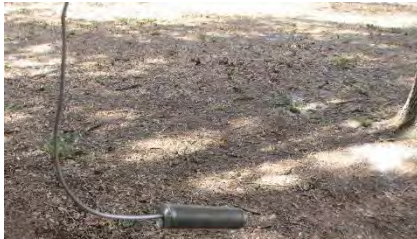
stainless steel suction lysimeter

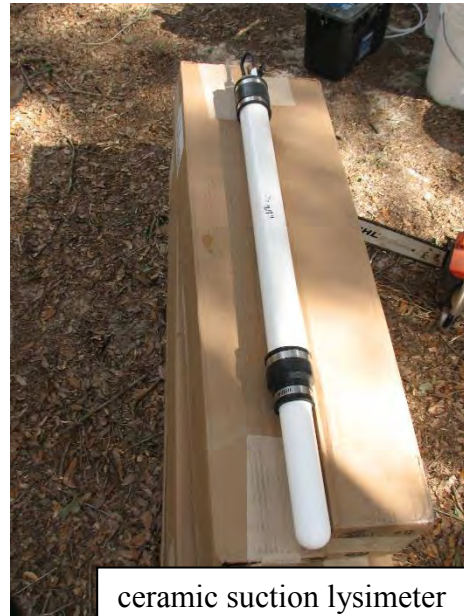
ceramic suction lysimeter

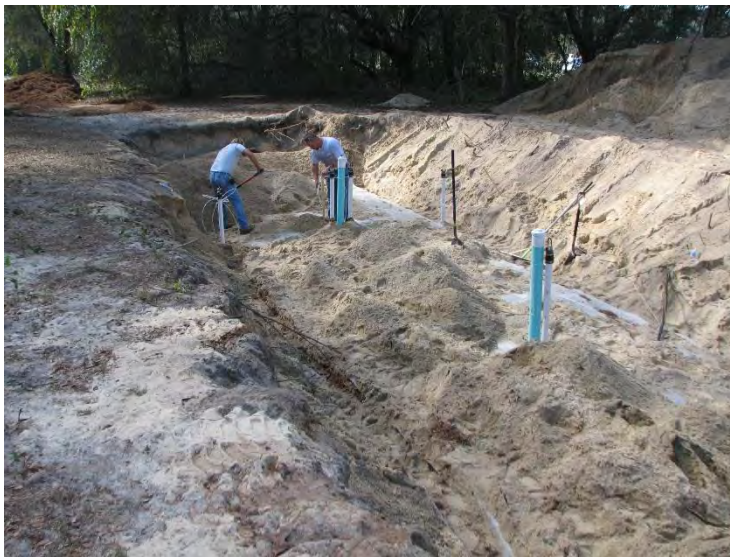
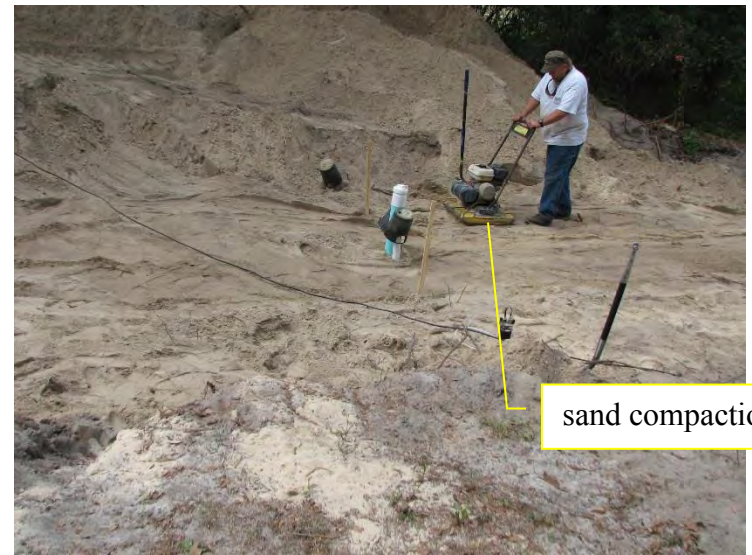
Figure 12
Native sand media

sand compaction

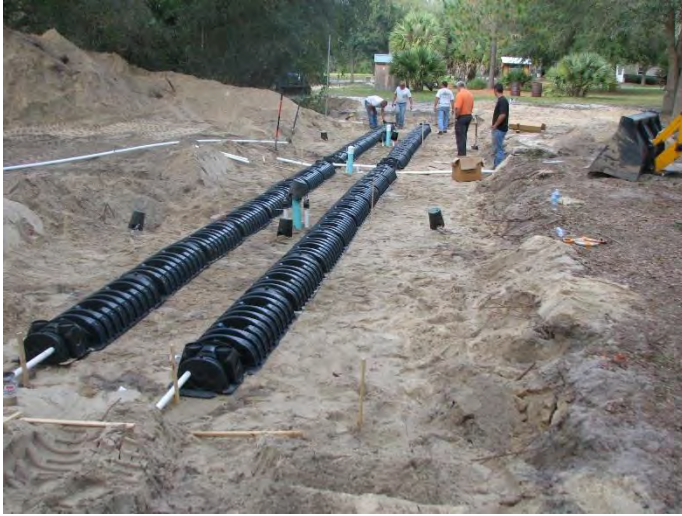
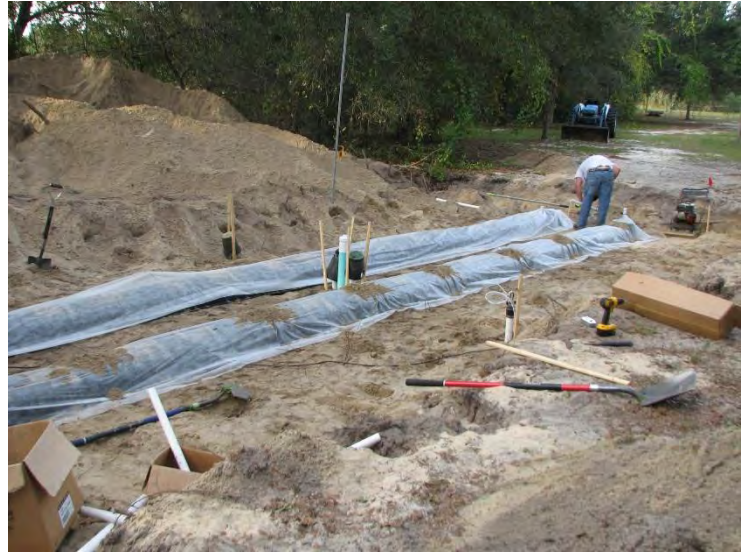
Figure 15
Infiltrator chambers

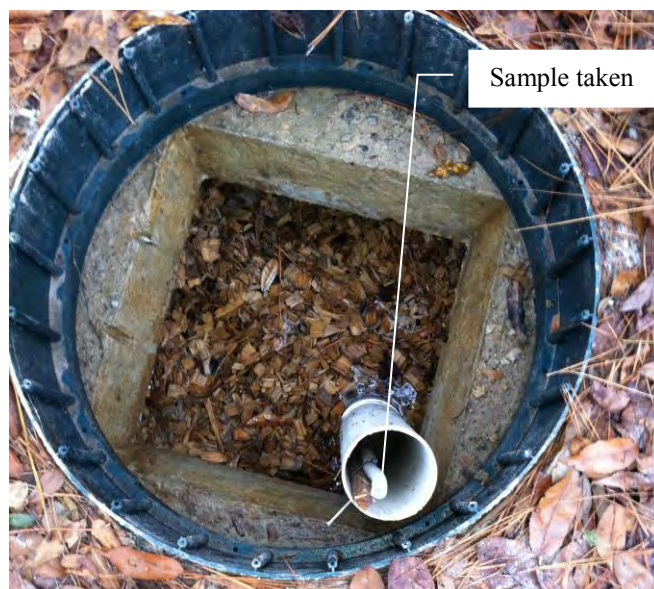
The fourth monitoring location is the Nitrex™ tank sample tube that is connected to the Nitrex™ effluent pipe (Figure 4). This sample represents the Nitrex™ effluent, which is the final effluent from the treatment system prior to being discharged to the soil infiltration system, or drainfield. Each drainfield line has an observation port installed at the end near the Nitrex system for monitoring (see Figure 2)

Figure 4
Nitrex™ Tank (B-HS1-NITREX sample)

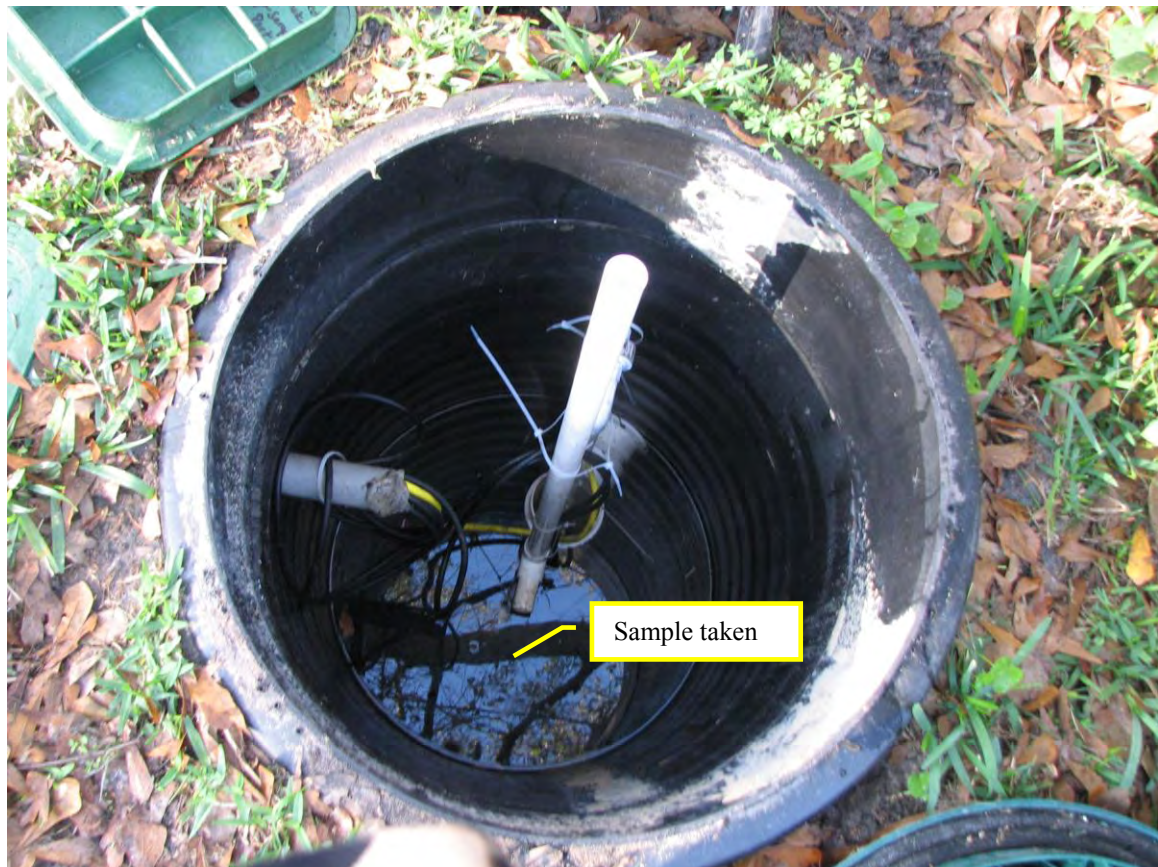
Figure 5
Stage 1 effluent sample taken in pump tank (B-HS2-ST1 sample)

Recirculation tank effluent is discharged by gravity to a distribution box located inside the Stage 1 biofilter, which splits the flow between two perforated distribution pipes along the top of the unsaturated Stage 1 biofilter media. In the Stage 1 biofilter, wastewater percolates downward through the unsaturated expanded clay media where nitrification occurs. Stage 1 biofilter effluent flows into the pump tank (which contains the pump and float switches). The third primary monitoring point, B-HS2-ST1, is the Stage 1 effluent sampled approximately 1.5 feet below the surface of the pump tank (Figure 5).

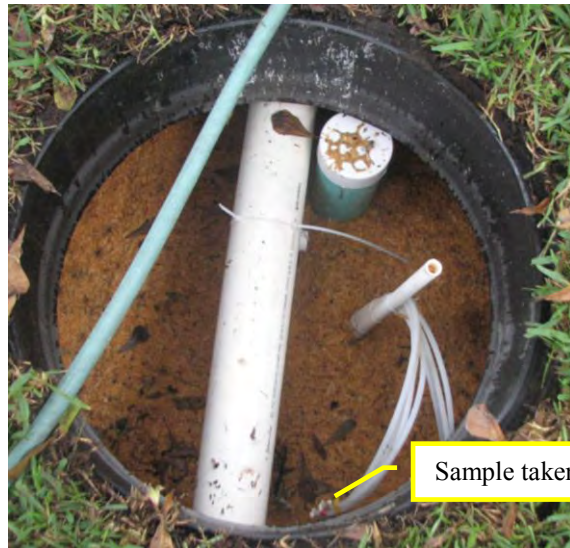
The first chamber of the Stage 2 biofilter contains 42-inches of lignocellulosic media. Stainless steel samplers are positioned at 6-inch increments for vertical profiling throughout the lignocellulosic media. The fourth primary sampling point is a stainless steel sampler positioned at the bottom of the lignocellulosic media (B-HS2-LIGNO-0). The B-HS2-LIGNO-0 sample represents the lignocellulosic media effluent (Figure 6).

Figure 6
First Chamber of Stage 2 Biofilter (B-HS2-LIGNO-0 Sample)

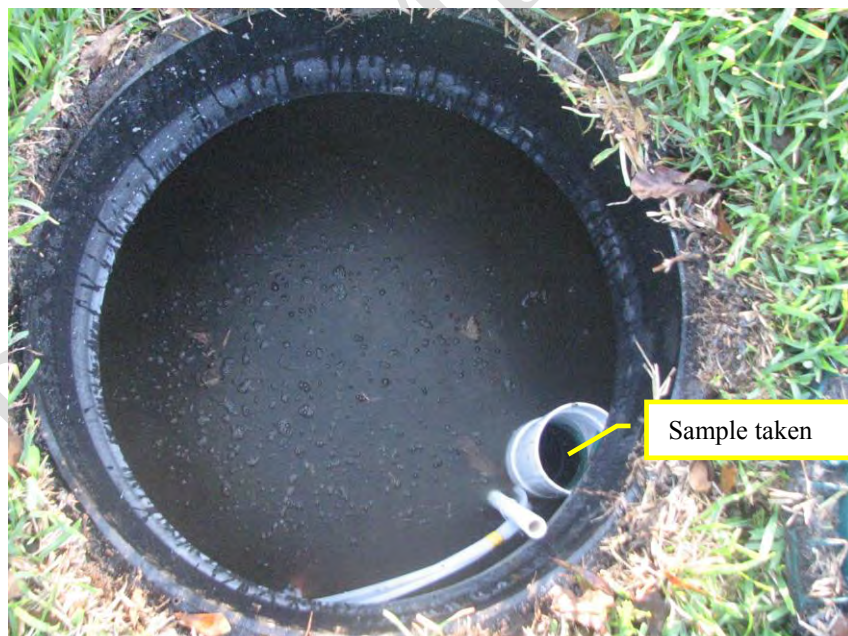
Figure 7
Second Chamber of Stage 2 Biofilter (B-HS2-ST2 Sample)

A collection pipe along the bottom transfers the first chamber (lignocellulosic media) effluent to the second chamber, which contains 24-inches of elemental sulfur mixed with oyster shell media. The fifth primary sampling point, B-HS2-ST2, is the second chamber of the Stage 2 biofilter effluent which is sampled approximately 1 foot below the surface of the effluent baffle tee. This sample location is after passage through the sulfur media; it is the final effluent from the treatment system prior to being discharged to the existing soil infiltration system, or drainfield (Figure 7).

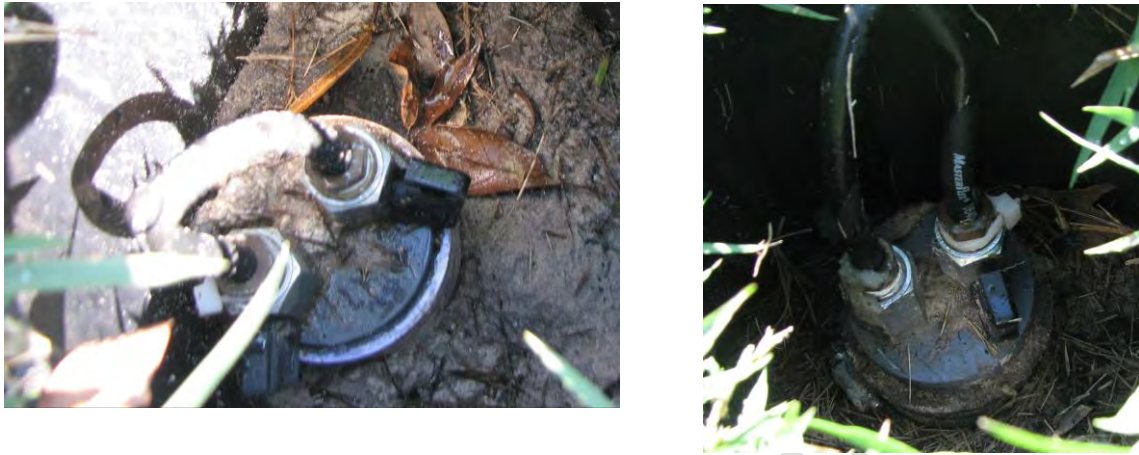
Figure 5
Stage 1 Suction Lysimeter (BHS3-LY01 and –LY02)

The STE dose tank effluent is pumped through the drip system hydraulic unit and discharged to the Stage 1&2a drip system (Zone 1). In the Stage 1&2a drip area, wastewater percolates downward through an 18-inch layer of unsaturated sand and a layer of lignocellulosic and sand media (9-inch maximum thickness) placed above a 30 mil PVC liner. The second and third sampling points are two suction lysimeters (BHS3-LY01 and BHS3-LY02) located at the interface of the overlying sand (Stage 1) and underlying lignocellulosic/sand mixture (Stage 2a). The suction lysimeters were installed with the bottom of the 9-inch ceramic placed at the interface of the two media layers. These sample locations ostensibly represent wastewater that has been nitrified by passage through the overlying sand layer (Figure 5).

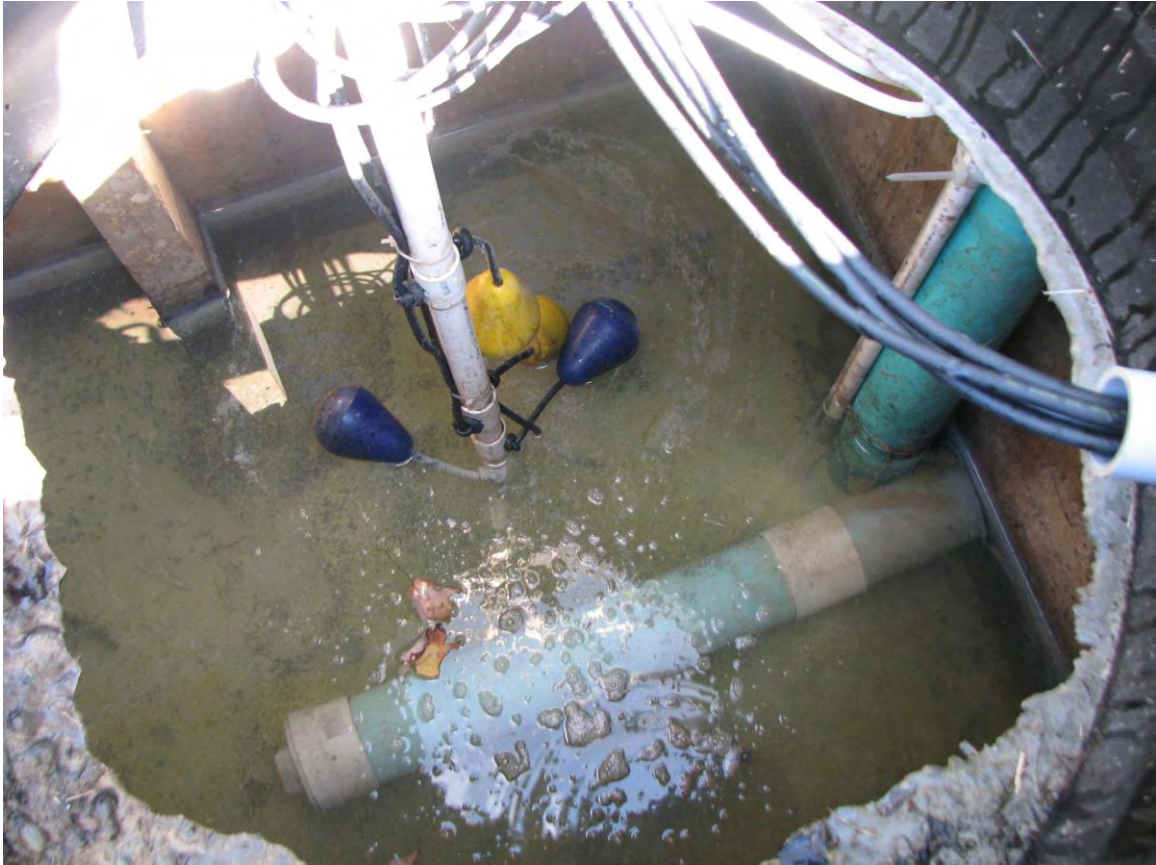
Figure 6
Second Chamber of Stage 2b Biofilter (B-HS3-ST2 Sample)

The liner effluent is conveyed to a Stage 2b biofilter, a concrete 1,050 gallon tank, containing elemental sulfur reactive media for additional treatment (denitrification). Wastewater flow is in an upward direction. The fifth sampling point, BHS3-SULFUR-6, is a stainless steel drivepoint sampler positioned 6-inches above the bottom of the sulfur media. The sixth sampling point, B-HS3-ST2, is the Stage 2b sulfur media biofilter effluent which is sampled approximately 6 inches below the water surface of the Stage 2b biofilter tank (Figure 6).

As previously discussed in Section 3.3, Sample Event 8 also included a Stage 2b biofilter sample taken 6 inches within the sulfur media. The BHS3-SULFUR-6 stainless steel drivepoint sampler results from this event indicate that the $\text{NO}_x\text{-N}$ was effectively reduced to 0.08 mg/L and sulfate concentration was 170 mg/L after passage through 6 inches of the sulfur media.

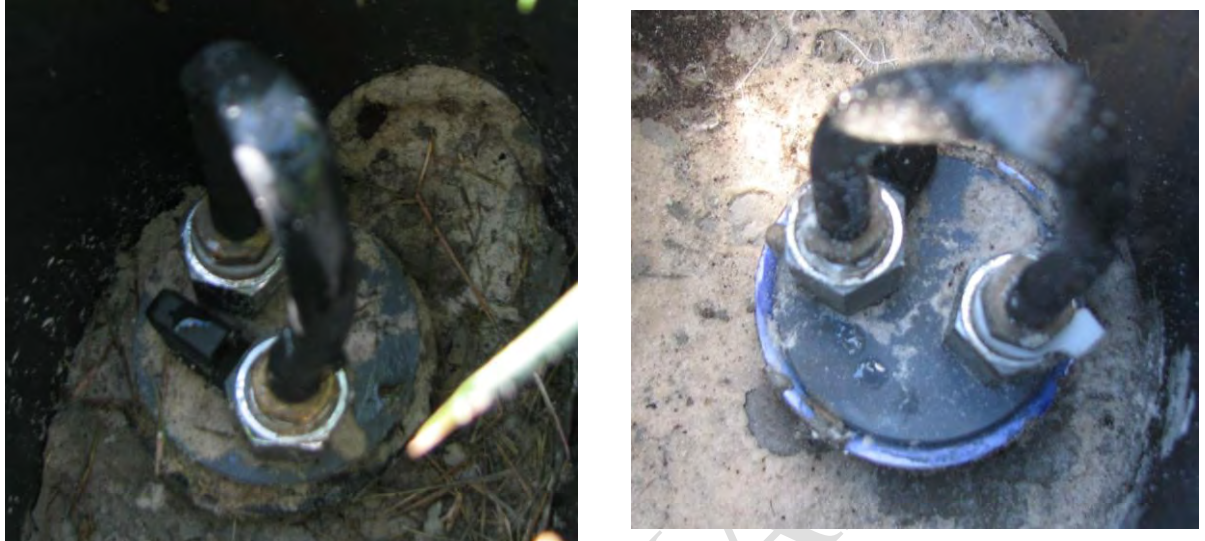
Figure 7
Treated Effluent Suction Lysimeter (B-HS3-LY03 and -LY04 sample)

The Stage 2b biofilter effluent is pumped through the drip system hydraulic unit and discharged through the treated effluent drip system emitters (Zone 2) to natural soil. Monitoring points 7 through 11 were placed below the Zone 2 drip emitters. Their locations are shown in Figure 3. Sampling points seven and eight are suction lysimeters (BHS3-LY03 and BHS3-LY04) located in the treated effluent drip area with the top of the 9 inch ceramic cup located 24 inches below the drip emitters to represent treatment through 24-inches of unsaturated soil (Figure 7). Sampling points nine, ten and eleven are also located within the treated effluent drip area; these are standpipe piezometers (BHS3-PZ07, BHS3-PZ08, and BHS3-PZ09) positioned so that the top of the 5-foot screen is 24-inches below the drip emitters (Figure 8).

Treated Effluent Soil Suction Lysimeters (LY03 and LY04): The treated effluent drip system monitoring devices LY03 and LY04 $\text{NO}_x\text{-N}$ concentrations were 5.6 mg/L and 2 mg/L, respectively, which is higher than the Stage 2b effluent concentration. This has been noted in each sampling event since system start-up. It appears that there must be another source of nitrogen to the effluent irrigation area, and it is suspected that fertilizer from the new sod installed in the area is still contributing to this result. The $\text{NO}_x\text{-N}$ concentrations did appear to decrease with time following sod installation and in the winter months with less rainfall; however in March and June the $\text{NO}_x\text{-N}$ concentrations increased possibly from sod fertilizer runoff in the rainy season (Figure 12).

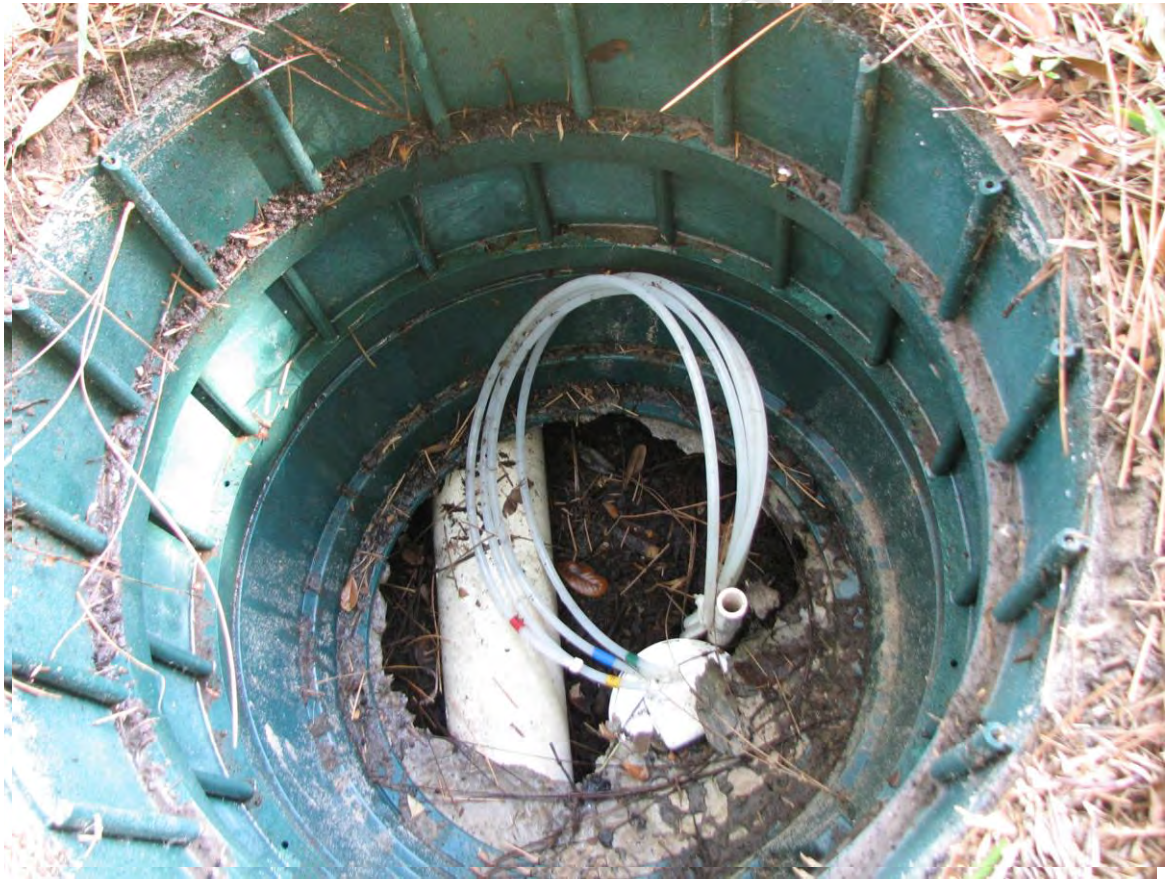
Figure 5
First Chamber of Stage 2 Biofilter (B-HS4-LIGNO-0 Sample)

The first chamber of the Stage 2 biofilter contains 42-inches of lignocellulosic media (Southern Yellow Pine (SYP)). Stainless steel samplers are positioned at 12-inch increments for vertical profiling throughout the lignocellulosic media. The third primary sampling point is a stainless steel sampler positioned at the bottom of the lignocellulosic media (B-HS4-LIGNO-0) with tubing to the surface. Twelve inches above B-HS4-LIGNO-0 is another stainless steel drivepoint sampler B-HS4-LIGNO-12, and so forth (B-HS4-LIGNO-24 and B-HS4-LIGNO-36). The B-HS4-LIGNO-0 sample represents the lignocellulosic media effluent (Figure 5).

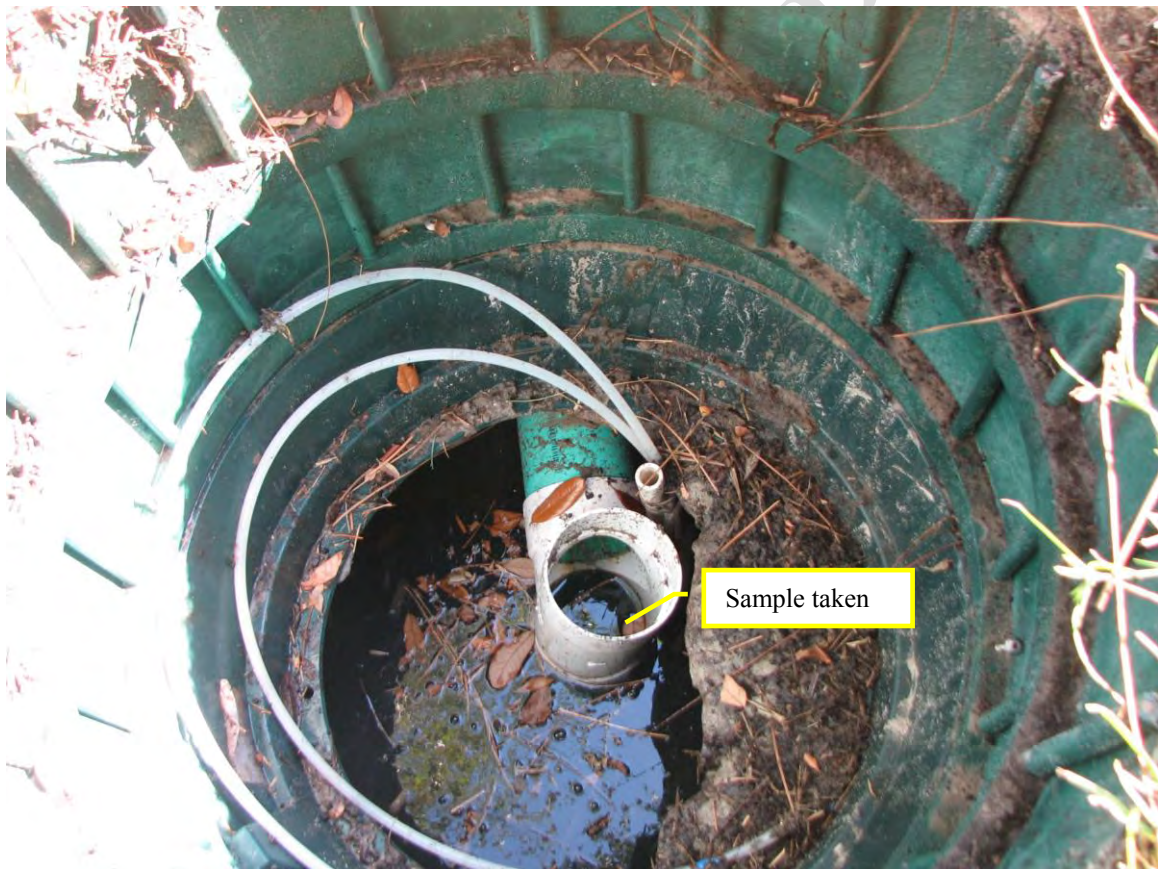
Figure 6
Second Chamber of Stage 2 Biofilter (B-HS4-ST2 Sample)

A collection pipe along the bottom transfers the first chamber (lignocellulosic media) effluent to the second chamber, which contains 18-inches of elemental sulfur mixed with oyster shell media. Similar to the lignocellulosic media chamber, stainless steel drive-point samplers are positioned to create a vertical profile. B-HS4-SULFUR-6 and B-HS4-SULFUR-12 are positioned 6-inches and 12-inches, respectively, above the bottom of the sulfur media. The fourth primary sampling point, B-HS4-ST2, is the second chamber of the Stage 2 biofilter effluent which is sampled approximately 1 foot below the surface of the effluent baffle tee. This sample location is after passage through the sulfur media; it is the final effluent from the treatment system prior to being discharged to the soil infiltration system, or drainfield (Figure 6).
