Florida Onsite Sewage Nitrogen Reduction Strategies Study

Evaluation of Full Scale Prototype Passive Nitrogen Reduction Systems (PNRS) and Recommendations for Future Implementation - Volume II of II

August 2015

**Installation Report for Passive Nitrogen Reduction System
B-HS1**

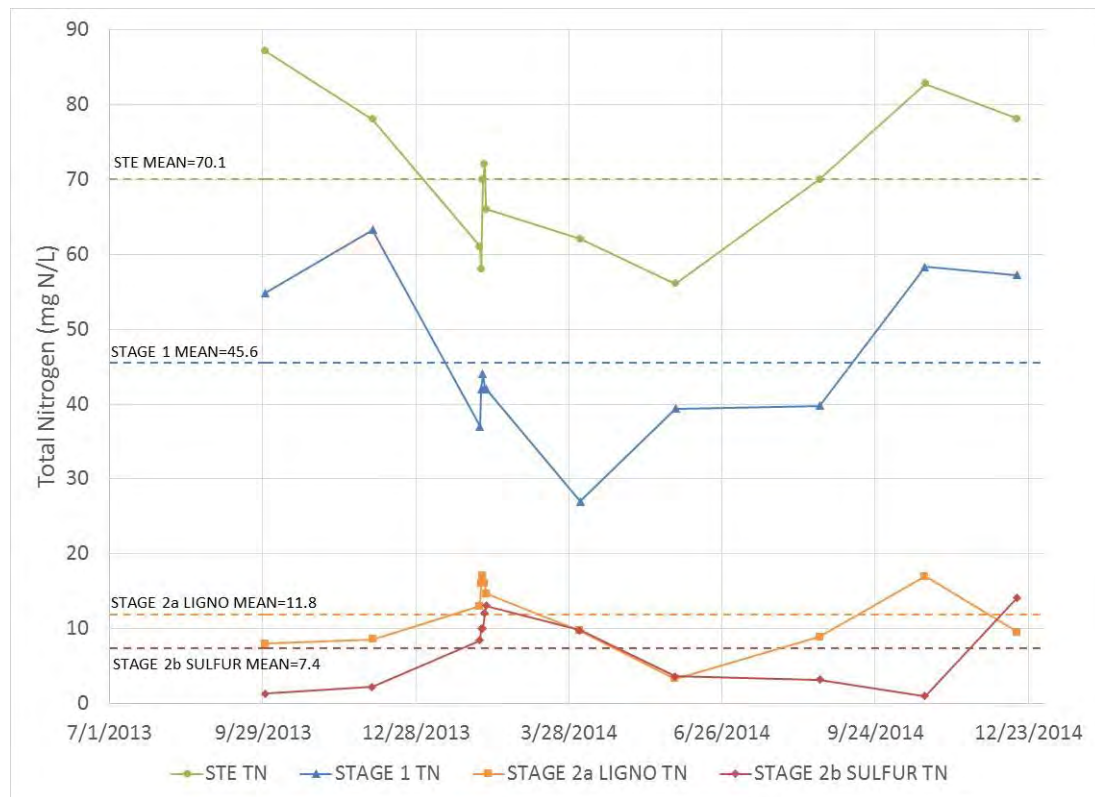
Figure 9
Total Nitrogen Time Series Graph
September 30, 2013 through December 16, 2014

A summary of the water quality data collected for the test system is presented in Table 5. Figure 9 provides a time series of influent and effluent TN over the study period. Figures 10 through 16 show box and whisker plots of the various monitoring points for the key parameters measured during the study period.

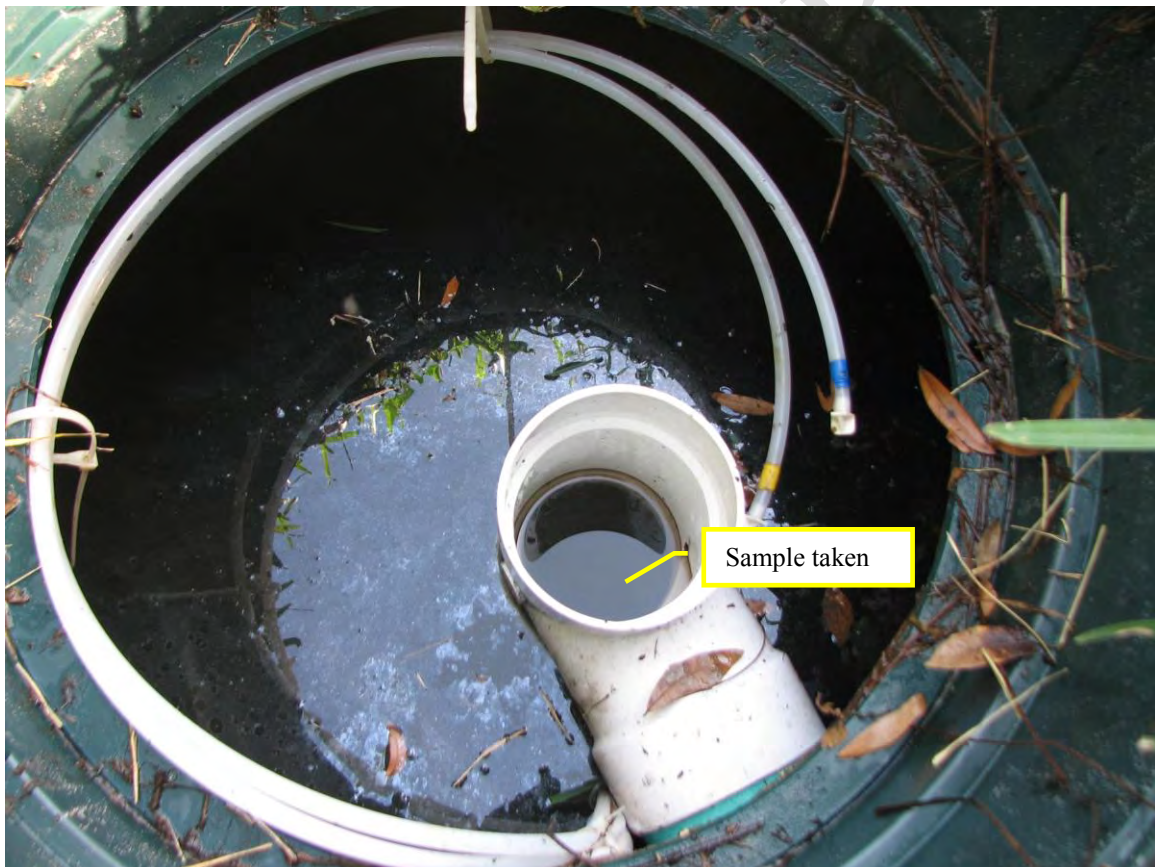
Figure 7
Second chamber of Stage 2 biofilter (B-HS5-ST2 sample)

A collection pipe along the bottom transfers the first chamber (lignocellulosic media) effluent to the second chamber, which contains 18-inches of elemental sulfur mixed with oyster shell media. Similar to the lignocellulosic media chamber, stainless steel drivepoint samplers are positioned to create a vertical profile. B-HS5-SULFUR-6 and B-HS5-SULFUR-12 are positioned 6-inches and 12-inches, respectively, above the bottom of the sulfur media. The fourth primary sampling point, B-HS5-ST2, is the second chamber of the Stage 2 biofilter effluent which is sampled approximately 1 foot below the surface of the effluent baffle tee. This sample location is after passage through the sulfur media; it is the final effluent from the treatment system prior to being discharged to the soil infiltration system, or drainfield (Figure 7).

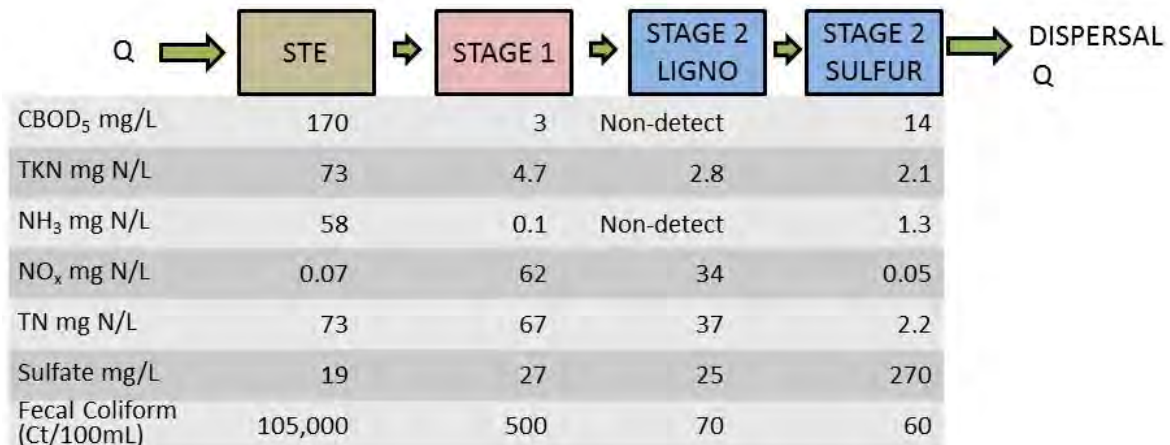
Figure 8
Graphical Representation of Nitrogen Results
Sample Event No. 8, December 15, 2014 (Experimental Day 524)

Water quality analytical results for Sample Event No. 8 are listed in Table 5. Key results are graphically displayed in Figure 8. A summary of the water quality data collected to date for the test system is presented in Table 6. The laboratory report containing the raw analytical data is included in Appendix A. The following discussion summarizes the water quality analytical results. The performance of the various system components was compared by considering the changes through treatment of nitrogen species (TKN, $\text{NH}_3\text{-N}$, and $\text{NO}_x\text{-N}$), as well as supporting water quality parameters.

Septic Tank Effluent (STE) Quality: The water quality characteristics of STE collected in Sample Event 8 were within the typical range generally expected for domestic STE. The measured STE total nitrogen (TN) concentration was 73 mg/L, which is within the high end of the range that has been typically reported for Florida single family residence STE.

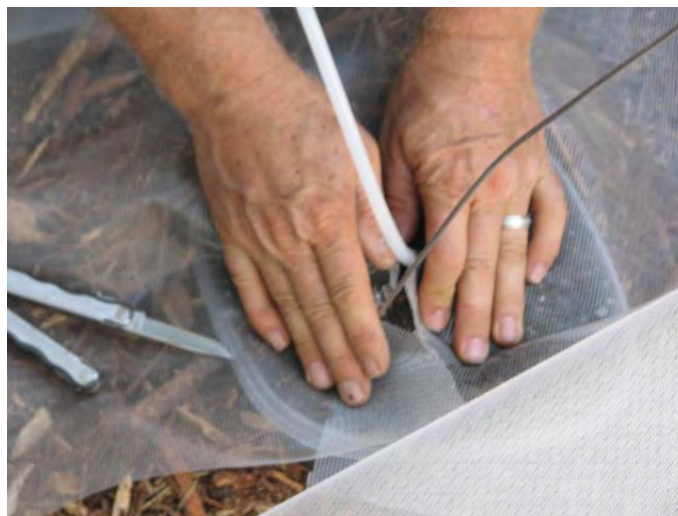
Figure 5
Stage 1 Unsaturated Biofilter Effluent (B-HS6-DP1 and B-HS6-DP2 sample)

The pump tank contents are discharged to the top of the Stage 1 biofilter through three Orenco™ spin nozzles. The spin nozzles visually appear to adequately cover the surface area of the biofilter and provide relatively uniform flow distribution. The four spray nozzles that were originally installed were replaced with the three spin nozzle sprayers on March 20, 2014. In the Stage 1 biofilter, wastewater percolates downward through expanded clay media where unsaturated conditions provide for ammonium oxidation and nitrification. The Stage 1 biofilter contains 30 inches of coarse expanded clay media (Riverlite™ 1/4; 1.1 to 4.8 mm). Two shallow pans, each containing a drive point sampler, were installed underneath the expanded clay layer and on top of the Stage 2a lignocellulosic media (see Figure 5). The second and third sampling points (B-HS6-DP1 and B-HS6-DP2) are sampled by connecting a peristaltic pump to the drivepoint tubing of each pan. Each sample represents effluent from the unsaturated Stage 1 biofilter.

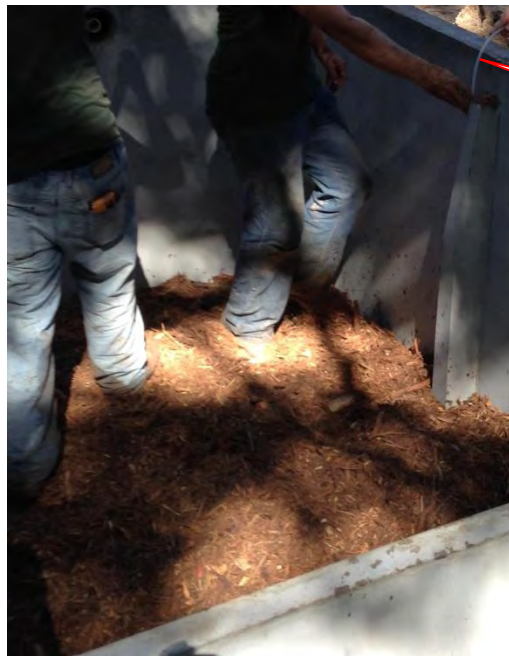
Figure 6
Stage 2a Saturated Biofilter Effluent (B-HS6-DP3 and B-HS6-DP4) sample tubing

Twelve inches of lignocellulosic media, a blended waste wood from AAA Tree Experts, Tallahassee, FL, was installed underneath the expanded clay media as a supplemental carbon source for denitrification. A single 4-inch diameter outlet pipe connected the Stage 1&2a tank to the Stage 2b tank. The pipe was installed along the centerline of the Stage 1&2a tank with the invert at 4-inches above the interior bottom of the tank. Therefore, approximately 4-inches of the lignocellulosic media is saturated, promoting oxygen depletion and denitrification of the nitrified effluent. Two additional stainless steel drive points were installed at the bottom of the Stage 2a saturated lignocellulosic media (see Figure 6). These drive points sampled water from near the very bottom of the tank. The fourth and fifth sampling points (B-HS6-DP3 and B-HS6-DP4) are each sampled by connecting a peristaltic pump to the drive point tubing. Samples from each of the two monitoring points possibly represent the effluent from the Stage 2a saturated biofilter.

Drive point
tubing

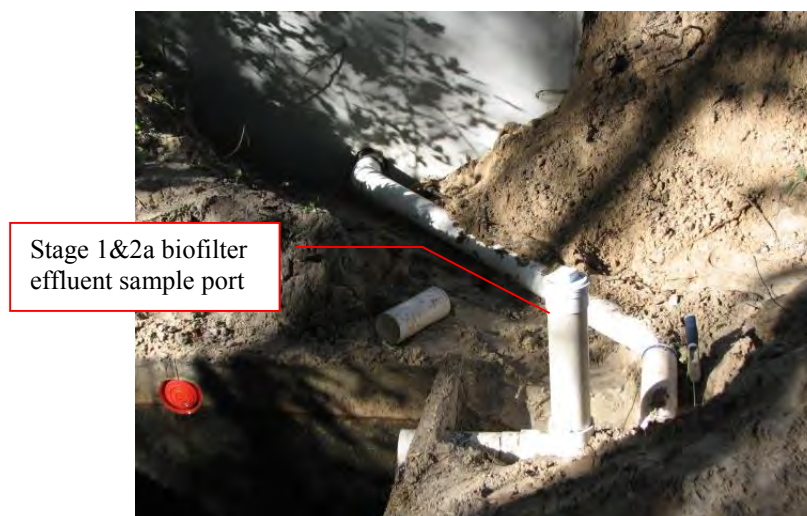
Figure 8
Stage 1&2a Biofilter Effluent Sample Port (B-HS6-ST1&2a sample)

The effluent from the Stage 1&2a biofilter flows into the Stage 2b biofilter by gravity. The sixth sampling point (B-HS6-ST1&2a) is taken from a sample port in the gravity pipe con-

necting the Stage 1&2a biofilter outlet to the Stage 2b biofilter inlet representing the Stage 1&2a biofilter effluent (see Figure 8).

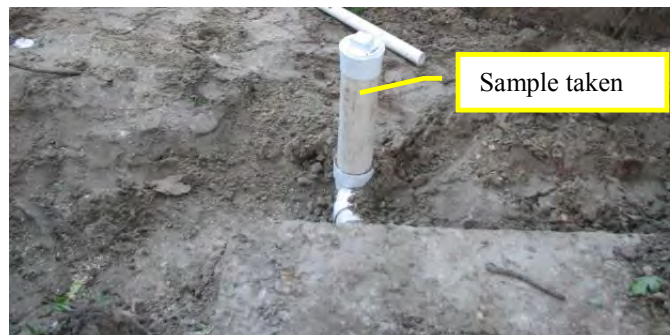
Figure 10
Stage 2b Biofilter Effluent (B-HS6-ST2b-P sample)

The eighth sampling point (B-HS6-ST2b-P) is from a sample port in the gravity pipe connecting the Stage 2b biofilter outlet to the drainfield inlet also representing the treated effluent (Figure 10).

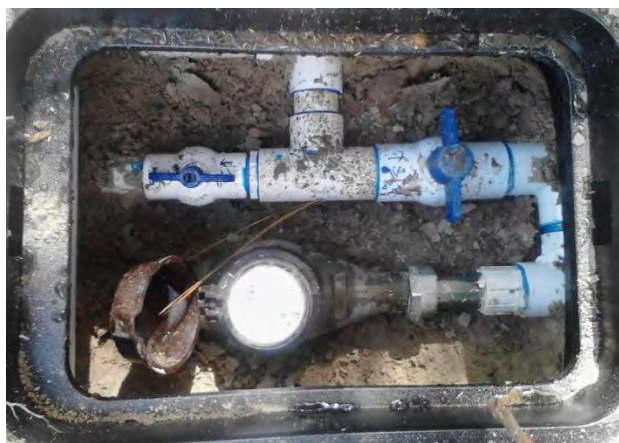
Figure 11
Treatment system flow meter

The PNRS treatment system flow meter (Figure 11) is located on the pump tank discharge line and records the cumulative flow in gallons pumped from the pump chamber to the combined Stage 1&2a biofilter. The control panel includes telemetry where reports are generated regarding alarms, pump cycles, and other information using a Vericomm control panel system.

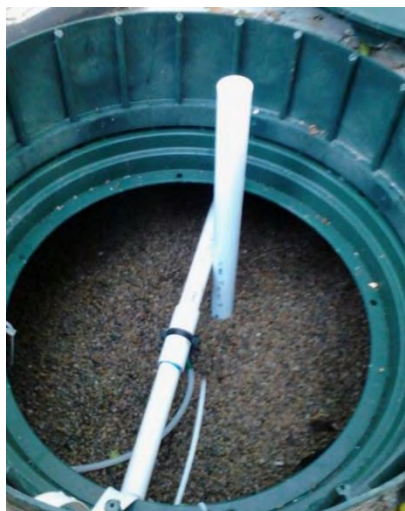
Figure 12
Piezometer installed on April 19, 2014 in the Stage 1&2a Tank

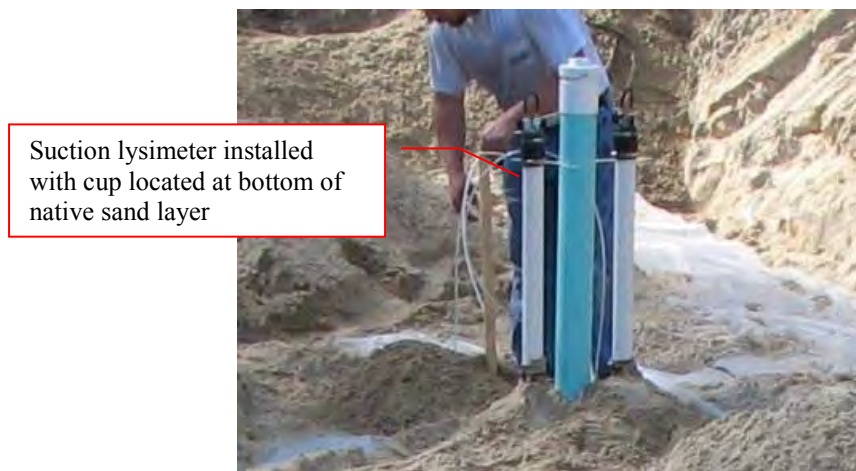
Stage 1 Effluent: STE in the pump tank is discharged through a low-pressure distribution network installed inside Infiltrator EQ36-LP™ chambers. The low-pressure distribution network consists of a central manifold design with (4) 33-foot long, 1.25-inch diameter perforated laterals installed along the top of the 24-inch native sand media (unsaturated Stage 1 biofilter). In the Stage 1 biofilter, wastewater percolates downward through the unsaturated native sand media where nitrification occurs. Ceramic cup suction lysimeters (BHS7-ST1-SL-01, BHS7-ST1-SL-02, BHS7-ST1-SL-03, and BHS7-ST1-SL-04) were installed with the cup at the bottom of the native sand layer to represent water quality after downward passage through the sand layer (see Figure 6). In addition, one stainless steel drivepoint (BHS7-ST1-DP-01) was installed in a shallow pan at the bottom of the native sand layer (see Figure 7). However, this sample point

Figure 6
Stage 1 biofilter effluent sample taken from suction lysimeter (BHS7-ST1-SL samples)

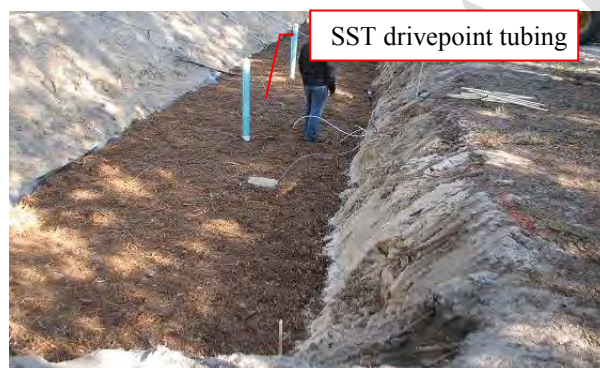
Figure 8

Line Water Samples (Perceived Stage 2 Effluent): Directly below the 24-inch native sand Stage 1 biofilter is a 12-inch layer of lignocellulosic media as a supplemental car-

bon source for denitrification (Stage 2 biofilter). This material is a blended urban waste wood from Wood Resource Recovery, Ocala, FL. The Stage 2 biofilter treatment area was prepared with a 30 mil PVC liner installed below the lignocellulosic media. The liner was installed with a 6 inch lip around the outside perimeter. Therefore, approximately 6-inches of the lignocellulosic media can reach saturation from applied wastewater, promoting oxygen depletion and denitrification of the nitrified effluent. At the bottom of the Stage 2 biofilter lignocellulosic media, directly above the liner, stainless steel drivepoint samplers were installed (see Figure 8) including: BHS7-ST2-DP-02, BHS7-ST2-DP-03, BHS7-ST2-DP-04, BHS7-ST2-DP-05, BHS7-ST2-DP-06, BHS7-ST2-DP-07, and BHS7-ST2-DP-08. DP03, DP05, DP06, DP07 and DP08 were sampled regularly and formed the basis for the liner samples mean. As discussed, it appeared that much of the Stage 1 effluent did not flow into/through the liner, so these sample points may not be representative of system effluent.

Stage 2 biofilter effluent sample taken from drivepoint (BHS7-ST2-DP samples)

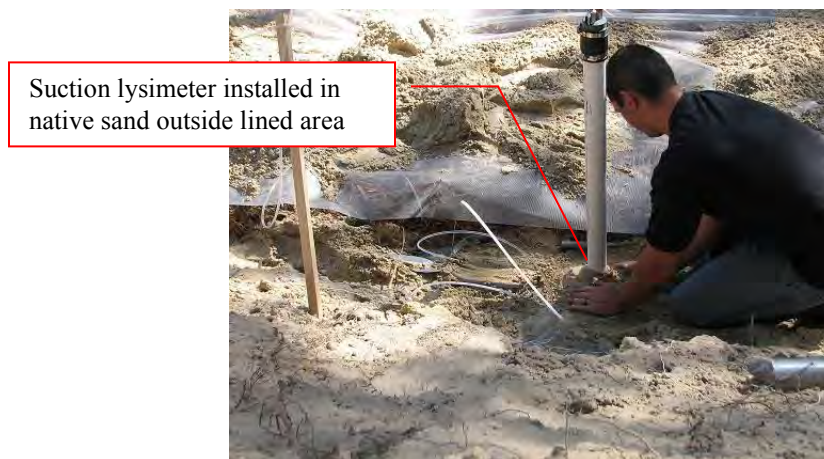
Figure 9

Perimeter Monitoring Points: As discussed previously, it was anticipated that the treated effluent would be discharged from the liner under saturated conditions by flowing over the lip of the liner and into the soil surrounding the perimeter of the lined area. Ceramic cup suction lysimeters (BHS7-EFF-SL-06, BHS7-EFF-SL-07, BHS7-EFF-SL-08, and BHS7-EFF-SL-09) were installed around the perimeter of the liner, with the bottom of the cup approximately 6-inches below the lip of the liner within the native sand (see Figure 9) to represent this treated effluent. In addition, stainless steel drivepoints (BHS7-EFF-DP-09, BHS7-EFF-DP-10, BHS7-EFF-DP-11, BHS7-EFF-DP-12) were installed in shallow pans adjacent to the lip of the liner (see Figure 10). Based on liner water levels and other data, it appeared that much of the Stage 1 effluent did not flow into the liner, rather, soil moisture appeared to move laterally out from the treatment area to the surrounding unsaturated soil. Perimeter water quality therefore may be more repre-

Treated effluent sample taken from suction lysimeter (BHS7-EFF-SL samples)

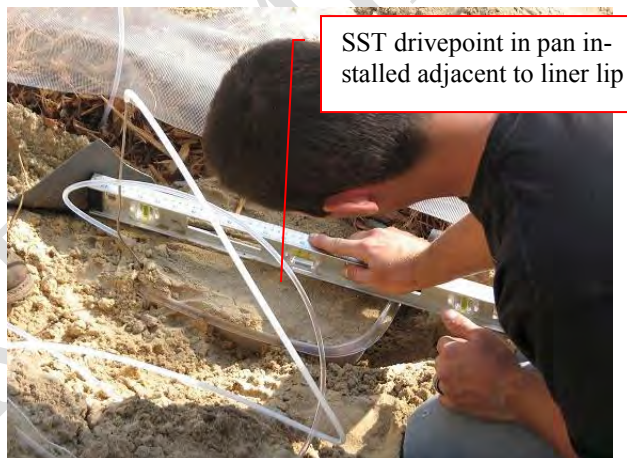
Figure 10

Treated effluent sample taken from drivepoint in pan (BHS7-EFF-DP samples)

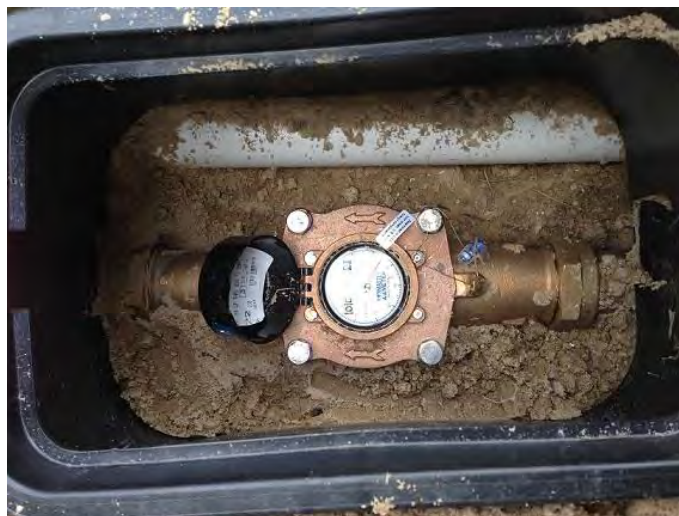
The PNRS treatment system flow meter (Figure 11) is located on the pump tank discharge line and records the cumulative flow in gallons pumped from the pump chamber to the low-pressure distribution network.

Figure 11
PNRS system flow meter
