Florida Onsite Sewage Nitrogen Reduction Strategies Study

B-HS6 Field System Monitoring Report No. 8

Progress Report

February 2015

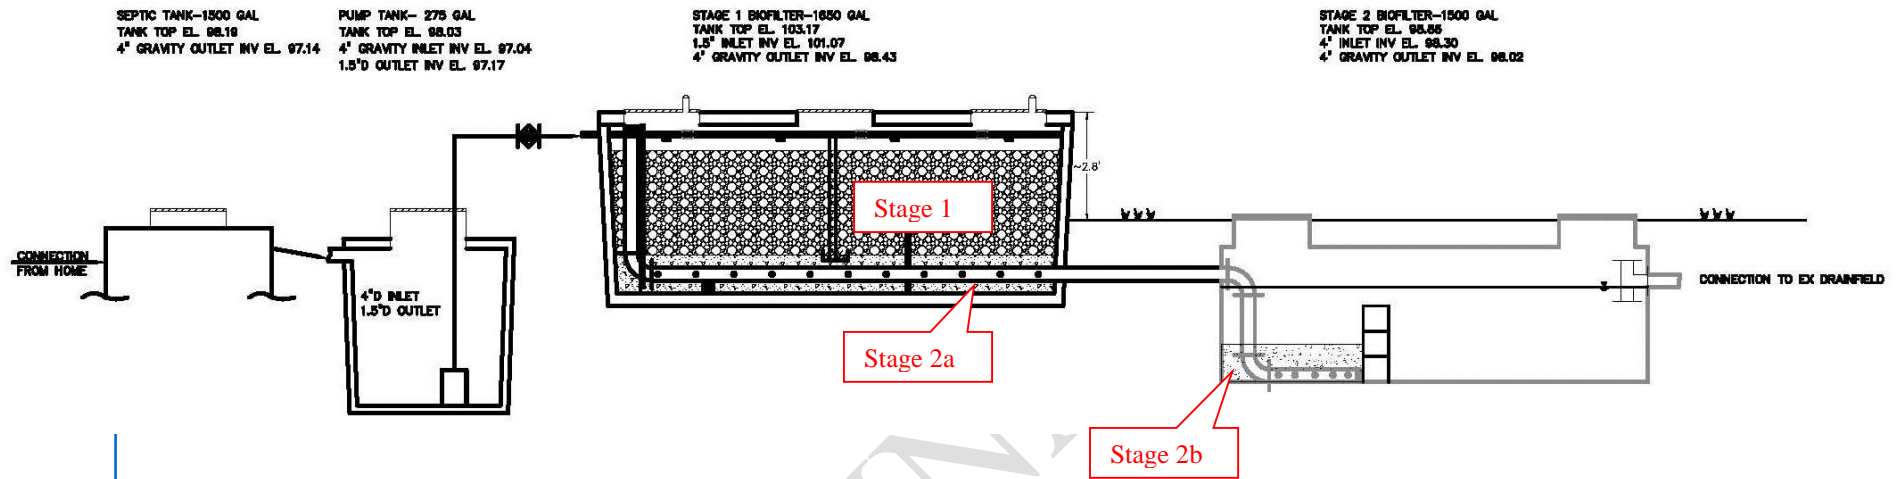
Figure 2
Flow Schematic of B-HS6 PNRS installed in Wakulla County

Treated effluent is discharged to a soil dispersal system (drainfield) consisting of four Infiltrator trenches. Three of the four Infiltrator trenches are 40 feet in length, and the fourth is 36 feet. The layout of the system and a flow schematic are shown in Figures 1 and 2, respectively.

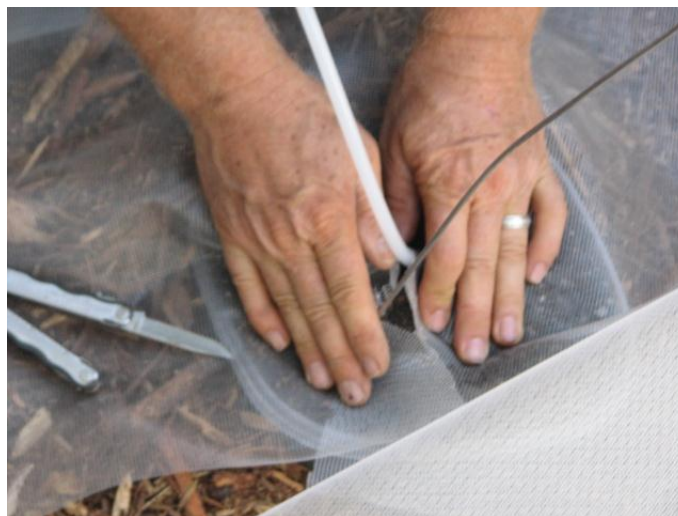
The pump tank contents are discharged to the top of the Stage 1 biofilter through three Orenco™ spin nozzles. The spin nozzles visually appear to adequately cover the surface area of the biofilter and provide relatively uniform flow distribution. The four spray nozzles that were originally installed were replaced with the three spin nozzle sprayers on March 20, 2014. In the Stage 1 biofilter, wastewater percolates downward through expanded clay media where unsaturated conditions provide for ammonium oxidation and nitrification. The Stage 1 biofilter contains 30 inches of coarse expanded clay media (Riverlite™ 1/4; 1.1 to 4.8 mm). Two shallow pans, each containing a drive point sampler, were installed underneath the expanded clay layer and on top of the Stage 2a lignocellulosic media (see Figure 5). The second and third sampling points (B-HS6-DP1 and B-HS6-DP2) are sampled by connecting a peristaltic pump to the drivepoint tubing of each pan. Each sample represents effluent from the unsaturated Stage 1 biofilter.

Figure 5
Stage 1 Unsaturated Biofilter Effluent (B-HS6-DP1 and B-HS6-DP2 sample)

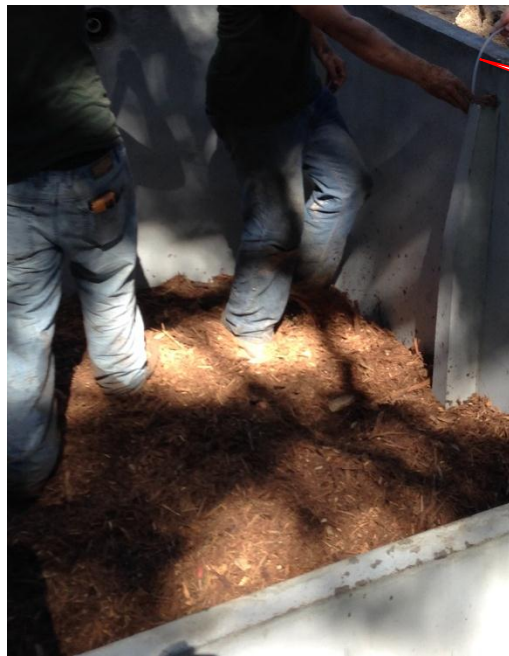
Twelve inches of lignocellulosic media, a blended waste wood from AAA Tree Experts, Tallahassee, FL, was installed underneath the expanded clay media as a supplemental carbon source for denitrification. A single 4-inch diameter outlet pipe connected the Stage 1&2a tank to the Stage 2b tank. The pipe was installed along the centerline of the Stage 1&2a tank with the invert at 4-inches above the interior bottom of the tank. Therefore, approximately 4-inches of the lignocellulosic media is saturated, promoting oxygen depletion and denitrification of the nitrified effluent. Two additional stainless steel drive points were installed at the bottom of the Stage 2a saturated lignocellulosic media (see Figure 6). These drive points sampled water from near the very bottom of the tank. The fourth and fifth sampling points (B-HS6-DP3 and B-HS6-DP4) are each sampled by connecting a peristaltic pump to the drive point tubing. Samples from each of the two monitoring points possibly represent the effluent from the Stage 2a saturated biofilter.

Drive point
tubing

Figure 6
Stage 2a Saturated Biofilter Effluent (B-HS6-DP3 and B-HS6-DP4) sample tubing

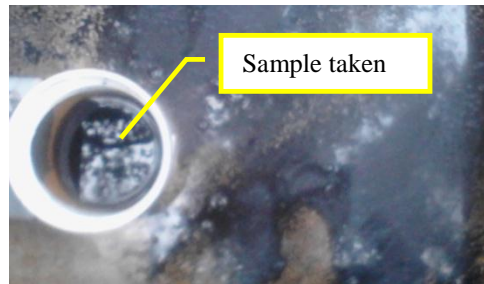
Effluent from the Stage 1&2a biofilter enters the saturated denitrification (Stage 2b) biofilter at the bottom of the tank through a 4-inch diameter perforated pipe, flows upward through the 12-inches of elemental sulfur and oyster shell media mixture, and moves laterally over a concrete block wall to the second chamber. The Stage 2b biofilter effluent discharges near the top of the tank; therefore denitrification occurs in the saturated environment. The seventh primary sampling point, (B-HS6-ST2b-T) is the second chamber of the Stage 2 biofilter effluent, which is sampled approximately 1 foot below the surface of the effluent baffle tee. This sample location is after passage through the sulfur media; it is the final effluent from the treatment system prior to being discharged to the soil infiltration system, or drainfield (Figure 9).

Figure 9
Stage 2b Biofilter Effluent (B-HS6-ST2b-T sample)

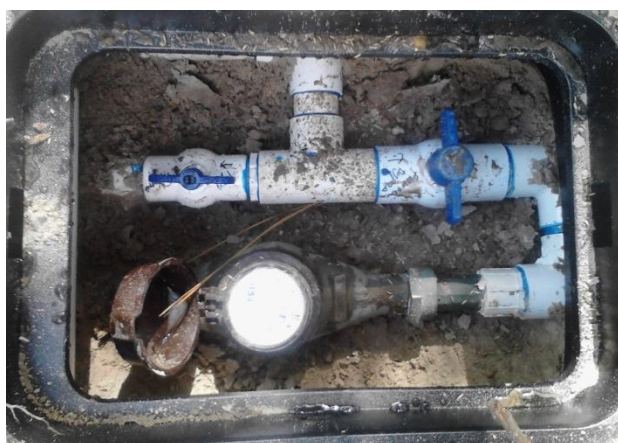
The PNRS treatment system flow meter (Figure 11) is located on the pump tank discharge line and records the cumulative flow in gallons pumped from the pump chamber to the combined Stage 1&2a biofilter. The control panel includes telemetry where reports are generated regarding alarms, pump cycles, and other information using a Vericomm control panel system.

Figure 11
Treatment system flow meter

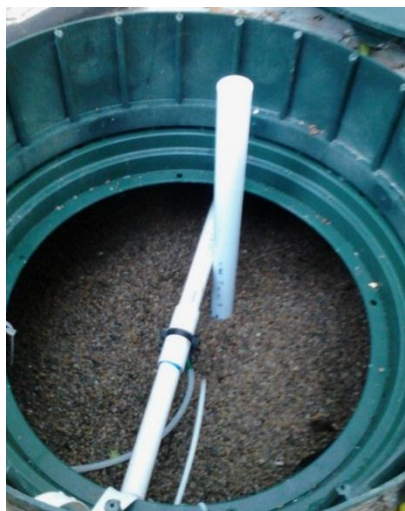
Based on the hydraulic design of the system, a normally expected water level in the Stage 1&2a tank would be approximately 98.52 ft. elevation, or a depth above tank bottom of 4.8 inches. The normal operation level in the Stage 1&2a tanks therefore could be expected to vary between 4 and 6 inches above the tank bottom. Water levels above these values could adversely affect treatment performance and would suggest hydraulic blockages in the system. While purging the Stage 1 effluent drive points DP1 and DP2 during Sample Event No. 2, it was observed that the water level in the Stage 1&2a tank was elevated above the pans holding the drive points. The water level in the Stage 1&2a tank was found to be elevated approximately 10-inches above the invert of the collection pipe during that sample event. This water level would saturate all 12-inches of the ligno-cellulosic media and approximately 2-inches of the expanded clay media. The elevated water level could quite possibly have affected the performance of the system as monitored in Sample Event 2. A piezometer was installed within the Stage 1&2a tank on April 10, 2014 to provide better access to water level observations (Figure 12).

Figure 12
Piezometer installed on April 19, 2014 in the Stage 1&2a Tank

Table 3 summarizes the water level readings recorded. On April 14, 2014, it was determined the clog in the system was in the inlet pipe on the Stage 2b sulfur tank. An unsuccessful attempt was made with a plumbing snake to clear the clog. On April 16, 2014, the clog was cleared using compressed air and a 4-inch rubber bladder; the water level in the Stage 1&2a tank was restored to normal operational levels. During the following monitoring event, Sample Event No. 3, the water level in the Stage 1&2a tank was at normal operational levels. A system check on May 27, 2014 indicated that the water level was elevated approximately 8 inches above the tank bottom. A repair on the inlet pipe to the Stage 2b sulfur tank was completed on May 31, 2014. The repair included drilling additional holes in the inlet pipe and replacing the mesh material surrounding the pipe with a different type with larger mesh size to prevent future clogging. During a system check on September 26, 2014, the water level in the Stage 1&2a tank piezometer was again elevated by approximately 8 inches. This could have resulted in greater saturation of lignocellulosic media in Stage 2a, but submergence of the pans holding drive points DP1 and DP2 would not be expected. It was determined that the outflow pipe of the Stage 1&2a tank was partially clogged. A clean out was installed on the outflow pipe, just downgradient of the Stage 1&2a tank on October 9, 2014 which allowed access to clean the perforations from inside the effluent collection pipe. In addition, additional holes were drilled in the effluent collection pipe (from inside the pipe) inside the tank.

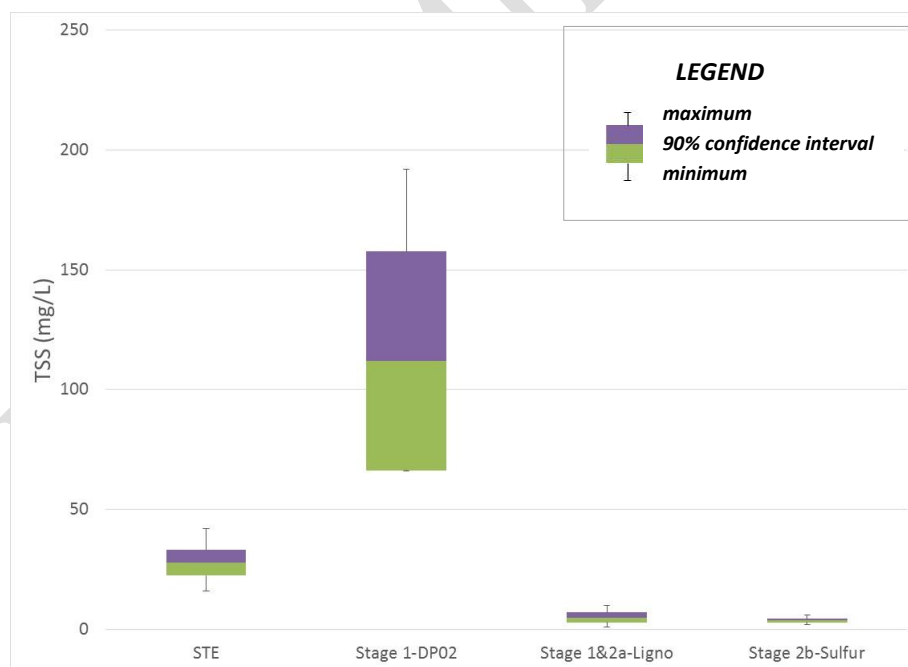
Figure 16
TSS Box and Whisker Plot

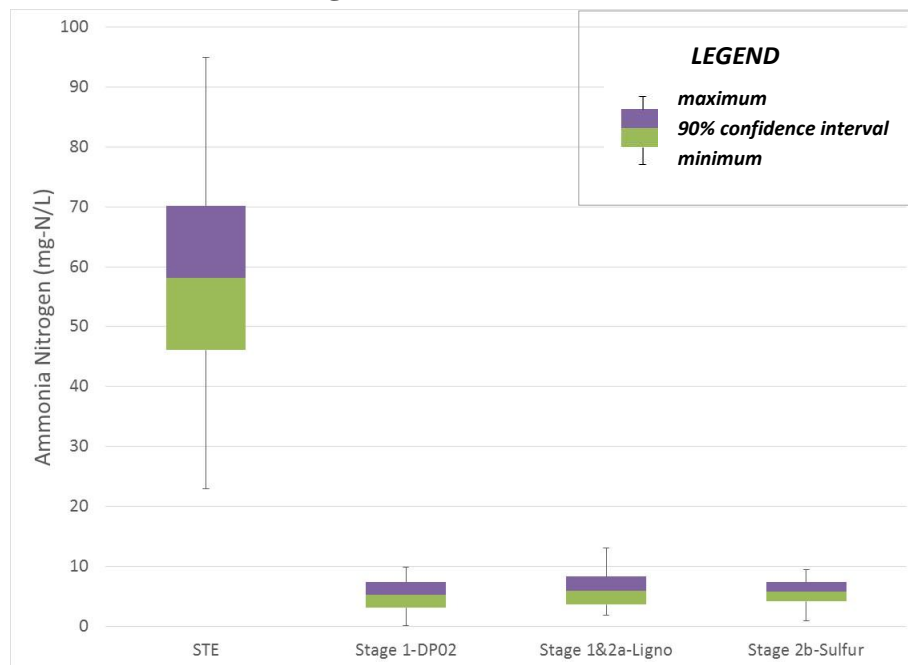
Figure 18
Ammonia N (NH₃-N) Box and Whisker Plot

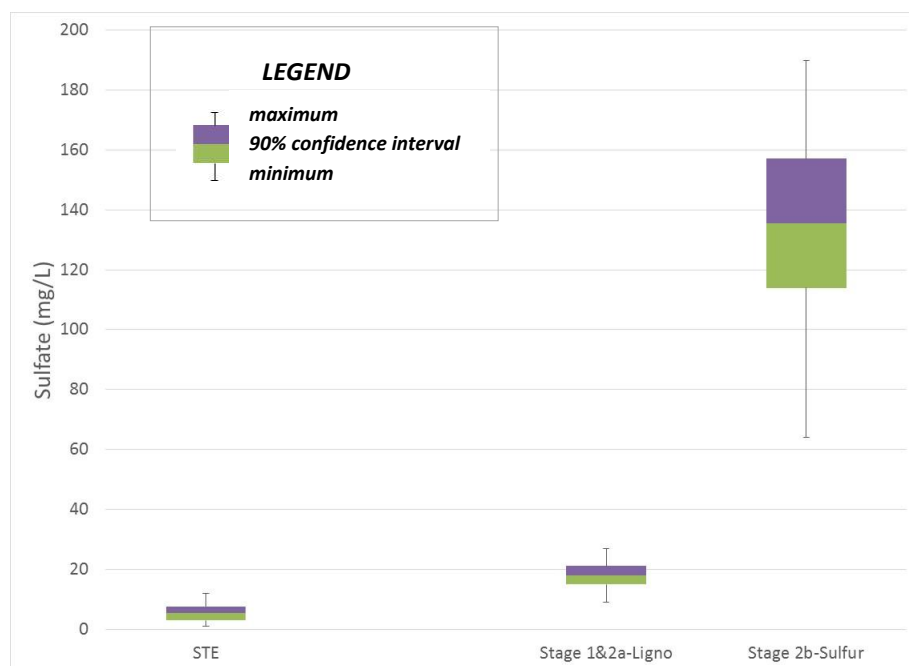
Figure 20
Sulfate (SO₄) Box and Whisker Plot
