Florida Onsite Sewage Nitrogen Reduction Strategies Study

B-HS6 Field System Monitoring Report No. 7

Progress Report

December 2014

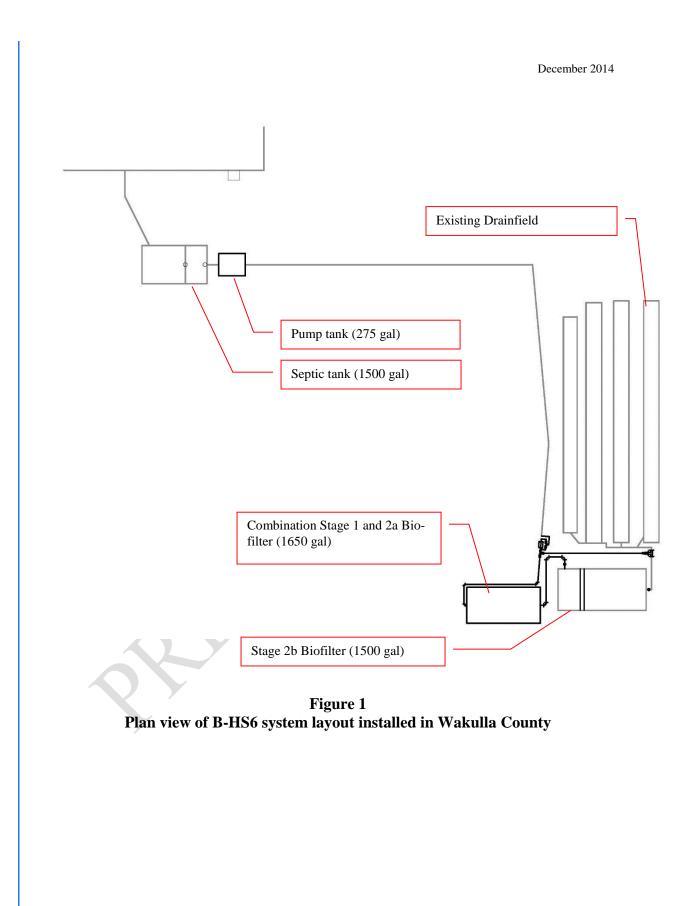
The B-HS6 field site is located in Wakulla County, FL. The nitrogen reducing onsite treatment system for the single family residence was installed in November 2013. Operation commenced on November 14, 2013. Design and construction details were presented previously in the Task B.6 document. Figure 1 is a system schematic showing the system components and layout of the installation. A flow schematic of the system is shown in Figure 2. The new system replaced the previously installed PNRS system installed at field site B-HS1. The previously installed components that were removed were the Aerocell[™] unsaturated media filter chamber, Nitrex[™] media and split

recirculation device. The existing 1,500 gallon dual chamber septic tank will continue to provide primary treatment for the new PNRS system. However, the effluent screen was moved to the outlet and a vented tee was installed between the chambers per 64E-6.013(2)(h). The existing pump and floats were moved from the second chamber of the primary tank into a new 275 gallon pump tank. A 1,650 gallon concrete tank housing a combined Stage 1 and Stage 2a media biofilter was installed. The existing 1,500 gallon concrete single chamber tank which had contained the Nitrex[™] media was converted to a Stage 2b saturated sulfur media biofilter. The denitrified treated effluent is discharged into the soil via the existing drainfield (standard Infiltrator EQ36 Quick 4 trenches).

Treated effluent is discharged to a soil dispersal system (drainfield) consisting of four Infiltrator trenches. Three of the four Infiltrator trenches are 40 feet in length, and the fourth is 36 feet. The layout of the system and a flow schematic are shown in Figures 1 and 2, respectively.

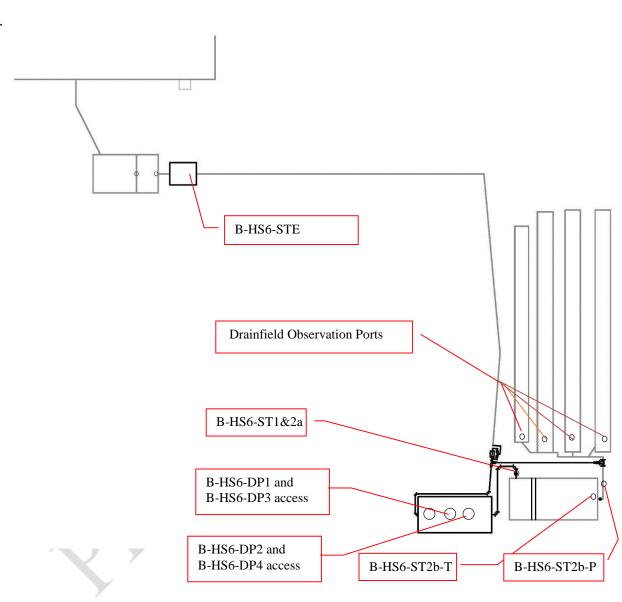
Figure 3 B-HS6 Treatment System Sampling and Monitoring Locations

Four of the eight monitoring points shown in Figure 3 were sampled for this sample event. Monitoring point B-HS6-ST2b-T was not sampled as the water quality was very similar to the adjacent monitoring point B-HS6-STb-P. B-HS6-DP1, B-HS6-DP3, B-HS6-DP4 located in the Stage 1&2a tank were also not sampled during this sample event. Household wastewater enters the 1st chamber of the primary tank and exits the second chamber as septic tank effluent through an effluent screen into the pump tank (which contains the pump and float switches). The first monitoring point, B-HS6-STE, is the effluent sampled from a sample port on the pump discharge line (Figure 4), which is referred to as primary effluent or septic tank effluent (STE). Samples from monitoring point B-HS6-STE are representative of the whole household wastewater and represent the influent to the remainder of the onsite nitrogen reduction system.

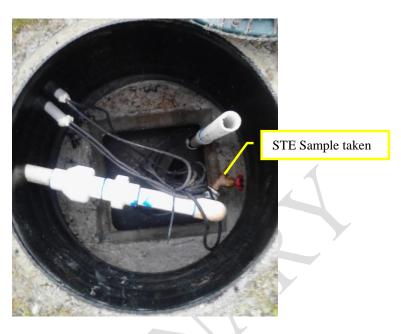
Figure 4 Primary Effluent (B-HS6-STE sample)

Septic Tank Effluent (STE) Quality: The water quality characteristics of STE collected in Sample Event 7 were within the typical range generally expected for domestic STE except for the NO_x-N concentration of 36 mg/L. In the previous 8 samples of STE the NO_x-N concentration ranged from 0.01 to 0.13 mg/L with a mean of 0.03 \pm 0.04 mg/L, n=8. The reported NO_x-N concentration of 36 mg/L is likely a laboratory error as STE is a highly reducing environment with measured DO of 0.37 mg/L and ORP of -215 mV. Assuming the NO_x-N value is a laboratory error, the measured TN concentration for this sample event was approximately 69 mg-N/L, which is in the range typically seen for this household.

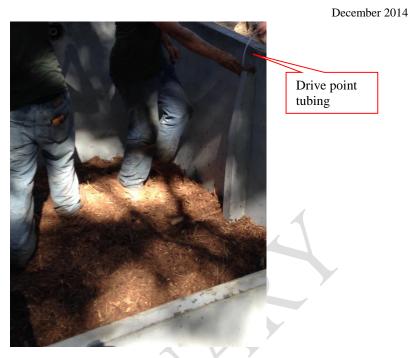
Twelve inches of lignocellulosic media, a blended waste wood from AAA Tree Experts, Tallahassee, FL, was installed underneath the expanded clay media as a supplemental carbon source for denitrification. A single 4-inch diameter outlet pipe connected the Stage 1&2a tank to the Stage 2b tank. The pipe was installed along the centerline of the Stage 1&2a tank with the invert at 4-inches above the interior bottom of the tank. Therefore, approximately 4-inches of the lignocellulosic media is saturated, promoting oxygen depletion and denitrification of the nitrified effluent. Two additional stainless steel drive points were installed at the bottom of the Stage 2a saturated lignocellulosic media (see Figure 6). These drive points sampled water from near the very bottom of the tank. The fourth and fifth sampling points (B-HS6-DP3 and B-HS6-DP4) are sampled by connecting a peristaltic pump to the drive point tubing, representing the Stage 2a saturated biofilter effluent.

Figure 6 Stage 2a Saturated Biofilter Effluent (B-HS6-DP3 and B-HS6-DP4) sample tubing

Stage 2a Saturated Effluent (DP3 and DP4): Not sampled for Sample Event 7.

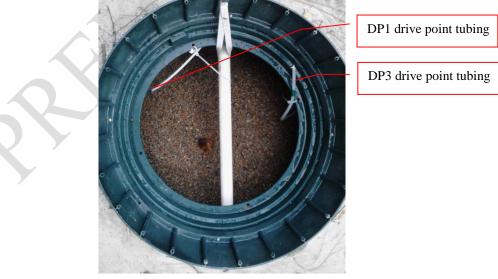
The tubing for sample points B-HS6-DP1 and B-HS6-DP3 are accessed via the middle tank cover (Figure 7), and B-HS6-DP2 and B-HS6-DP4 are accessed through the tank cover on the outlet side of the tank.

Figure 7 Drivepoint tubing access (B-HS6-DP1 and B-HS6-DP3 sample)

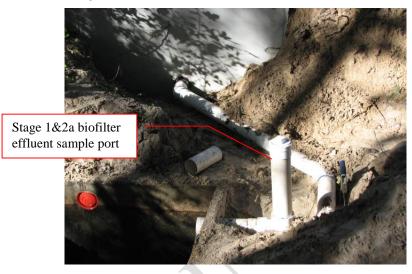
PAGE 1-9 HAZEN AND SAWYER, P.C. The effluent from the Stage 1&2a biofilter flows into the Stage 2b biofilter by gravity. The sixth sampling point (B-HS6-ST1&2a) is taken from a sample port in the gravity pipe connecting the Stage 1&2a biofilter outlet to the Stage 2b biofilter inlet representing the Stage 1&2a biofilter effluent (see Figure 8).

Figure 8 Stage 1&2a Biofilter Effluent Sample Port (B-HS6-ST1&2a sample)

Stage 1&2a Tank Effluent (ST1&2a): The sample port between the Stage 1&2a combination tank and the Stage 2b sulfur tank represents the effluent from the Stage 1&2a tank and the influent to the Stage 2b biofilter. The Stage 1&2a sample port effluent TKN was 9 mg/L of which 8.7 mg/L was NH₃-N. The NO_x-N concentration was 35 mg/L and was accompanied by a measured DO of 1.47 mg/L DO and ORP of 167 mV. The Stage 1&2a effluent TSS concentration was below the method detection level of 1 mg/L and CBOD₅ was 6 mg/L. The ST1&2a sample indicates incomplete ammonia removal and some nitrate removal in the Stage 1&2a biofilter.
